# PEDESTRIAN / BICYCLE SAFETY REVIEW

SR 501 / Clearlake Road from Dixon Boulevard to Michigan Avenue

February 2016

## **Pedestrian/Bicycle Safety Review Report for SR 501/Clearlake Road from Dixon Boulevard to Michigan Avenue**

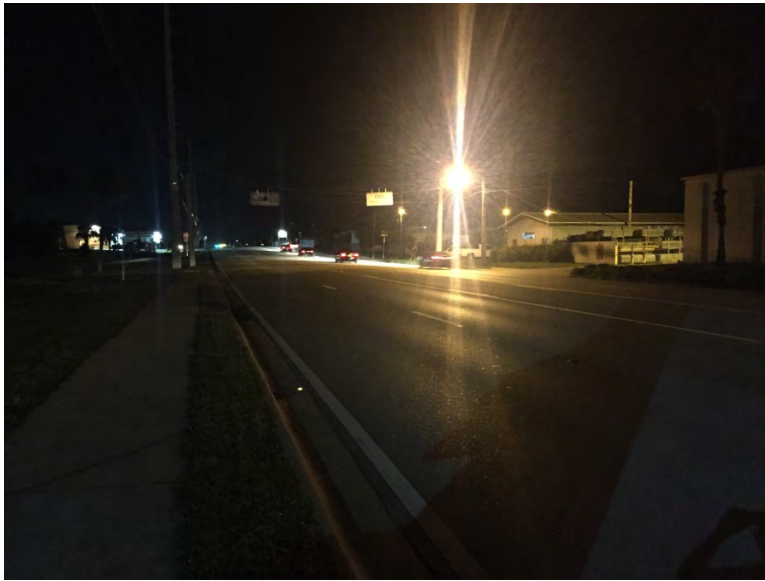
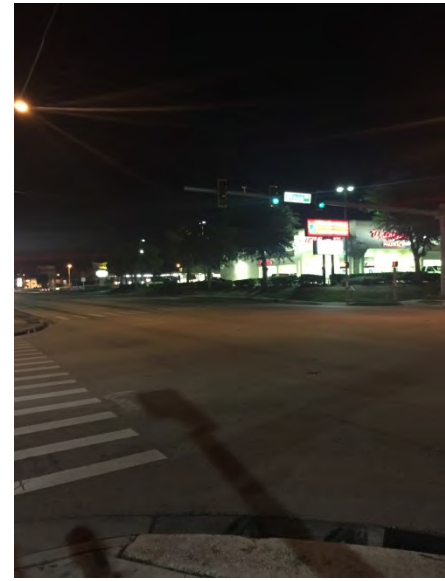
**Issue #1: Corridor Lighting**

The crash statistics showed 35 percent of the pedestrian/bicycle crashes, including both fatal pedestrian crashes, occurred during non-daylight conditions. Intermittent corridor lighting is provided along SR 501's west side only between Dixon Avenue and the Brevard County Central Area Adult Education Center (BCCAAEC), and between Rosetine Street to Michigan Avenue. Corridor lighting is not provided between BCCAAEC and Rosetine Street (Brevard County jurisdiction). During the nighttime field review, the study team observed inconsistent lighting levels along the corridor, making it difficult to see pedestrians or bicyclists along the corridor at night, especially those wearing dark clothing. **Figure 8** and **Figure 9** illustrate the lighting conditions the field review team observed. Ambient lighting from businesses on the corners contributed to the lighting conditions at the signalized intersections.

- Consider upgrading the lighting at the signalized intersections to meet the requirements of section 7.3.2.2 in Volume 1 of the FDOT PPM. This may require the existing lighting to be replaced.
- Consider conducting field measurements of existing lighting levels in the areas along the corridor with existing lighting to evaluate lighting uniformity levels and add lighting where necessary.
- Consider conducting a lighting justification study along unlit portions of the corridor to determine if additional lighting is justified.

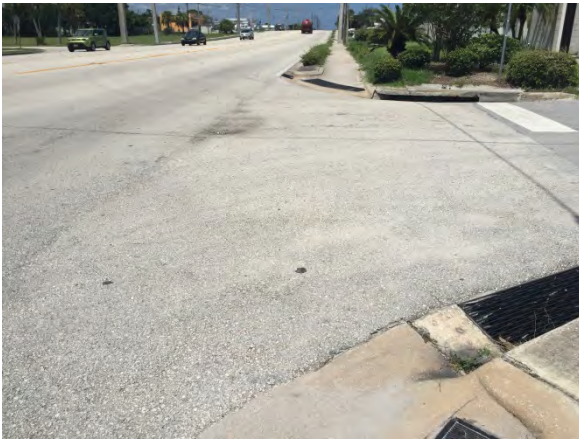
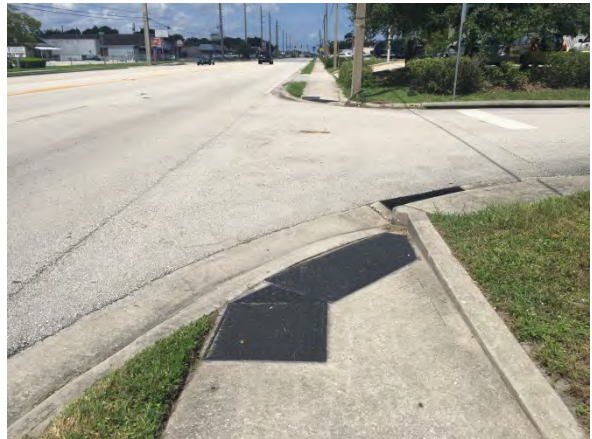
Marked crosswalks are not included along any of the minor street approaches at the unsignalized intersections throughout the corridor (see **Figure 10** and **Figure 11**). This was observed along the east and west sides of the study corridor. Inclusion of standard crosswalks at the unsignalized intersections and major driveways may give better indication to drivers that pedestrians may be present.

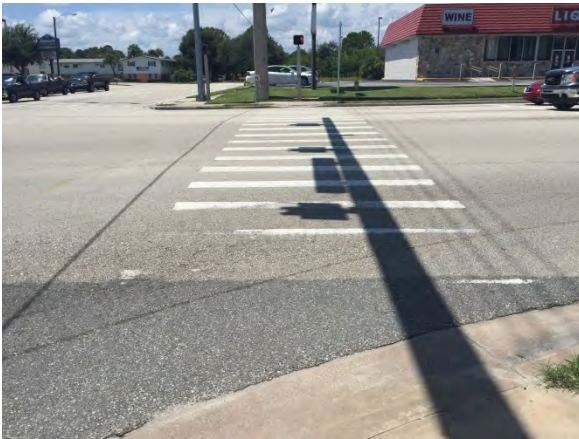
Figure 12

Crosswalk markings at some signalized intersections are beginning to wear (illustrated in **Figure 12**). The crosswalks at the signalized intersections south of Michigan Avenue (Dixon Boulevard and Rosetine/Tate Street) are marked with the old standard emphasis markings (shown in **Figure 13**).

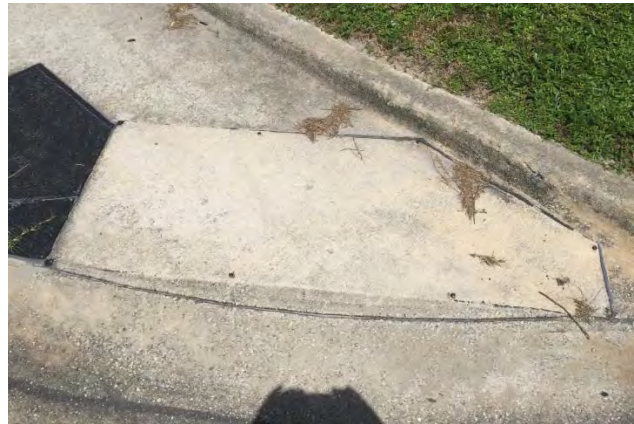
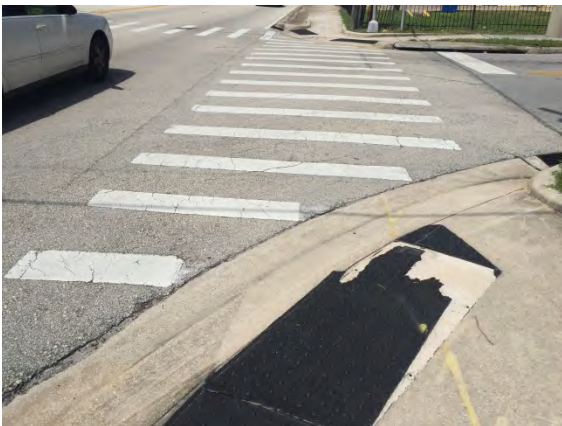
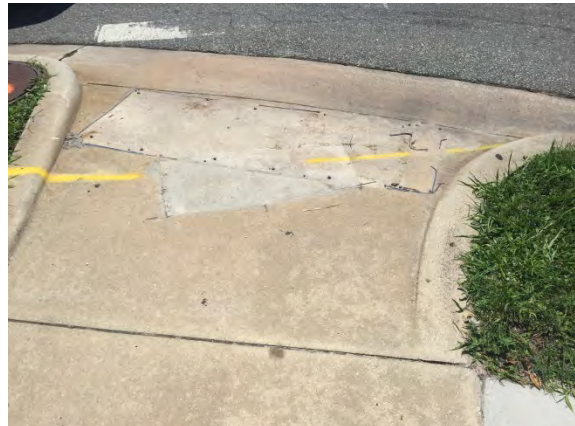
The detectable warning surfaces appear to be nailed down into the concrete. As a result, many of the surfaces have been displaced from the curb ramps at both signalized and unsignalized intersection locations. These displacements and absences of the detectable warning surfaces are shown in **Figure 14** through **Figure 17**.

Consider replacing/installing detectable warning surfaces per FDOT standard index 304 at both the signalized and unsignalized crossings south of the Michigan Avenue intersection.

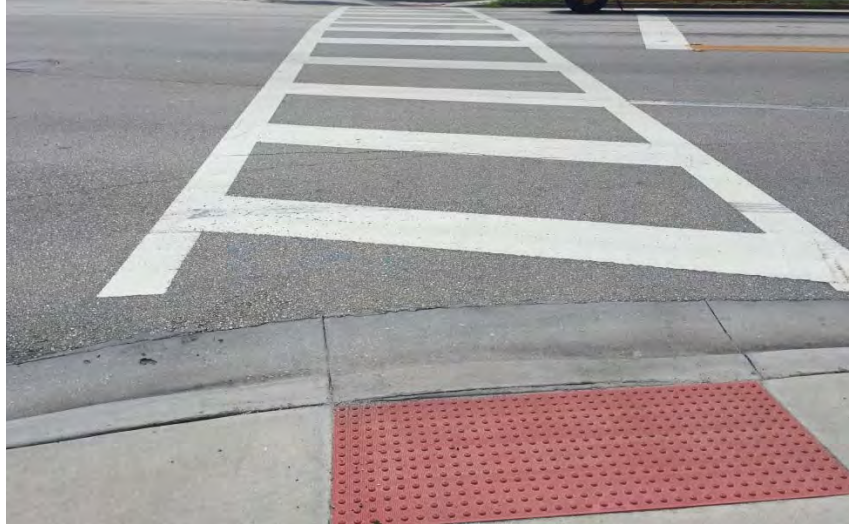
**Figure 18**

The pedestrian facilities at the intersection of SR 501 at Michigan Avenue were upgraded in 2012. Crosswalks were added to the north and east legs of the intersection. As part of the pedestrian facilities improvements, new detectable warning surfaces were installed. An example of an installed detectable warning surface at the Michigan Avenue intersection is shown in **Figure 18**.

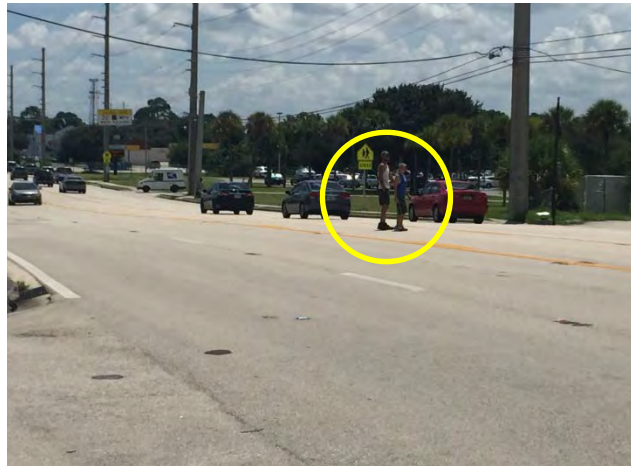
A 12-foot center two-way left-turn lane (TWLTL) is provided along the length of SR 501. The center two-way left-turn lane is an area of conflict between pedestrians/bicyclist and vehicles as pedestrians and bicyclists were observed using the center TWLTL as a refuge to cross SR 501 (**Figure 19**). This creates issues when drivers utilize the center TWLTL.

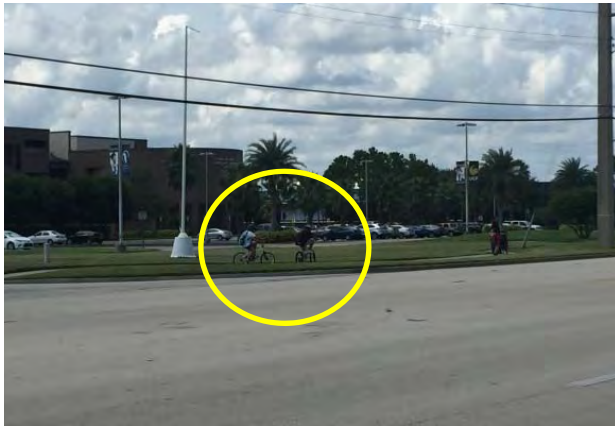
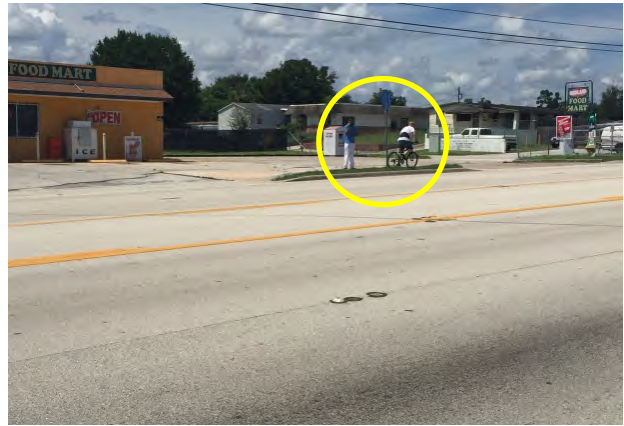
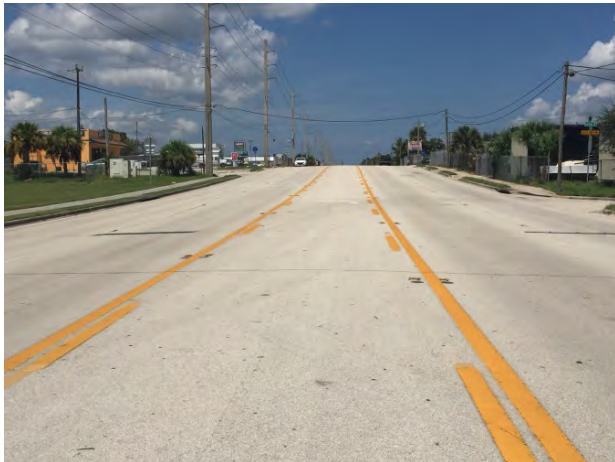
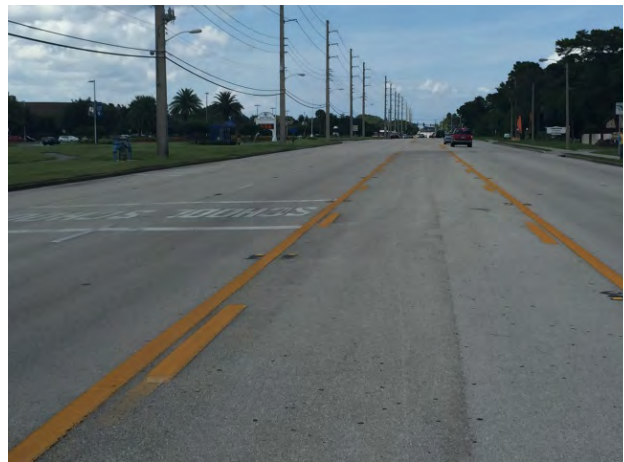
Over half of the bicycle crashes involved bicyclist riding along the sidewalk and against the flow of traffic. Most bicyclists observed in the field were riding along the sidewalks. Examples of the observed bicycle activity are illustrated in **Figure 21** and **Figure 22**. No bicycle lanes are provided along the length of the corridor as shown in **Figure 23** and **Figure 24**. No paved shoulders are provided as curb and gutter is present along the length of the corridor. Bicyclists may not feel safe or comfortable riding in the travel lanes as the posted speed is 45 mph.

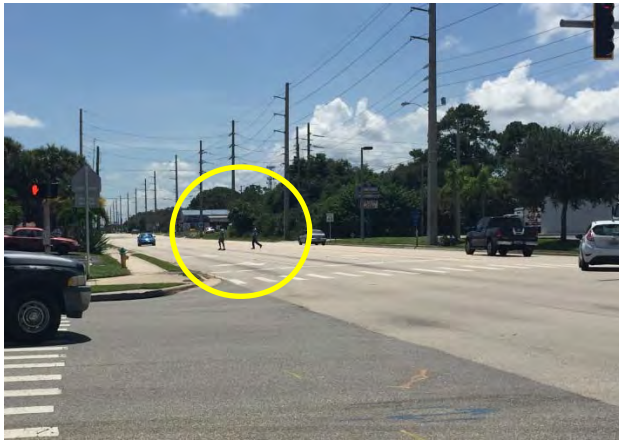
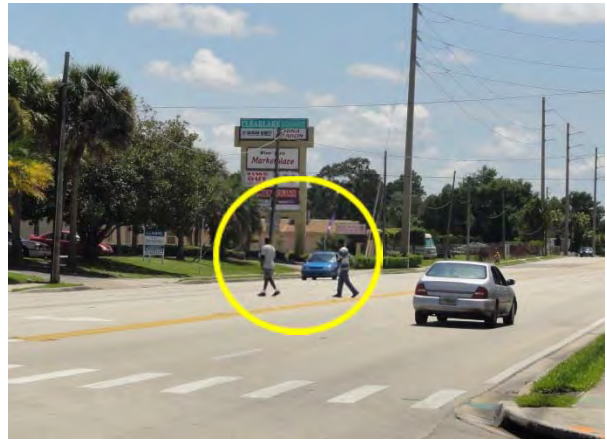
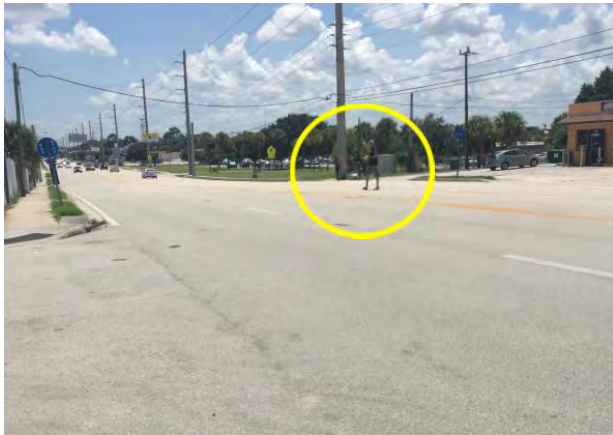
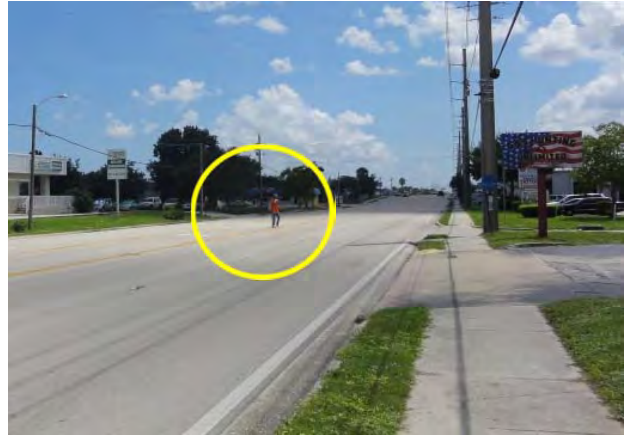
The field review team observed several instances where pedestrians chose to cross SR 501 at an unmarked and unsignalized location. As shown in **Figure 25** and **Figure 26** the pedestrians were observed crossing the south leg of the intersection of SR 501 and Dixon Boulevard less than 150 feet south of the marked signalized crosswalk location. In other instances, pedestrians were not as close to a signalized crosswalk and were observed crossing SR 501 and utilizing the center TWLTL as a pedestrian refuge (**Figure 27** and **Figure 28**).

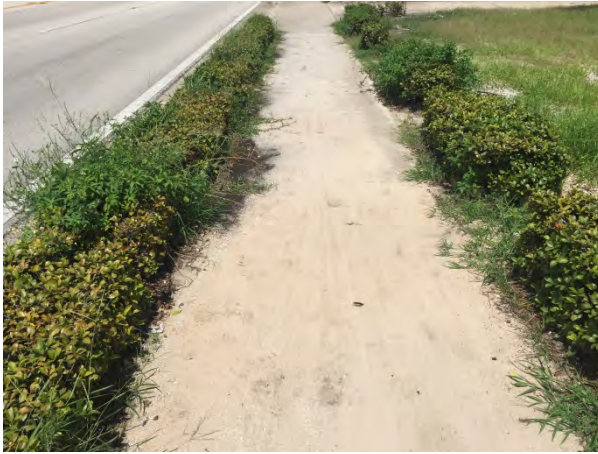
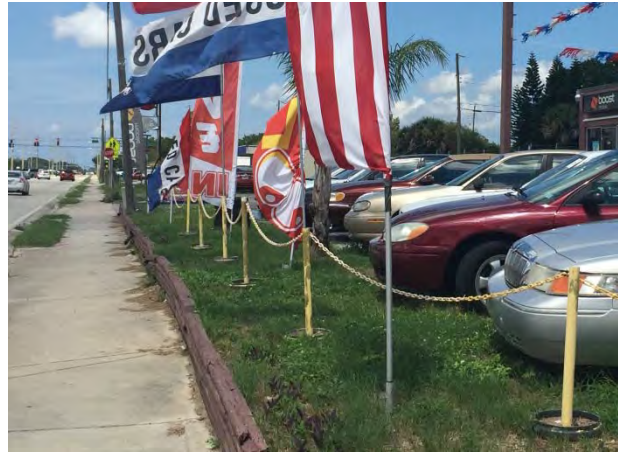
There were instances where dirt from the adjacent landscaping had washed out onto the sidewalk, completely covering the concrete surface. This was observed on the east sidewalk on the northeast corner of the intersection of SR 501 and Dixon Boulevard. The material washed away from the slope in front of Walgreens. This also occurred on the east sidewalk on the northeast corner of the intersection of SR 501 and Clearlake Court (illustrated in **Figure 29**). A palm tree was observed encroaching over the sidewalk on the east side of SR 501 near the car wash.

Consider cleaning the sidewalk surfaces, trimming trees, and working with the FDOT and/or local business owners to replace/upgrade the landscaping slopes and retaining wall so that the sidewalk will remain free of debris. Coordination with FDOT is suggested to determine if the landscaping slopes and wooden walls are within the FDOT right-of-way. If the landscaping is within the FDOT right-of-way, coordination between FDOT and local business owners should occur to better maintain landscaping.

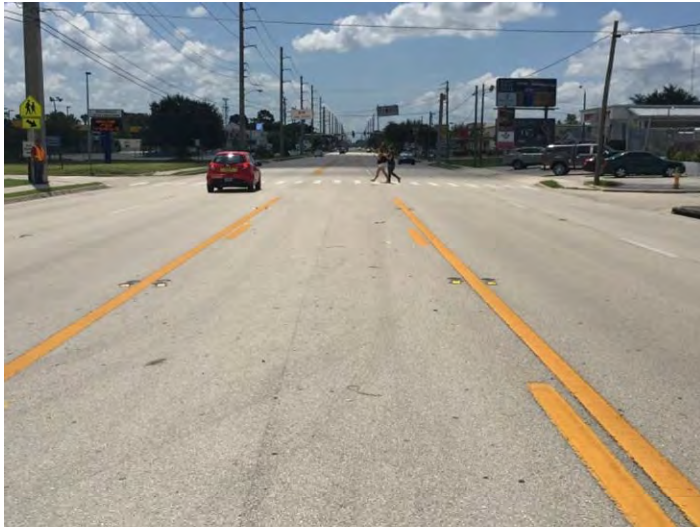
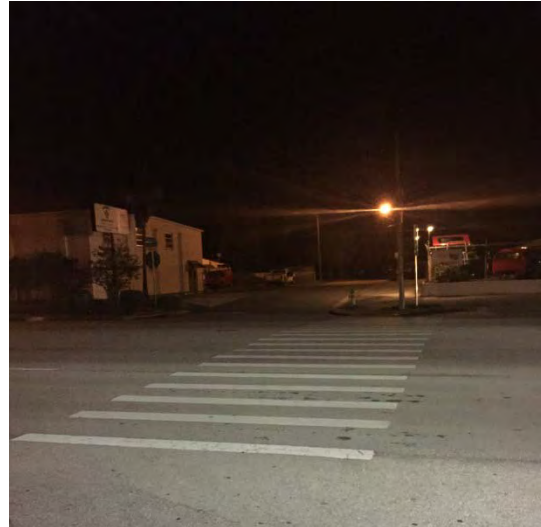
A mid-block crosswalk is present at the entrance to the BCCAEC, on the south side of the Clearlake Court intersection. The crosswalk is no longer attended by a crossing guard and would no longer be considered a school crossing once the school zone signs and pavement markings are removed. Pedestrian crossing activity was observed in the vicinity during the field review (**Figure 37**). **Figure 38** illustrates the lighting conditions at the crosswalk under night conditions. The fate of the mid-block crosswalk will need to be determined as part of the school zone removal (refer to **Issue #11: Overhead School Zone Structures**).

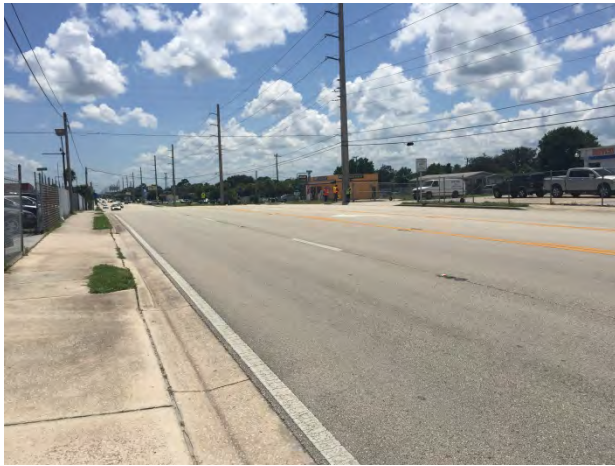
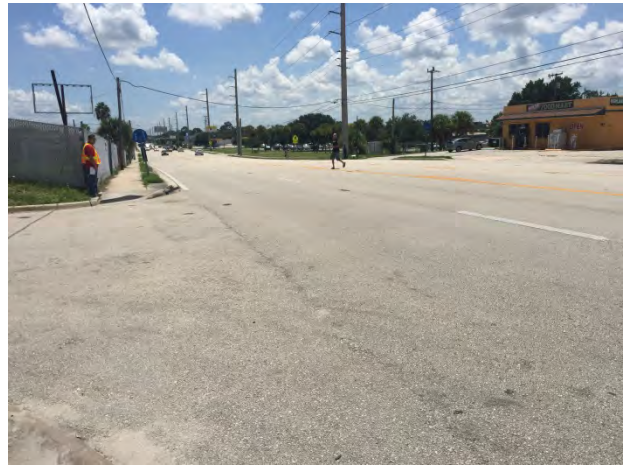
**Issue #14: Sight Distance**

Consider conducting a sight distance evaluation at the intersection to determine the available sight distance at the intersection. Also, determine if the fence is on private property or within the FDOT right-of-way. If adequate sight distance is not provided, coordinate with the appropriate owner (FDOT or the land owner) to consider replacement, relocation, or removal of the fence. Sight distance could be improved with transparent fence materials.

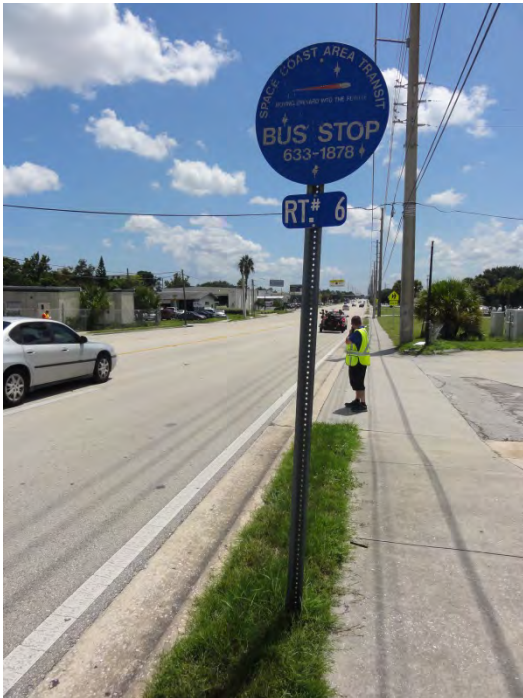
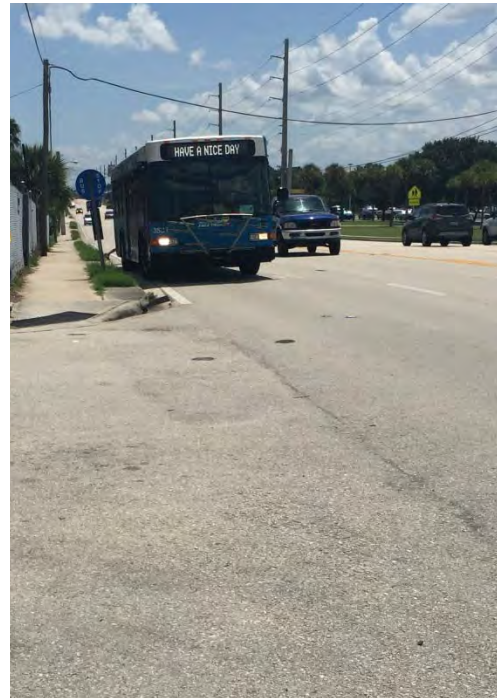
Bus stops are located near the northeast and southwest corners of the Highland Court intersection (shown in **Figure 44** and **Figure 45**, respectively). Pedestrian crossings were observed at this location associated with the transit stops. Pedestrians look for vehicle gaps to make their crossing and use the TWLTL as a refuge. However, the vertical curve of the roadway at this location limits sight distance for pedestrians crossing the street. Two pedestrians were hit near Highland Court and two near Loring Street (immediately to the south). All four pedestrian crossing crashes occurred during the day, involved southbound vehicles, and resulted in injury.

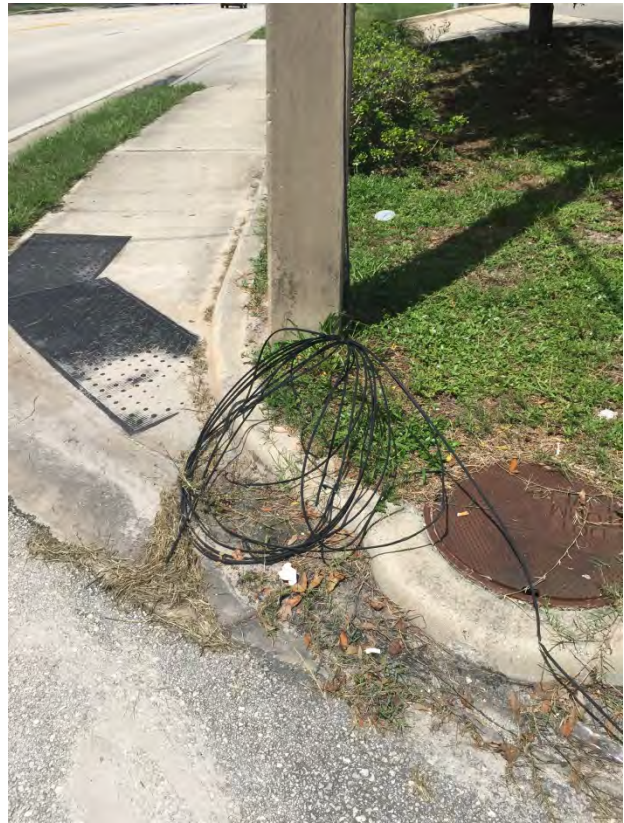
Figure 47

Loose wiring associated with the pole on the northeast corner of the intersection of SR 501 at Furnari Street is rolled up on the ground adjacent to the sidewalk and man hole, posing a trip hazard to pedestrians at the intersection. This tripping hazard is illustrated in **Figure 47**.

Coordinate with the utility provider to remove the trip hazard.

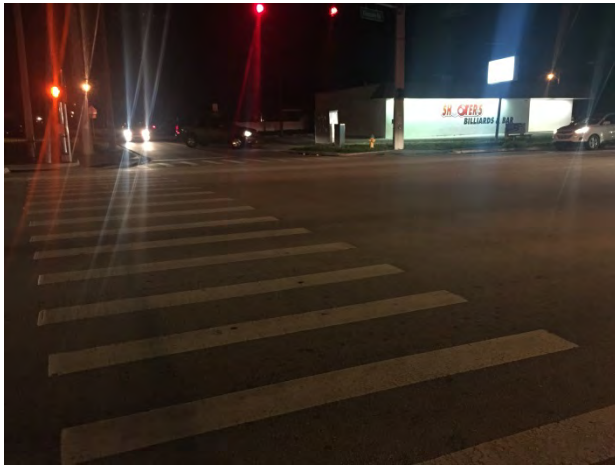
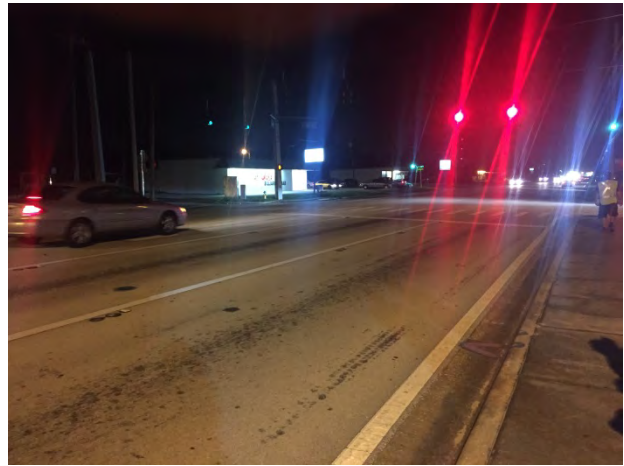
Intersection lighting is provided on the northwest corner of the intersection. **Figure 52** and **Figure 53** show the intersection lighting conditions at night. Three of the six pedestrian and bicycle-related crashes occurred at night and all three crashes resulted in at least one injury and one involved a fatality.

Consider upgrading the lighting at the intersection to meet the requirements of section 7.3.2.2 in Volume 1 of the FDOT PPM. This may require the existing lighting to be replaced.

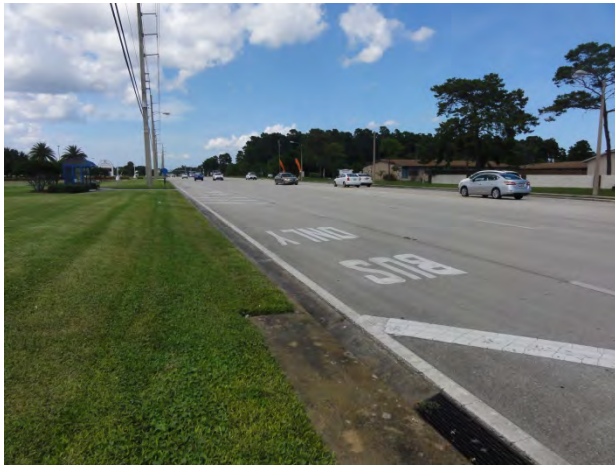
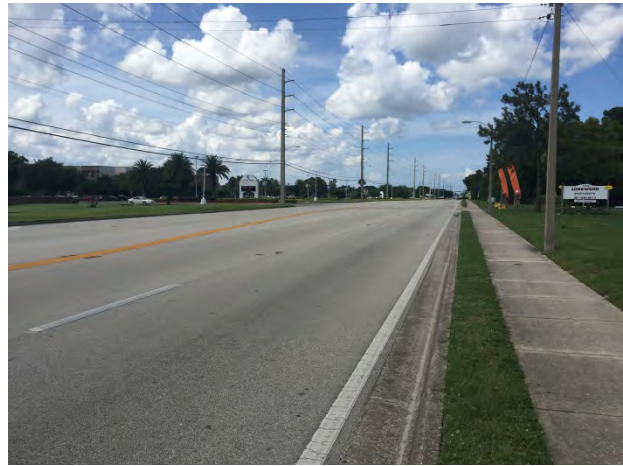
An intersection study was conducted by FDOT in September 2014 at the intersection of SR 501 at EFSC. There is high pedestrian activity due to interactions between the residential land uses on the east side of SR 501, the college, and a major transit stop. A recommendation from the study was to install a marked mid-block crosswalk with a refuge island approximately 170' south of the main entrance to the EFSC. **Figure 54** and **Figure 55** illustrate SR 501 in the vicinity of the proposed crosswalk location. It was also recommended the transit stop on the north side of the Longwood Apartments be relocated to the proposed crosswalk location to encourage transit riders to utilize the crosswalk. A draft concept of the proposed crosswalk is included in **Appendix C**.

Coordinate with FDOT to determine the progress of this project. FDOT has mentioned that there are potential issues with the proposed location due to queue spillback from the northbound left-turn movement at the entrance to the college. The field review team noted some pedestrians crossing in the vicinity of this location and a marked crosswalk in this area may facilitate safer opportunities to cross for pedestrians, bicyclists, and transit users.

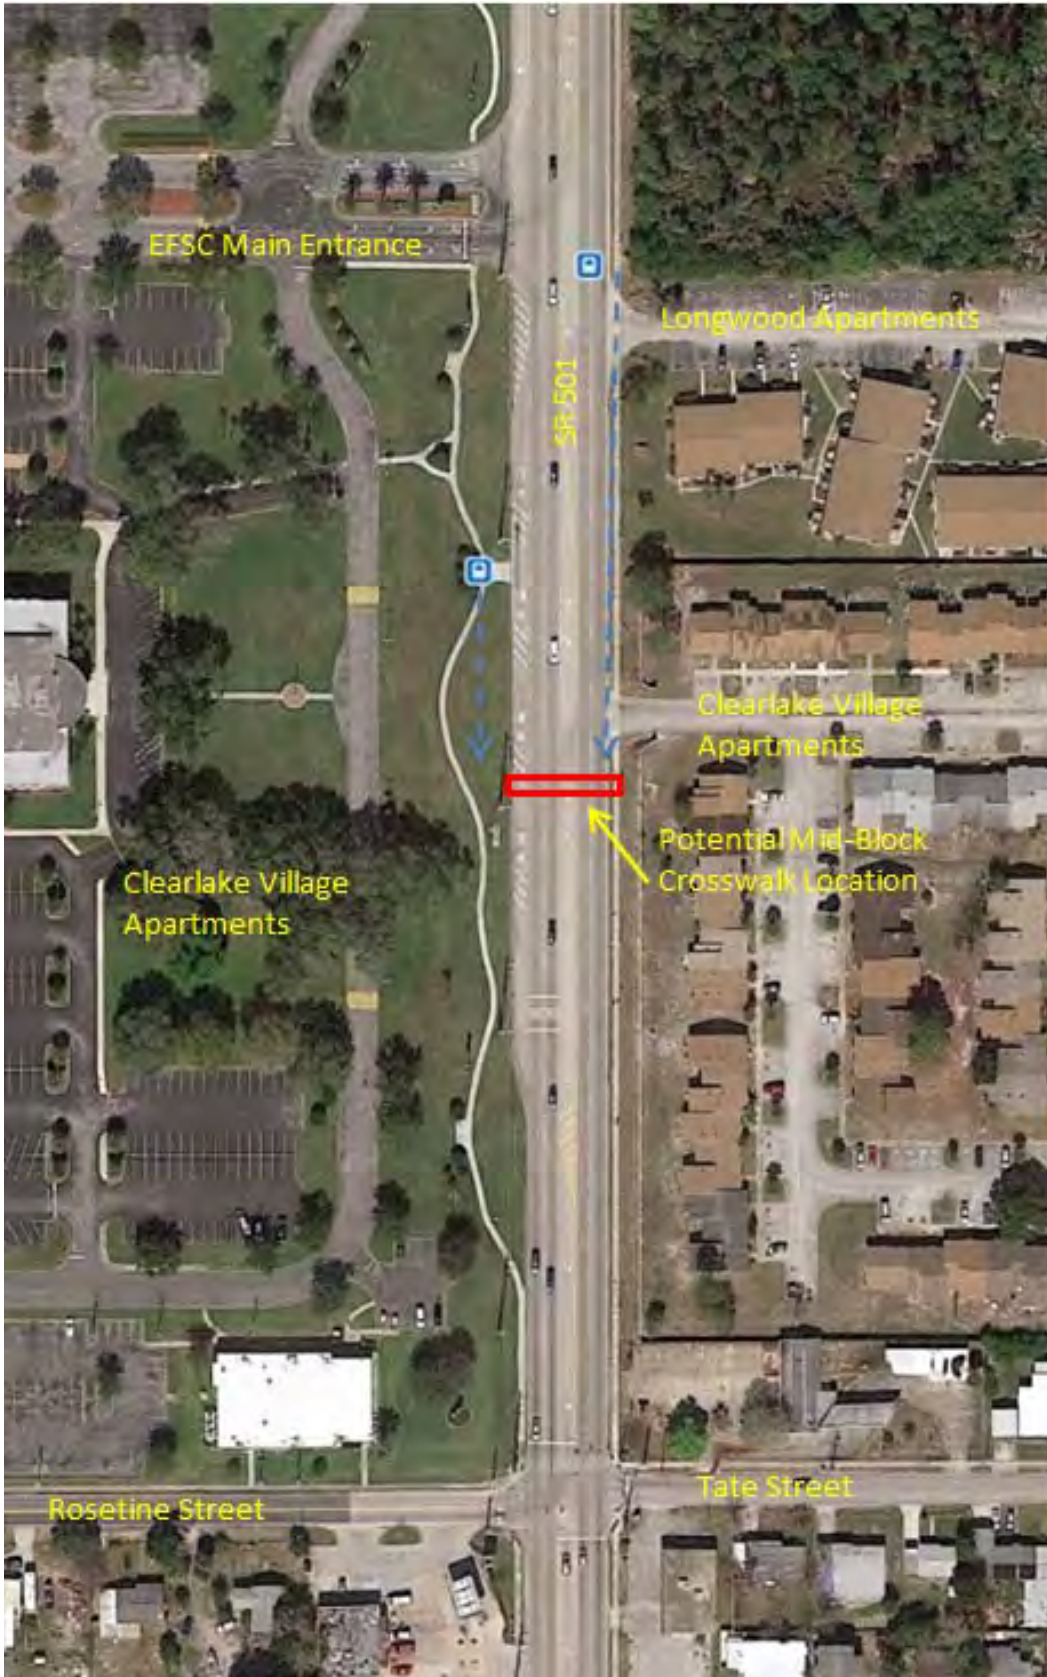
Figure 56

The team identified an alternative location approximately 400 feet south of the college entrance, just south of the Clearlake Village residential driveway. This location would minimize impacts to left-turn queues by removing the proposed crosswalk from active left-turn lanes (northbound and southbound). To accommodate this location, the existing southbound bus stop and shelter should be relocated 180 feet to the south, the northbound bus stop should be relocated 400 feet to the south, and a sidewalk connection from the relocated southbound bus stop into the campus should be provided. The City of Cocoa mentioned the potential development of the vacant parcel on the east side of the campus entrance and potential signalization of the intersection in the future. This location would also allow the mid-block crossing to remain if the main entrance to the campus were signalized in the future, as it would be more than 300 feet from adjacent crosswalks to the north or south. The potential mid-block location and bus stop relocation is illustrated in **Figure 56**.

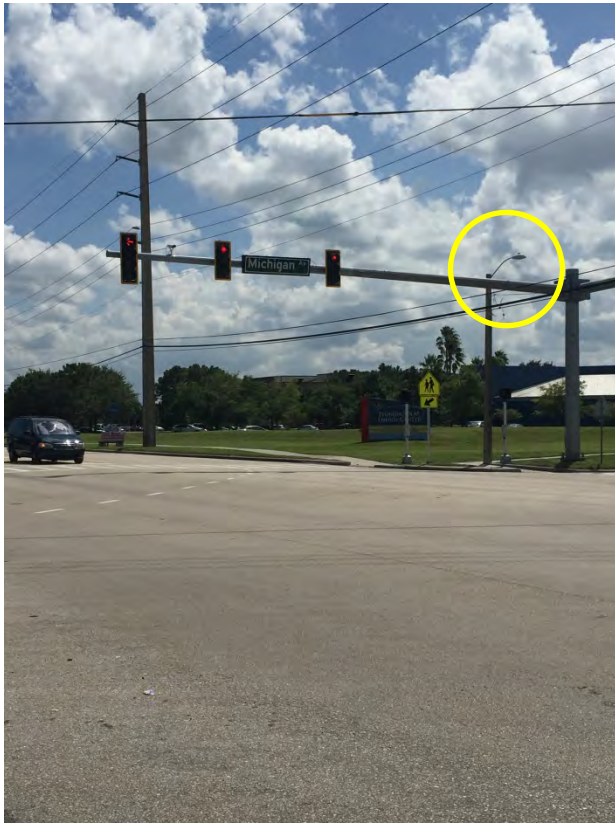
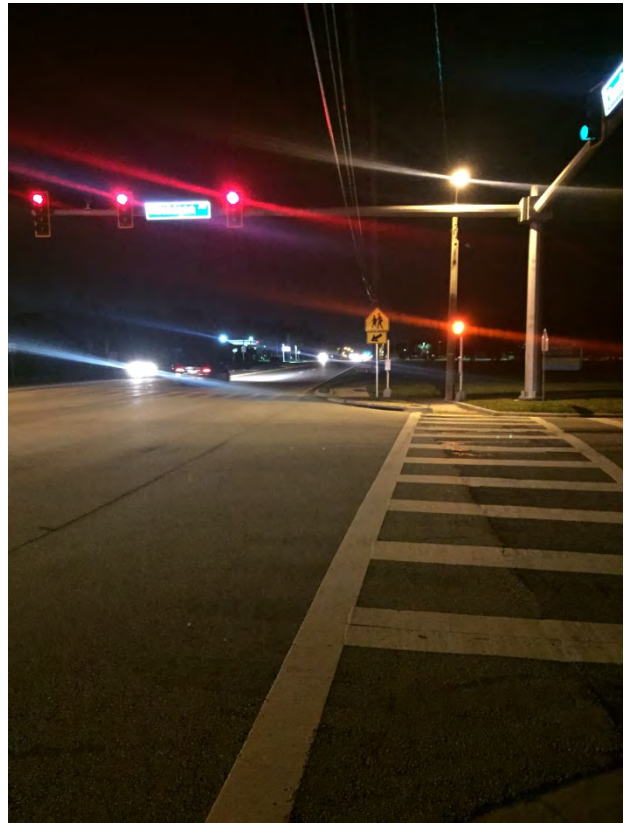
The intersection was recently upgraded from span wire to mast arms in addition to pedestrian facility upgrades. There was a light pole on the southwest corner of the intersection before the upgrades were made. Upon installation of the mast arm on the southwest corner, the light on that corner is blocked by the mast arm. **Figure 57** and **Figure 58** illustrate the location of the light pole and mast arm during daylight and nighttime conditions, respectively.

Consider upgrading the lighting at the intersection to meet the requirements of section 7.3.2.2 in Volume 1 of the FDOT PPM. This may require the existing lighting to be replaced.
