ROAD SAFETY AUDIT

Emerson Drive/Minton Road/Palm Bay Road from Jupiter Boulevard to Culver Drive

July 2016

Project Title: Emerson Drive Road Safety Audit

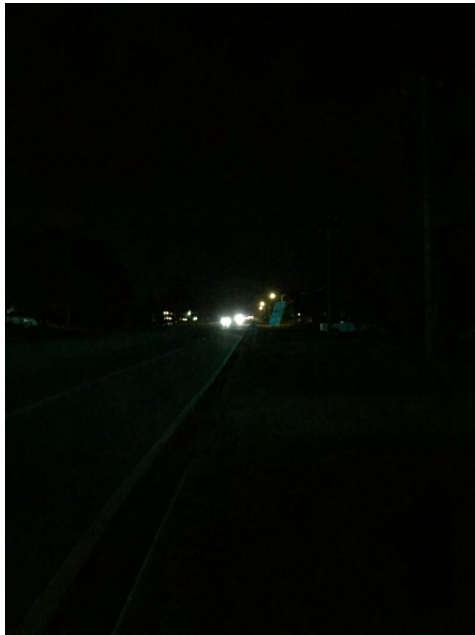
Figure 19

In addition to the segments and intersections within the study area, the study team also observed a lack of lighting along the south leg of Jupiter Boulevard (**Figure 19**). Luminaires were also burnt out near the merge area just west of the Emerson Drive/Jupiter Boulevard intersection (**Figure 20**).

In the near-term, consider upgrading the lighting at the signalized intersections to meet the requirements of Section 7.3.2.2 in Volume 1 of the FDOT Plans Preparation Manual (PPM). This may require the existing lighting to be replaced.

Consider a lighting uniformity study along Emerson Drive to review lighting consistency along this segment. Providing consistent lighting levels along this segment will make vehicles/pedestrians/bicyclists more visible during non-daylight lighting conditions. Also consider a lighting justification study along Minton Road and Palm Bay Road to determine if additional segment lighting is justified.

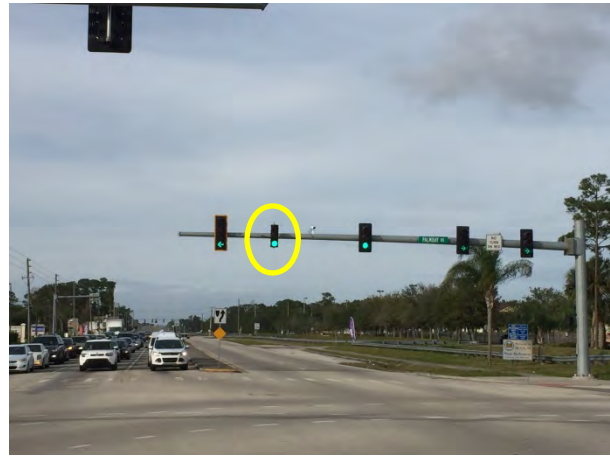
Figure 30

The study team observed signals missing signal head backplates at Emerson Drive/Jupiter Boulevard (**Figure 29**), Emerson Drive/Park and Ride Lot, Emerson Drive/Minton Road, and Minton Road/Palm Bay Road (**Figure 30**). Rear-end crashes at the signalized intersections accounted for 399 of the 440 crashes (91 percent) along the entire study corridor.

In the near-term, consider installing signal head backplates at the intersections where backplates are missing. Along with the backplate installation, consider adding the 3-inch yellow reflective sheeting (**Figure 31**) to all signal heads along the study corridor to help the signal heads stand out during the day and become more retroreflective at night. According to the FHWA Crash Modification Factor (CMF) Clearinghouse, adding the yellow reflective sheeting can reduce crashes at an intersection by up to 15 percent.
