ROAD SAFETY AUDIT

Malabar Road from Jupiter Boulevard to Minton Road and Emerson Drive to San Filippo Drive

June 2016

Project Title: Malabar Road Safety Audit

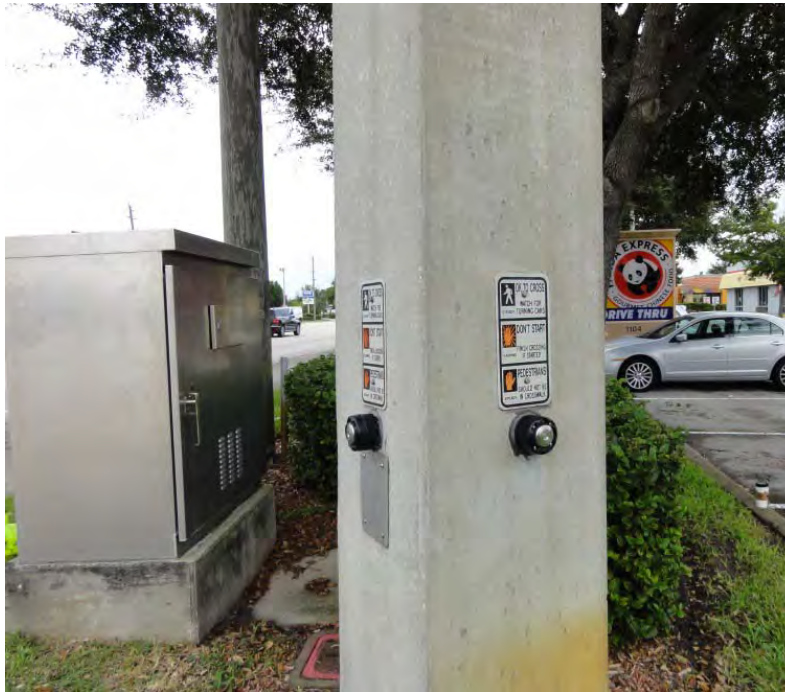
Figure 33

Issue #2: Pedestrian Signage at Signalized Intersections

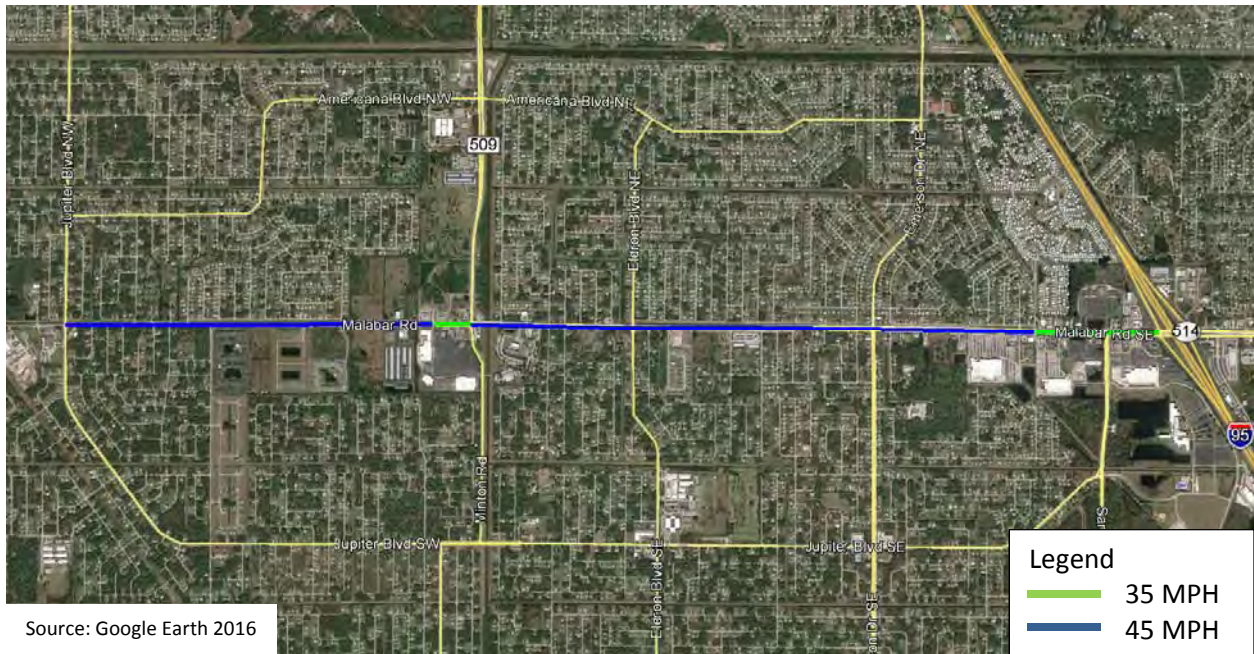
Figure 34

Issue #3: Speed Consistency

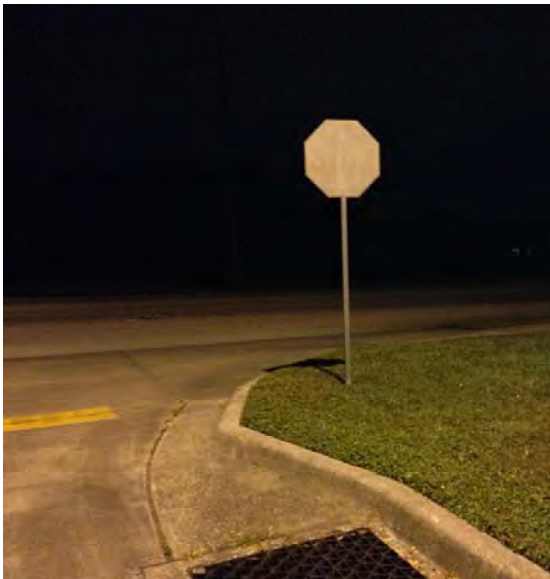
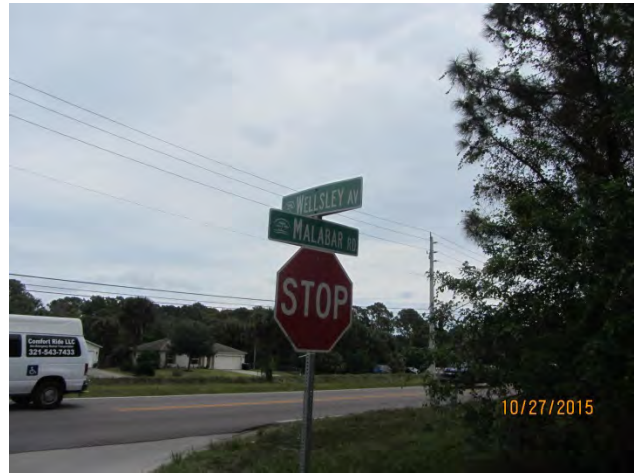
Issue #7: Stop Sign Retro-Reflectivity

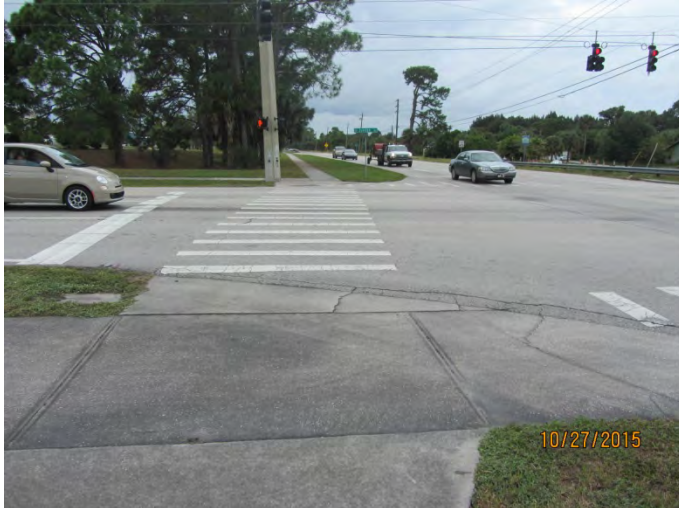
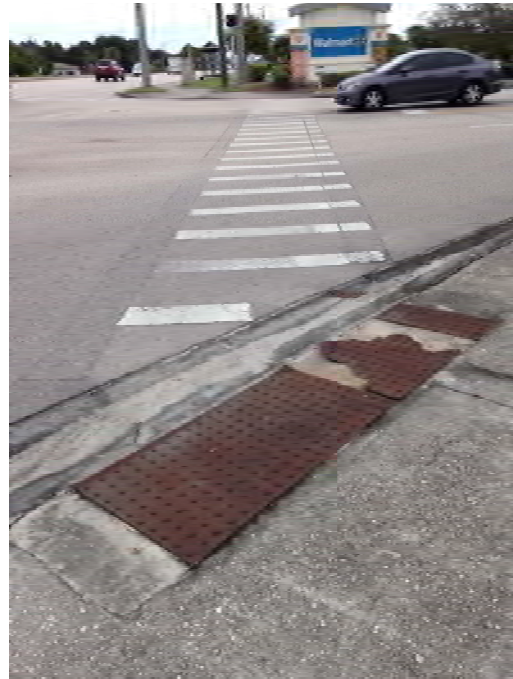
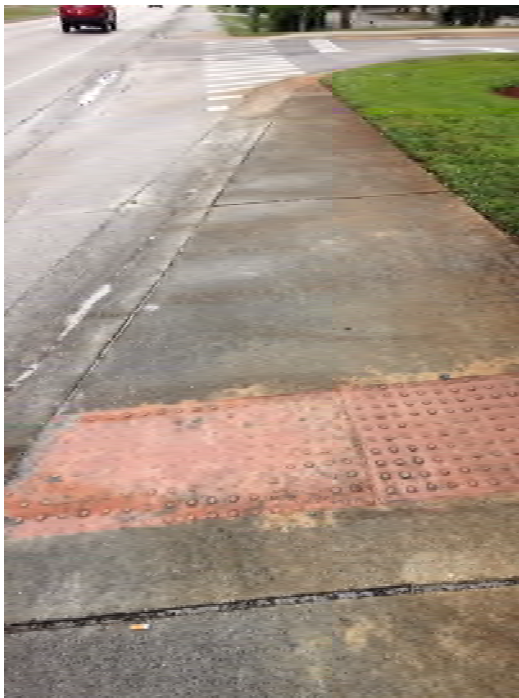
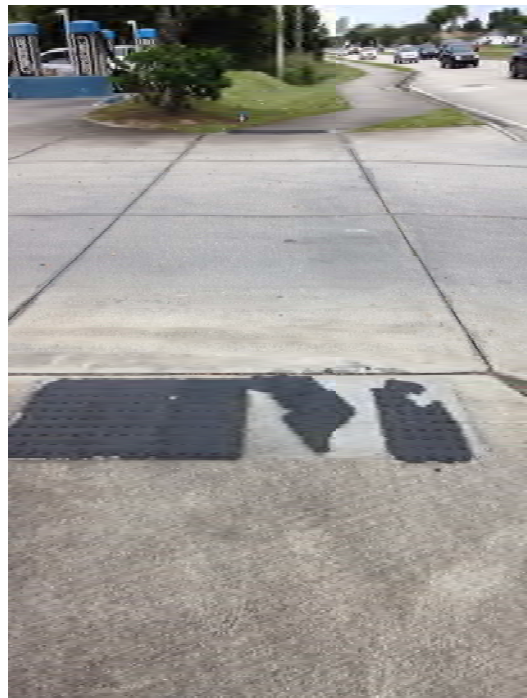
Issue #9: Detectable Warning Surfaces

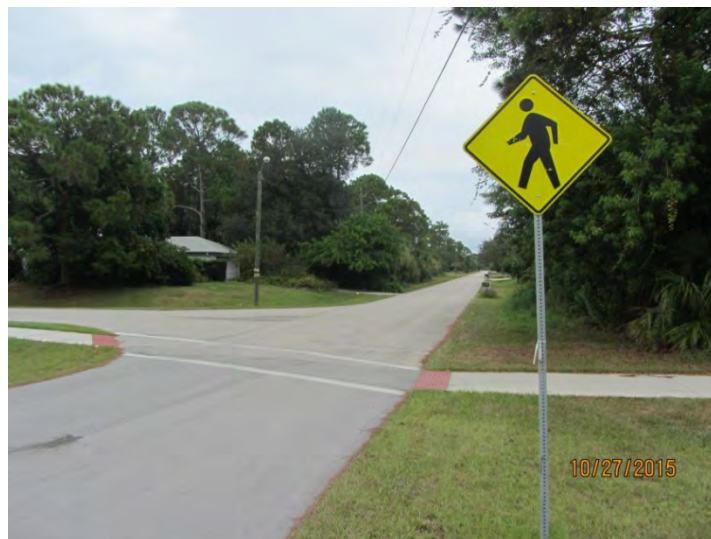
Figure 52

At the Greenbrier Avenue minor street sidewalk/trail crossing, a pedestrian warning sign along with standard crosswalk markings and detectable warning surfaces was recently installed (**Figure 52**). To provide consistency at the other minor street intersections between Jupiter Boulevard and Maywood Avenue/Daffodil Drive, consider installing the same treatments:

- Crosswalk markings per FDOT Design Standard Index 17346 pages 4 and 9.
- Detectable warning surfaces per FDOT Design Standard Index 304.
- Pedestrian crossing warning signage W11-2.

Consider installing stop bars and double yellow striping per FDOT Design Standard Index 17346 page 4. Consider assessing the stop sign placement at these intersections according to guidance in Section 2B.10 of the MUTCD and move closer to the roadway if applicable.

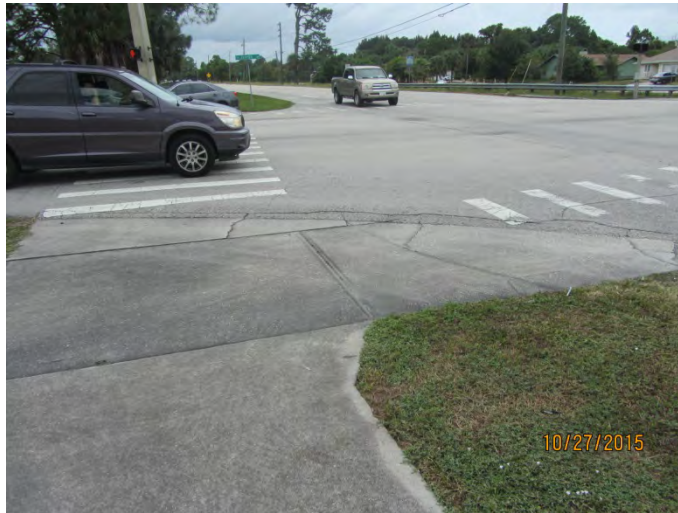
Figure 58

Issue #13: Turning Vehicles and Pedestrians in Crosswalk

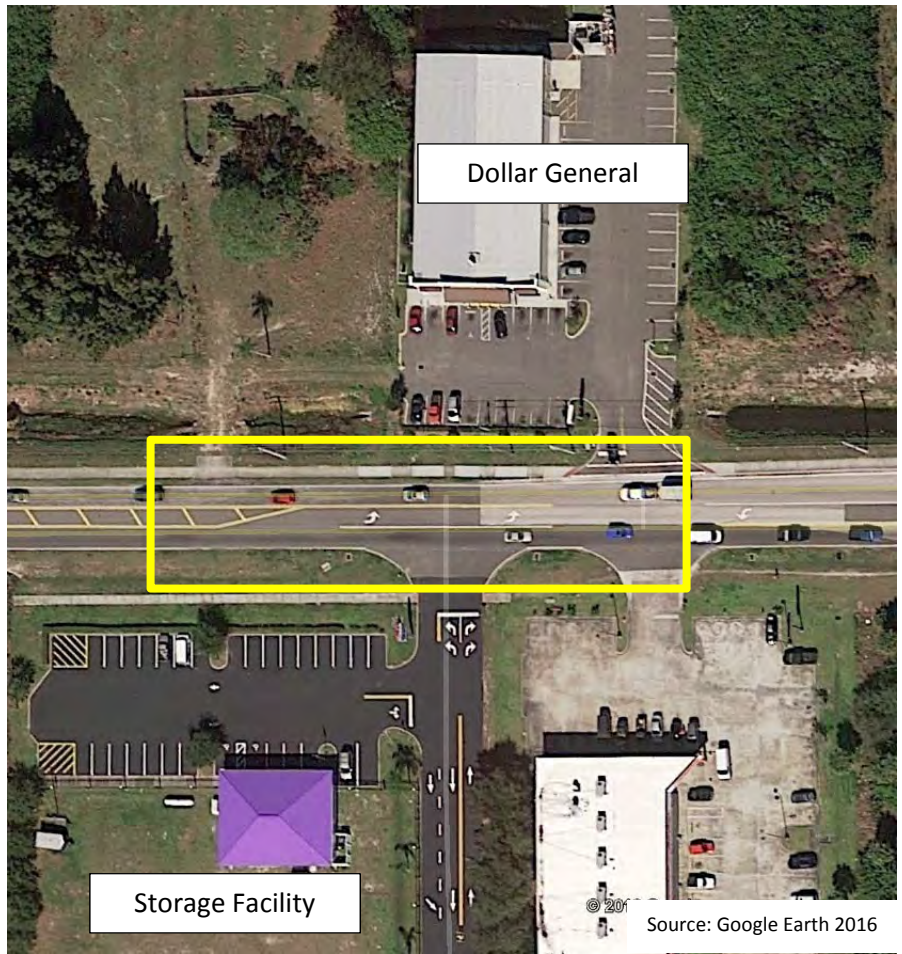
Figure 63

Issue #15: Left-Turn Lane into Dollar General

Consider restriping the eastbound left-turn lane as a two-way left-turn lane (TWLTL). This striping will alert drivers to the possible presence of left-turning vehicles coming from the opposite direction. A CENTER LANE TWO-WAY LEFT-TURN LANE ONLY sign (**R3-9a or b**) accompanied by a BEGIN sign (**R3-9cP**) should be considered in the eastbound direction prior to the start of the TWLTL (section 2B.24 in the MUTCD).

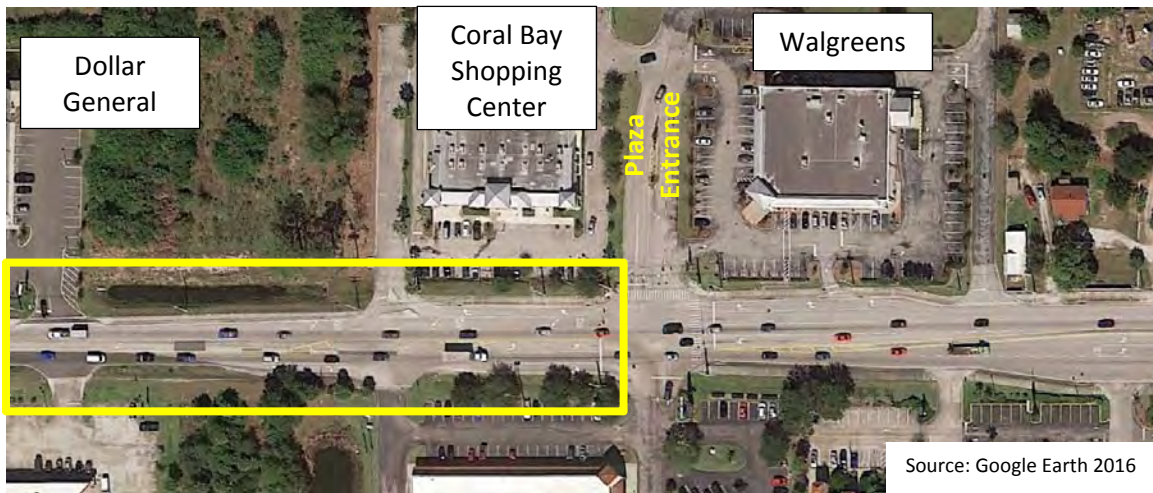
Figure 66

Issue #16: Merge Area West of Palm Bay West Plaza Entrance

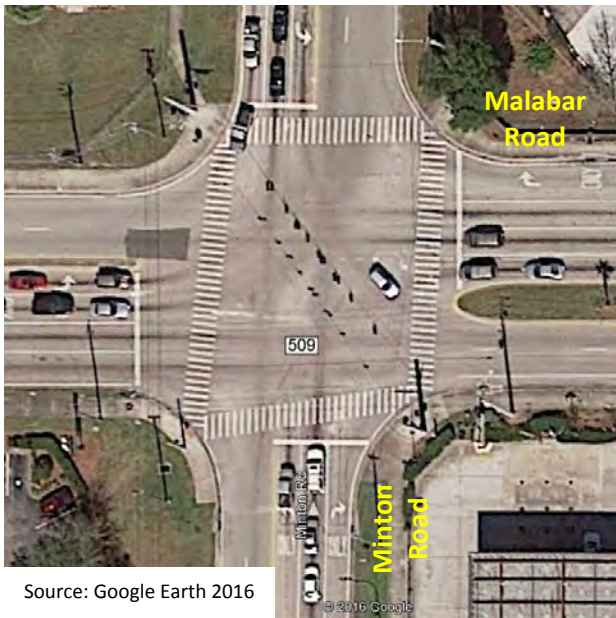
Figure 74

Issue #19: South and West Leg Crosswalks

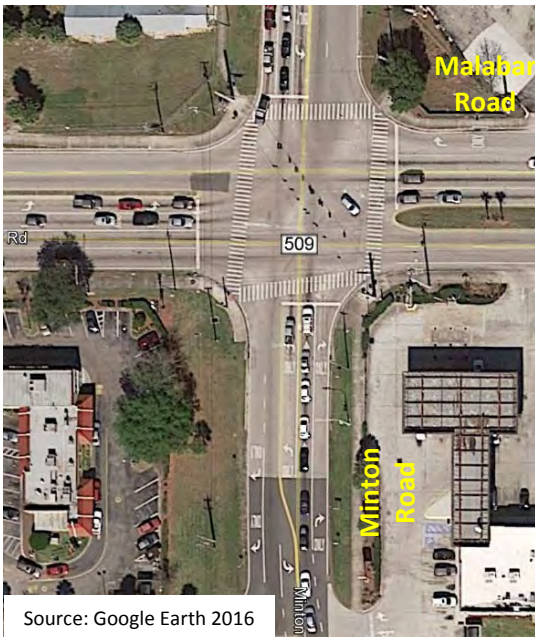
Figure 76

Issue #20: Northbound Lane Designations

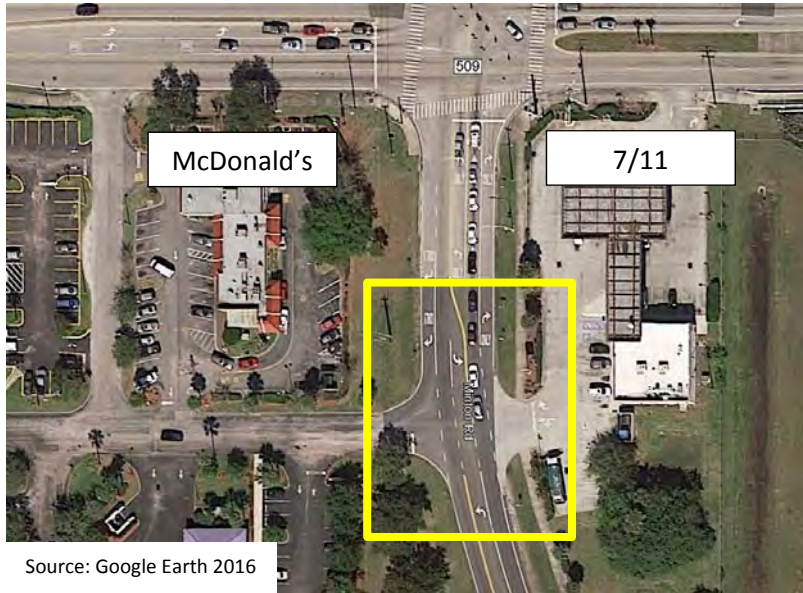
Figure 78

Issue #21: Minton Road Full Median Opening

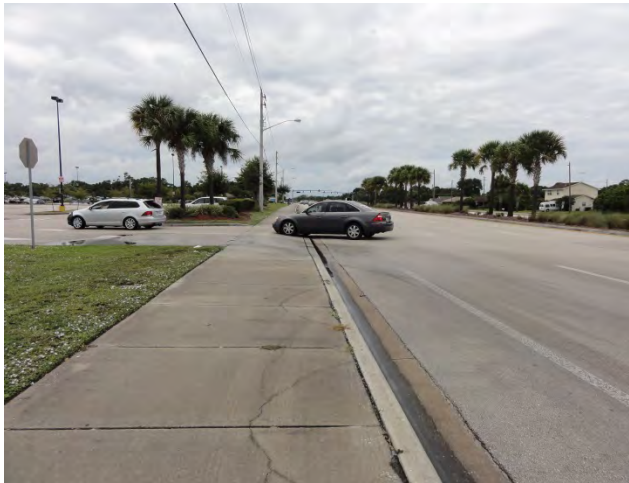
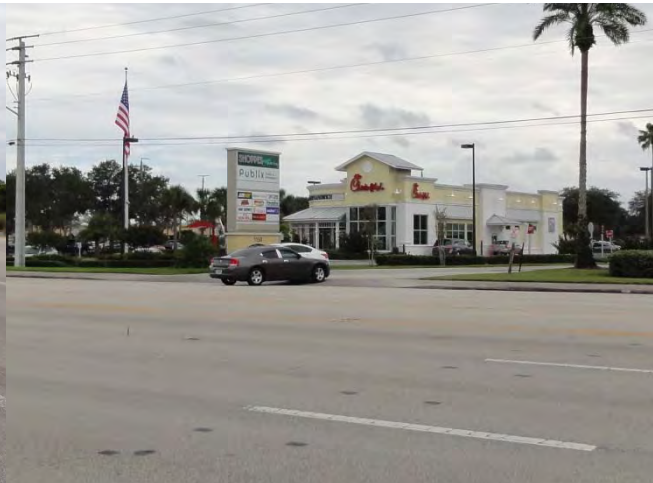
Issue #22: Driveway Slopes

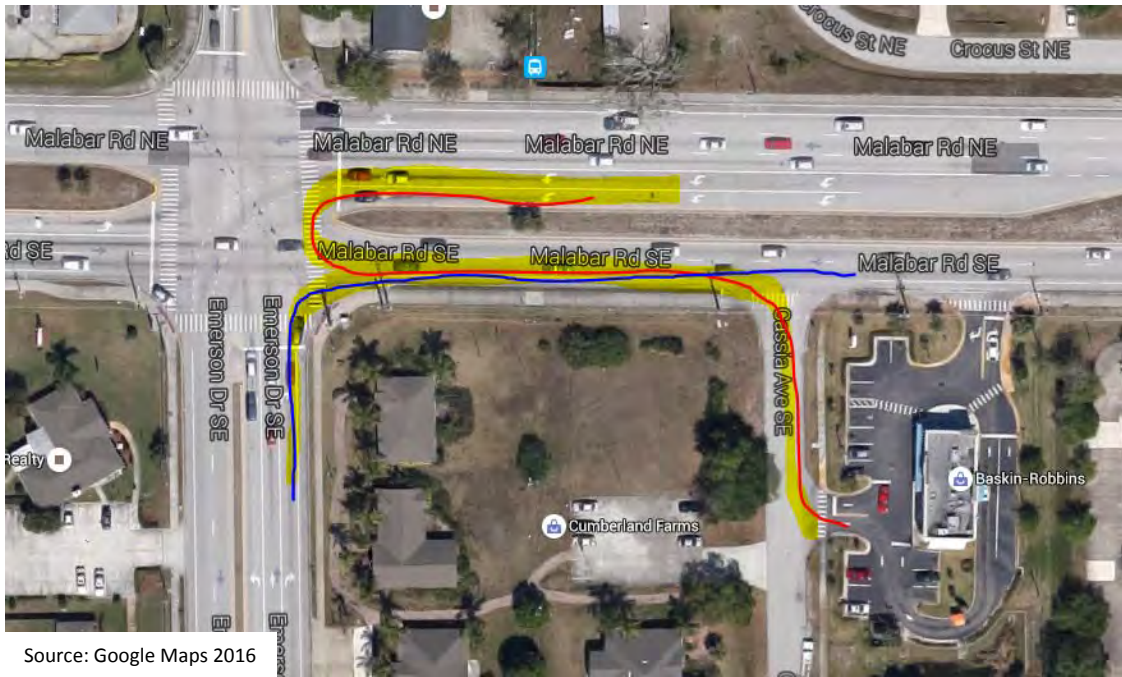
Figure 81

Issue #23: Northbound Right-Turn Conflicts

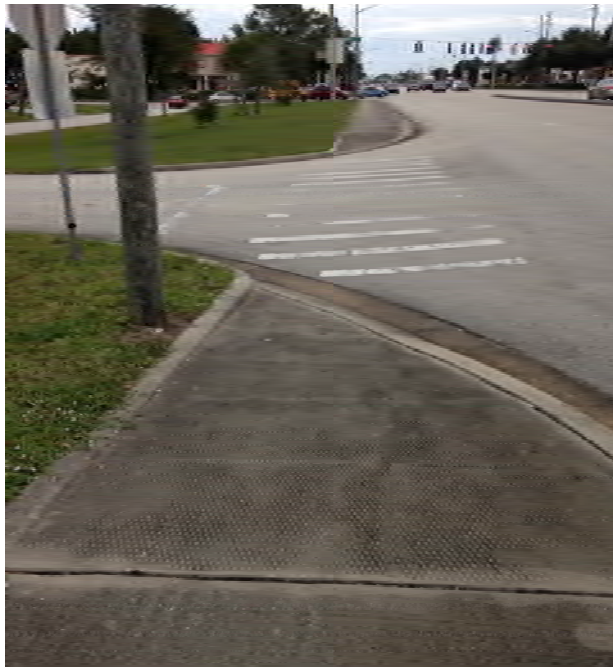
Figure 82

Issue #24: Eureka Avenue Curb Ramps

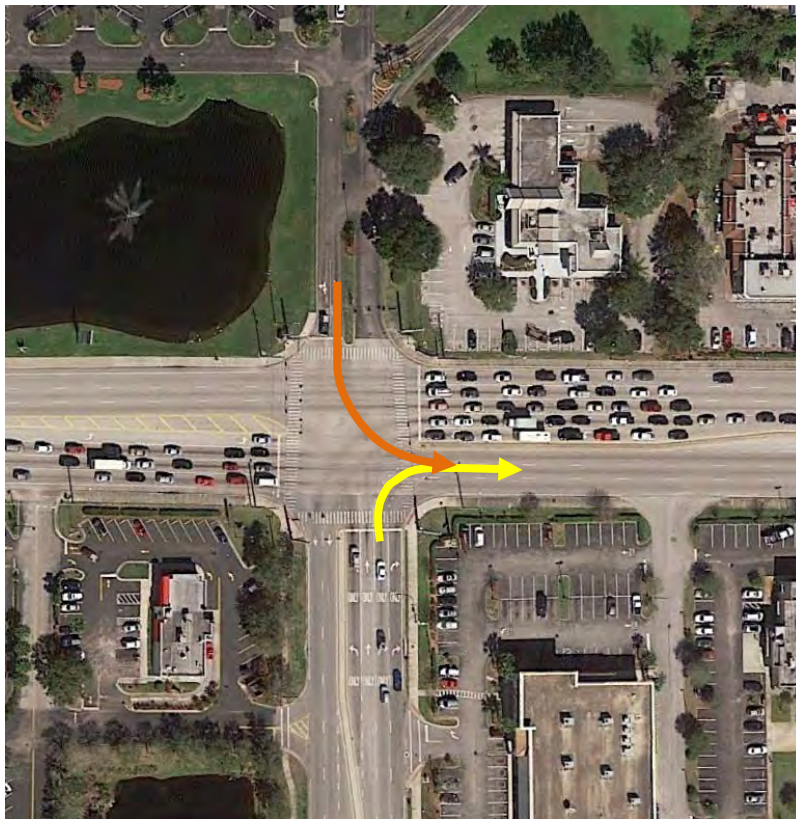
Figure 83

Issue #25: Northbound Right-Turn Conflicts
