PEDESTRIAN / BICYCLE SAFETY REVIEW

Palm Bay Road from Babcock Street to Lipscomb Street

February 2016

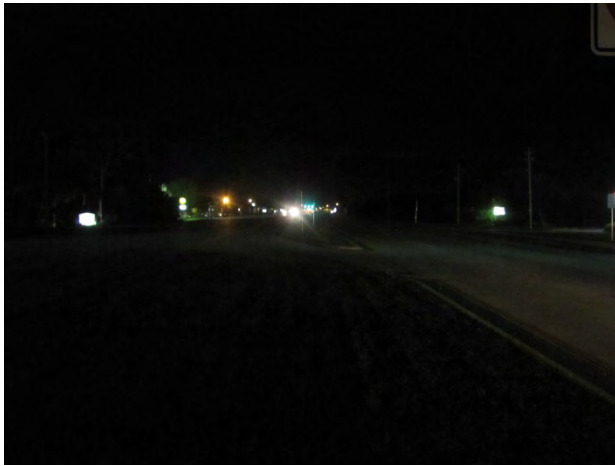
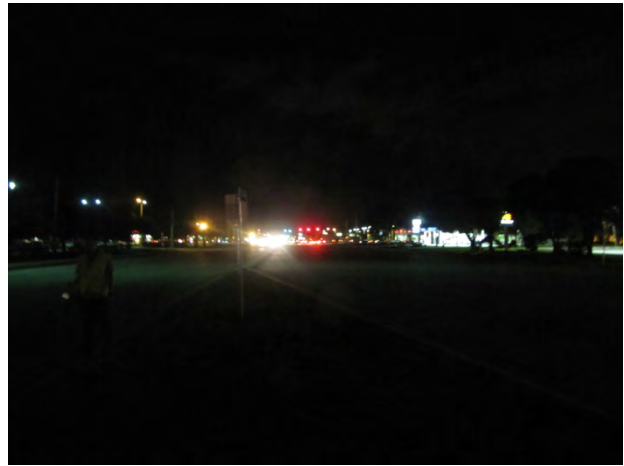
The crash statistics showed 33 percent of the pedestrian/bicycle crashes, including all three fatal pedestrian crashes, occurred during non-daylight conditions. Intersection lighting is present at the Babcock Street intersection with one light each on the southeast and southwest corners of the intersection. No intersection lighting is provided at Pinewood Drive, and one light is provided on the northwest corner of the Lipscomb Street intersection. Segment lighting is almost non-existent along the length of the corridor and during the nighttime field review, the study team experienced difficulty in seeing pedestrians or bicyclists along the corridor at night, especially those wearing dark clothing. The lighting conditions observed at nighttime are illustrated in **Figure 9** and **Figure 10**.

Consider upgrading the lighting at the intersection of Palm Bay Road and Babcock Street to meet the requirements of section 7.3.2.2 in Volume 1 of the FDOT PPM. This may require the existing lighting to be replaced.

Incremental implementation of lighting should be considered as funding may dictate potential implementation. Priority should be given to implementing intersection lighting at the remainder of the signalized intersections to meet the requirements of section 7.3.2.2 in Volume 1 of the FDOT PPM.

Priority then should be given to lighting the segment between Babcock Street and Knecht Road as this segment includes many of the corridor's nighttime crashes. As funding becomes available, consider implementing roadway lighting along the entire corridor.

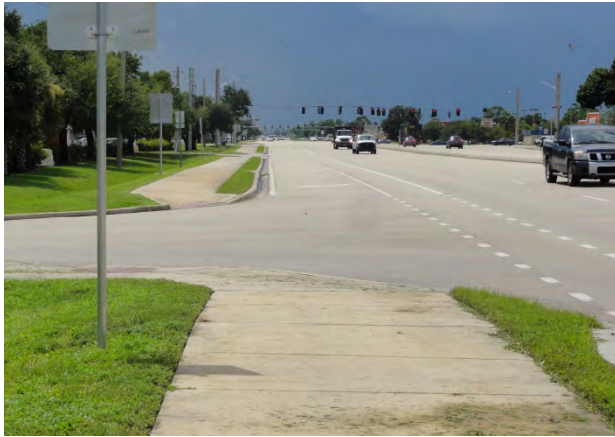
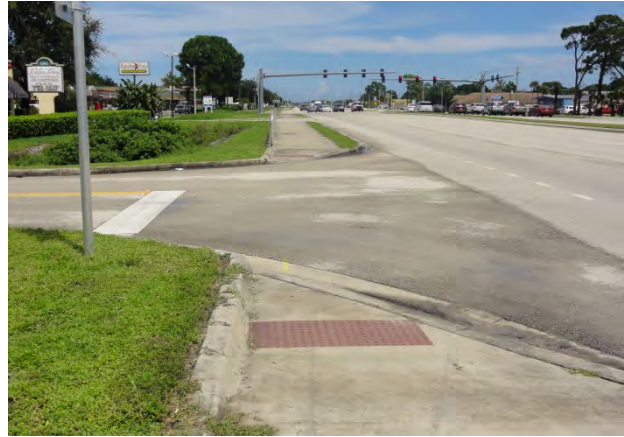
Marked crosswalks are not included along any of the minor street approaches at the unsignalized intersections throughout the corridor (see **Figure 11** and **Figure 12**). This was observed along the east and west sides of the study corridor. Inclusion of standard crosswalks at the unsignalized intersections and major driveways may give better indication to drivers that pedestrians may be present.

Consider marking all minor street approaches at unsignalized intersections along the corridor. Standard crosswalk markings as shown on sheet 9 of the FDOT Design Standard Index 17346 should be used for the unsignalized crossings. Special emphasis markings as shown on sheet 9 of Design Index 17346 should be used for the signalized crossings at the three signalized intersections within the study limits.

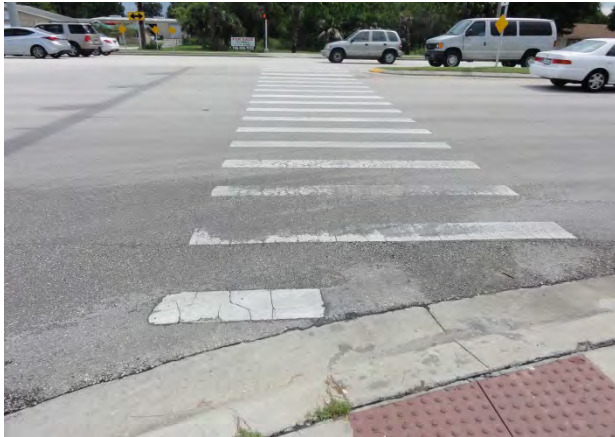
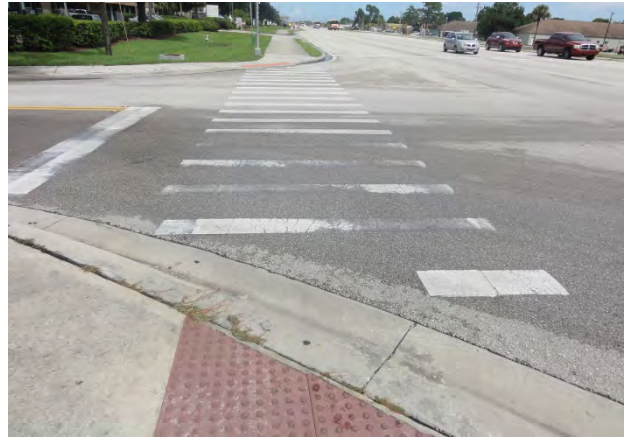
Crosswalk markings at some signalized intersections are beginning to wear (illustrated in **Figure 13**). The crosswalks at all three of the signalized intersections along the corridor are marked with the old standard emphasis markings (shown in **Figure 14**) with the exception of the south leg of the Lipscomb Street intersection. This intersection approach was recently modified in 2014/2015.

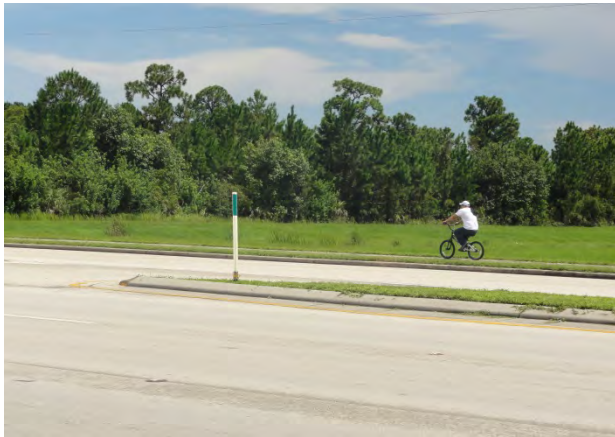
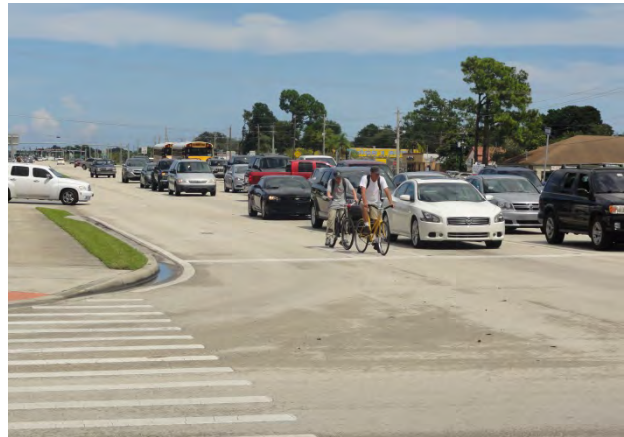
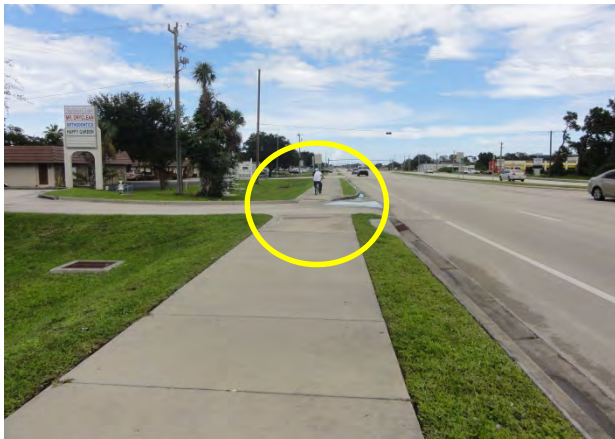
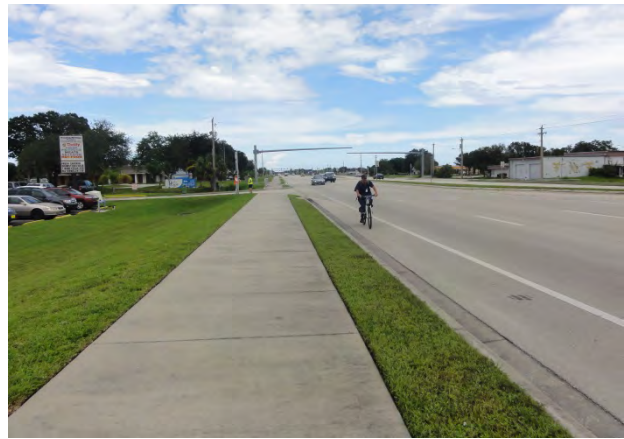
Over half of the bicycle crashes involved bicyclist riding along the sidewalk and against the flow of traffic. Some bicyclists were observed riding within the paved shoulder, but most bicyclists were observed riding along the sidewalks. Examples of observed bicycle activity are illustrated in **Figure 15** and **Figure 16**. No marked bicycle lanes are provided along the length of the corridor, but a five-foot paved shoulder is provided as shown in **Figure 17** and **Figure 18**.

The existing cross section includes three 11-foot eastbound and westbound travel lanes, five-foot paved shoulders, and a raised landscaped center median. In many locations, an exclusive left-turn is also provided resulting in approximately 77 feet of pavement. Based upon the existing pavement, there is not adequate width to accommodate buffered bike lanes in addition to the six 11-foot travel lanes, turn lanes, and raised center median without adjusting the existing curb line.

Appropriate bicycle lane signage and pavement markings should be installed using the existing five-foot paved shoulder according to the standards in the FDOT Standard Index 17347.

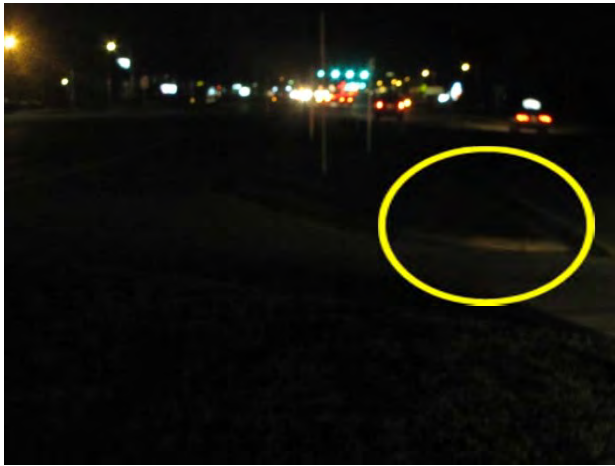
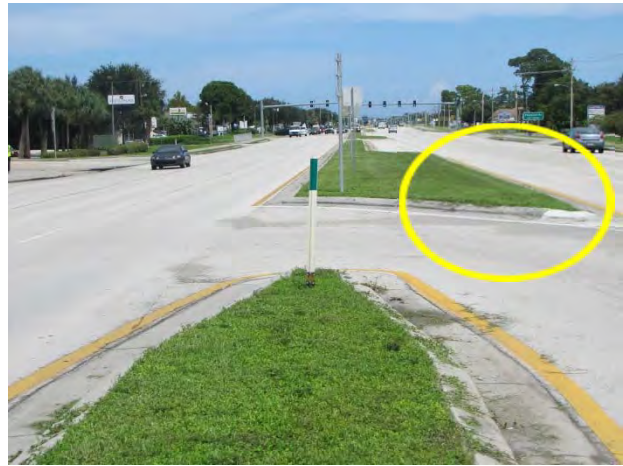
Twenty-eight percent of the pedestrian/bicycle crashes reported on the corridor in the analysis period involved pedestrians crossing at unmarked location between signalized intersections. The pedestrians are using the center median as refuge to complete two-stage crossings. The center median can be difficult to see at nighttime as illustrated in **Figure 19**. It is also difficult to differentiate between the paved median opening and raised grass median due to the darkness along this section of roadway. The paint on the center median nose is starting to wear and no longer appears to be yellow (**Figure 20**).

Consider restriping the median noses with a yellow retroreflective paint to increase visibility in the daytime and nighttime conditions. Installation of raised retroreflective pavement markers could also be considered as a center median nose treatment.

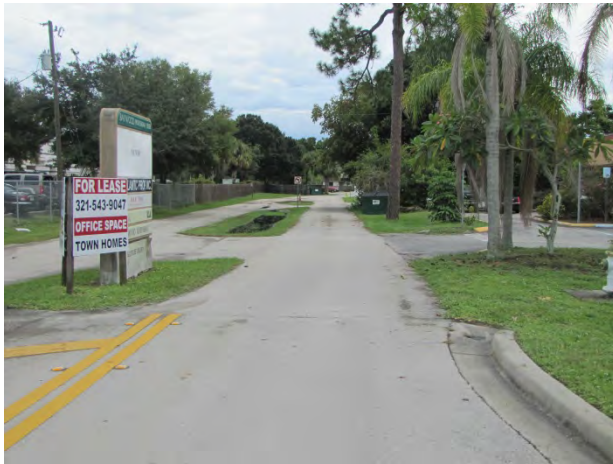
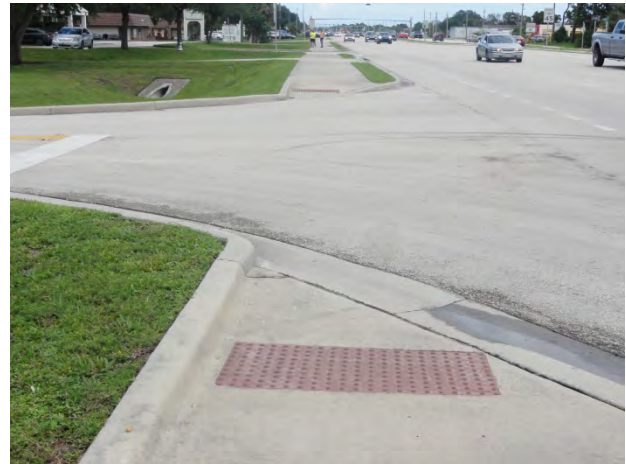
As the study team walked both sides of the corridor, very few sidewalks were observed along the minor street approaches. Eight-foot sidewalks are provided along both sides of Palm Bay Road for the entire limits of the study corridor, but there is limited sidewalk connectivity to the neighborhoods on the north and south sides of the roadway. The limited sidewalk connectivity creates situations where pedestrians and wheelchair-bound pedestrians must use the roadway for a hard surface to get to Palm Bay Road. Examples of some minor street approaches that lack sidewalks are presented in **Figure 21** and **Figure 22**.

Consider installing sidewalks along minor streets with pedestrian generators/attractors to enhance the pedestrian connectivity along the corridor. The following minor streets could be considered with a higher priority as they do not have sidewalks on either side of the roadway:

- Windwood Drive
- Monterey Drive
- Knecht Road
- Lakewood Drive
- Bottlebrush Drive
- Franklin Drive
- Woodlake Drive

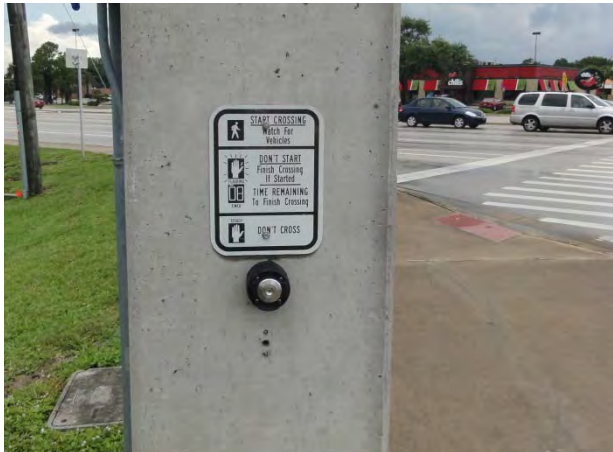
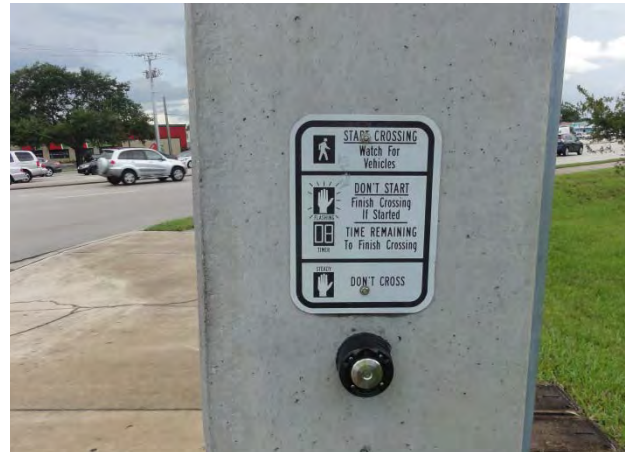
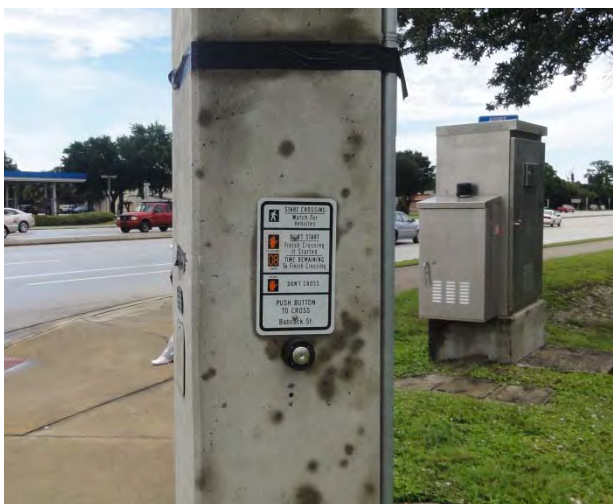
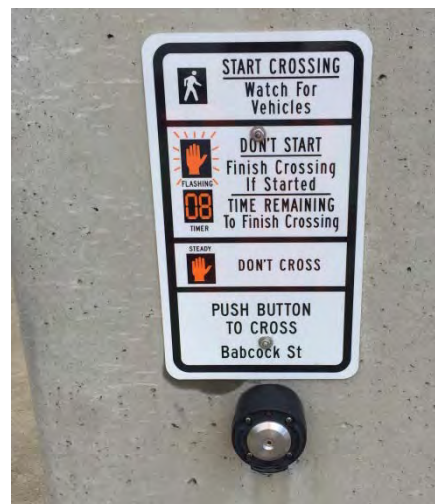
The push button signage is inconsistent on the four corners of the intersection. An old version of the R10-3 pedestrian plaques is present on the poles to cross the Palm Bay Road approaches as illustrated in **Figure 23** and **Figure 24**. This old version does not indicate to the pedestrian which road they are crossing. However, R10-3i pedestrian plaques are present to cross the Babcock Street approaches as shown in **Figure 25** and **Figure 26**.

Install R10-3i pedestrian plaques for the Palm Bay Road crossing movement on the applicable poles at the intersection to provide consistent pedestrian signage at the intersection.

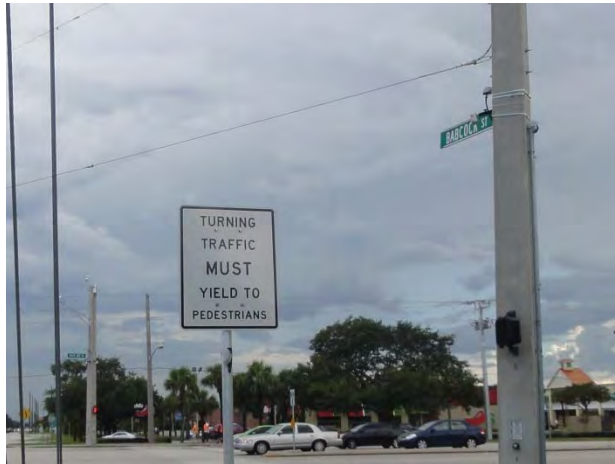
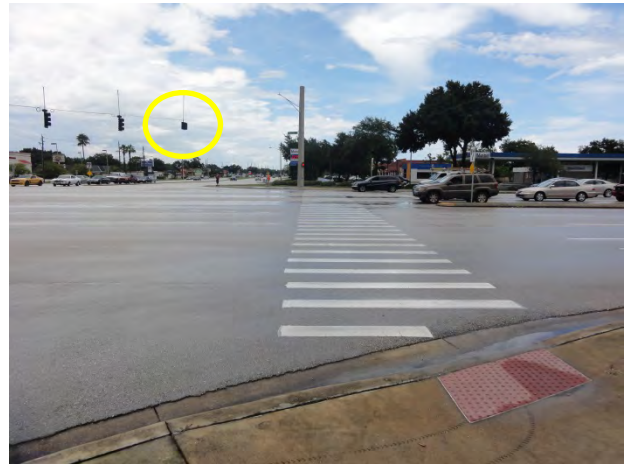
The study team observed relatively low right-turn on red (RTOR) vehicular yield compliance. There were multiple occasions where vehicles did not observe pedestrians and failed to yield the right-of-way to pedestrians within the crosswalk or on the corner of the intersection. Each approach includes a Turning Traffic Must Yield to Pedestrians sign as shown in **Figure 31**. The westbound approach has a dynamic message sign on the span wire (shown in **Figure 32**) that restricts the westbound RTOR movement when the pedestrian phase is activated to cross Babcock Street.

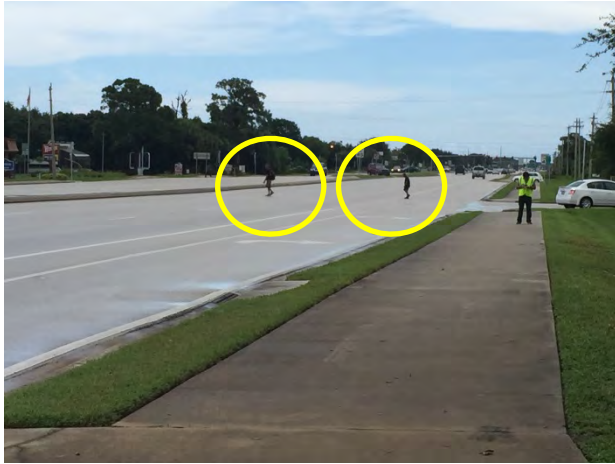
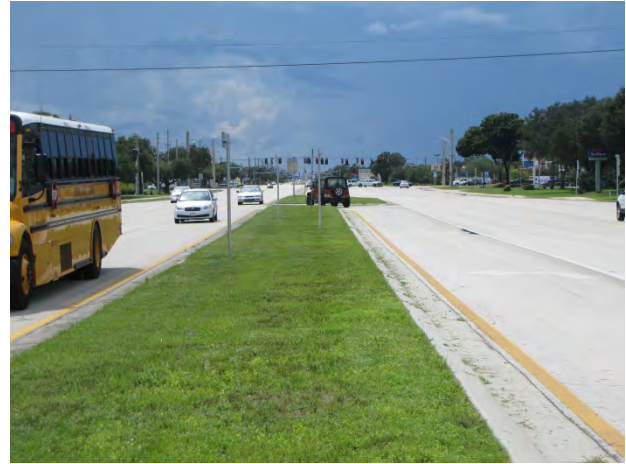
There were four pedestrian and bicycle-related crashes (3 pedestrian and 1 bicycle) at unmarked locations between Windwood Drive and Knecht Drive during the analysis period. All three fatal pedestrian crashes occurred along this segment. During the safety review, the study team observed pedestrian crossing within this segment (**Figure 33**) and this location was identified as a high pedestrian traffic area by the police officers in the area.

- Install lighting on the crosswalk's north and south sides.
- Stripe the crosswalk with Special Emphasis Crosswalk markings consistent with sheet 10 of the FDOT Design Index 17346.

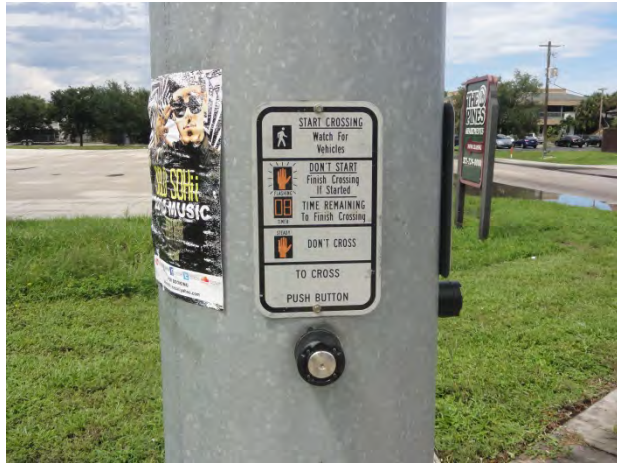
Figure 36

The pedestrian push button signage on northwest corner of the intersection does not indicate which street to cross as shown in **Figure 36**. The field review team observed pedestrians pushing both buttons on the pole to cross Palm Bay Road because the signage was unclear. The push button signage on the southwest corner's pole was missing. The lack of signage is illustrated in **Figure 37**.
