# PEDESTRIAN / BICYCLE SAFETY REVIEW

US 1 / Broadway Boulevard to Fay Boulevard

## **Pedestrian/Bicycle Safety Review Report for US 1 (North) from Broadway Boulevard to Fay Boulevard**

**Field Review Dates:** July 13<sup>th</sup> and 14<sup>th</sup>, 2015 (daytime/nighttime reviews and follow up meeting)

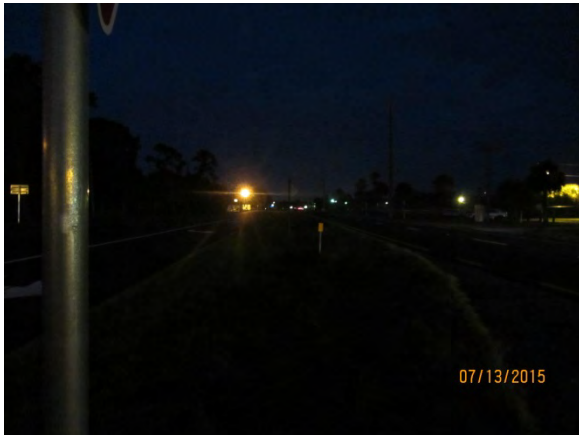
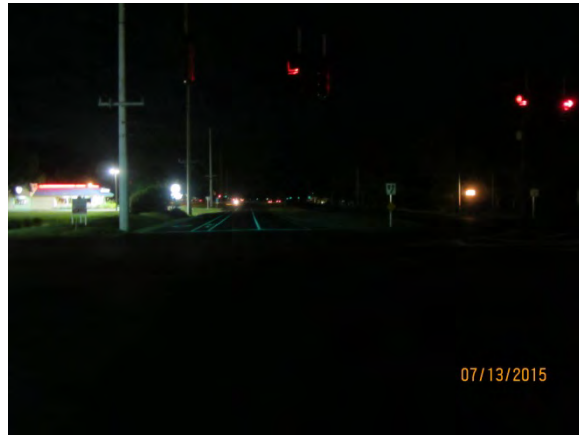
The crash statistics showed 75 percent of the pedestrian/bicycle crashes, including all six (6) fatal crashes, occurred during non-daylight conditions. During the nighttime field review, the study team observed the lack of corridor lighting (**Figure 6** and **Figure 7**). It would be difficult for a motorist to see a pedestrian/bicyclist along this corridor at night, especially if that vehicle is traveling at or near the posted speeds of 55 or 45 mph.

Where lighting was present (just south of Broadway Boulevard and intermittently between Spring Street and Cottrell Avenue), the field review team observed inconsistent lighting (lights would randomly turn on/off).

FDOT D5 recently completed a lighting justification project along US 1 from Camp Road to Fay Boulevard, including the entire length of the study corridor. The study found lighting is justified along the corridor and the project is currently funded by FDOT for construction during fiscal year 2017.

When the lighting is installed throughout the corridor, it should alleviate the issue of inconsistent lighting (lights turning on/off) observed at specific locations.

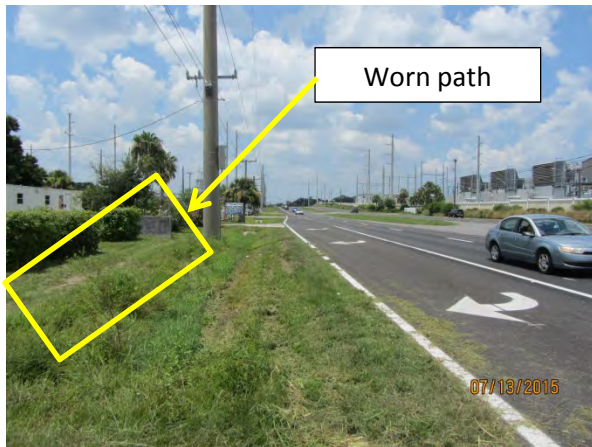
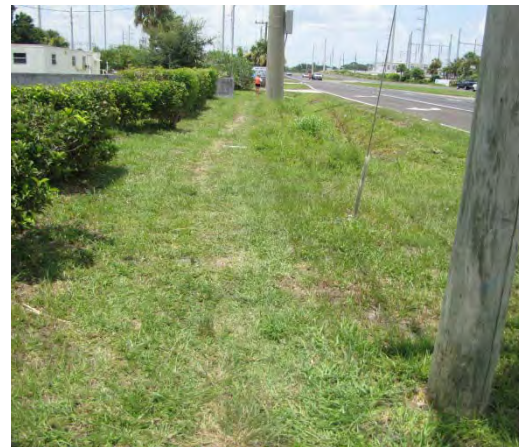
Very little sidewalk connectivity is present along the corridor (see **Figure 8** and **Figure 9**). The only continuous sidewalk located along the corridor is between Broadway Boulevard and Spring Street (which is cracked in spot locations and may need to be replaced) and in front of the CVS (southwest corner of Fay Boulevard intersection), both along the west side of the roadway. Spot sidewalks have also been constructed at three transit stops along the corridor (see **Figure 10**). Sidewalks are present on the west side of the roadway south of Broadway Boulevard and north of Fay Boulevard.

Sidewalks should be considered along the west side of the roadway throughout the study corridor length. Constructing the sidewalk on the west side would connect the gaps between the sidewalk south of Spring Street and the sidewalk north of Fay Boulevard. Based on observed pedestrian activity during the field review, the sidewalk could be constructed in phases:

- Phase 1 – Spring Street to southernmost Cocoa Flea Market entrance (across from Mahi Mahi Lane)
  - Also consider reconstructing sidewalk from Broadway Boulevard to Spring Street if in poor condition
- Phase 2 – Cottrell Avenue/BP Gas Station to Port St. John Plaza
  - Also consider constructing sidewalk on the east side of the roadway for this segment
- Phase 3 – Port St. John Plaza to CVS driveway just south of Fay Boulevard
- Phase 4 – Southernmost Cocoa Flea Market entrance to Cottrell Avenue
  - During the field review, pedestrians and bicyclists were observed utilizing the frontage road adjacent to the Cocoa Flea Market parking area (see **Figure 11**), thus the reason for this section to be Phase 4

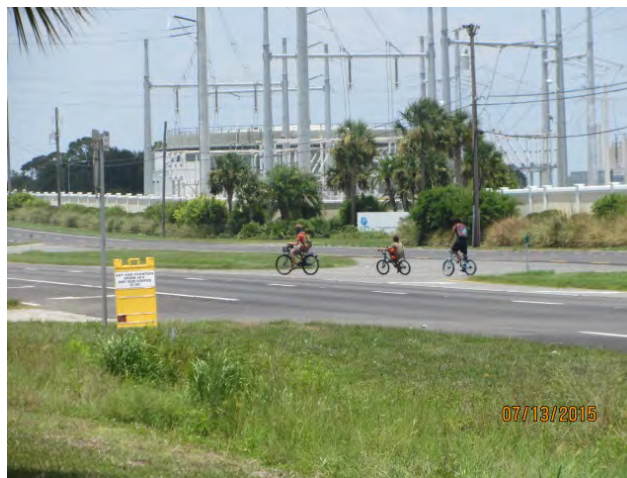
Figure 14

Pedestrians/bicyclists were observed crossing US 1 at these full median openings (**Figure 14**) and six (6) of the 12 crashes occurring along this segment were located at or within the direct vicinity of a full median opening. Having multiple full median openings within a short distance creates many conflict points for motorists and non-motorists to process.

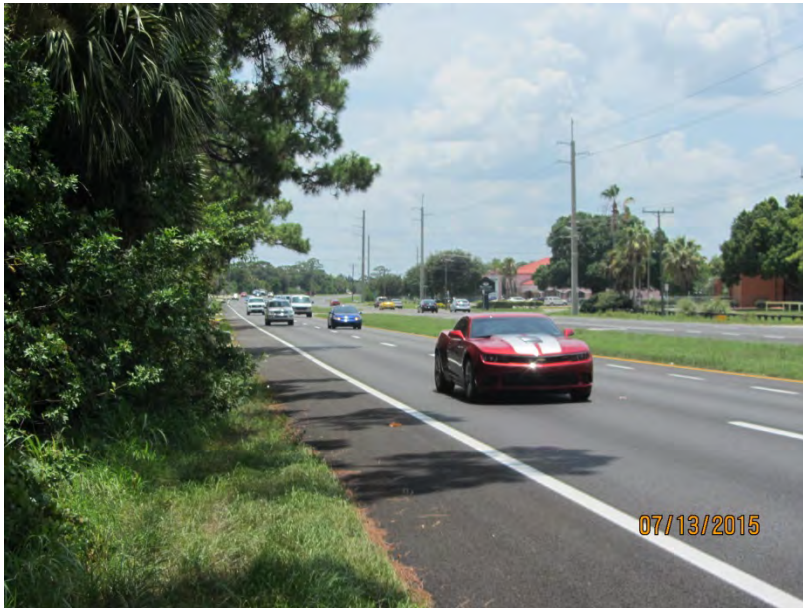
**Figure 15**

A few undeveloped wooded parcels are located on the east side of US 1 between Broadway Boulevard and Cottrell Avenue. These parcels have trees/shrubbery encroaching on the shoulder of the roadway, as seen in **Figure 15**. The study team also observed pedestrians walking out from the trees/underbrush on these undeveloped parcels to cross US 1. During the day, these pedestrians were obscured by shadows from the vegetation. No pedestrians were observed coming from the vegetation at night, but it would be difficult to impossible to see a pedestrian coming out from this area to cross the road.

Location	Issue Number	Issue	Suggestion
<b>MAINTENANCE</b>			
Corridor Wide	4	Undeveloped Parcels	Consider clearing and grubbing the vegetation back to the right of way (ROW) line, making the pedestrians more visible to motorists.
Corridor Wide	5	Signage	Consider adding pedestrian warning signage at high crash/high exposure locations throughout the corridor.
Broadway Boulevard Intersection	8	Missing/Worn Pavement Markings	Consider painting a crosswalk across the Broadway Boulevard approach. Consider restriping the centerline and stop bar for this approach as well.
Mid-Block between Spring Street and Cottrell Avenue	10	Pedestrian Crossing near Cocoa Flea Market	Pedestrian warning signage, as outlined in <b>Issue #5</b> , should be considered along this segment.
Port St. John Plaza Intersection	14	Driveway just South of Intersection	Consider trimming the trees/bushes within the right-of-way line to give motorists a better line of sight looking southbound. Consider adding a stop sign to this approach. Consider replacing the Do Not Enter sign with a new sign and moving further east, out of the bush area.

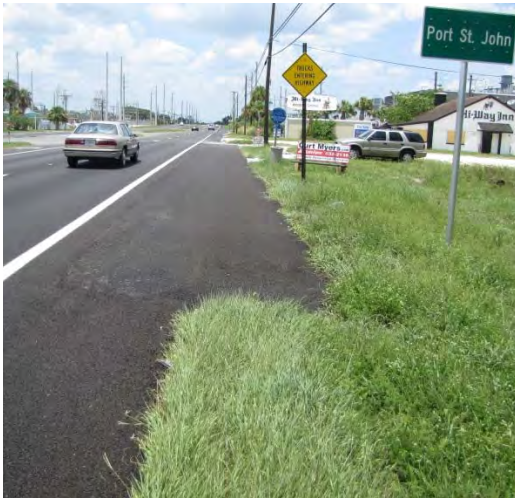
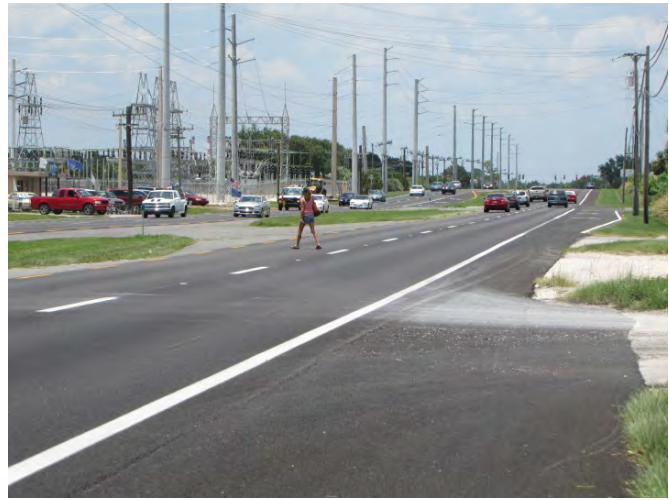
The study team observed no pedestrian crossing warning signs installed along the corridor. At Cottrell Avenue (**Figure 16** and **Figure 17**), five (5) pedestrian crashes occurred, with three (3) being fatal, and no pedestrian warning signage was present. The field review team also observed multiple pedestrians walking east and west across US 1 in this location.

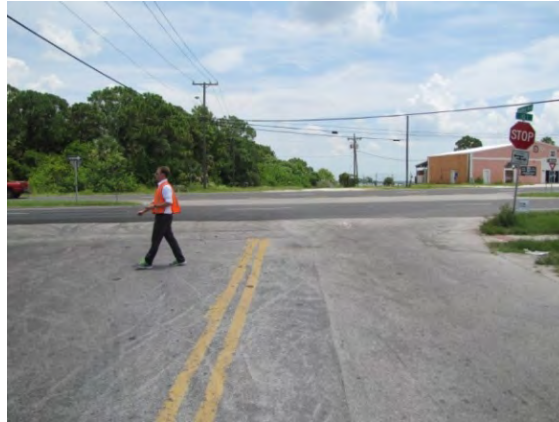
**Figure 21**

No crosswalk is provided on the Broadway Boulevard approach to US 1 (**Figure 21**). The centerline and stop bar striping for this approach is worn.

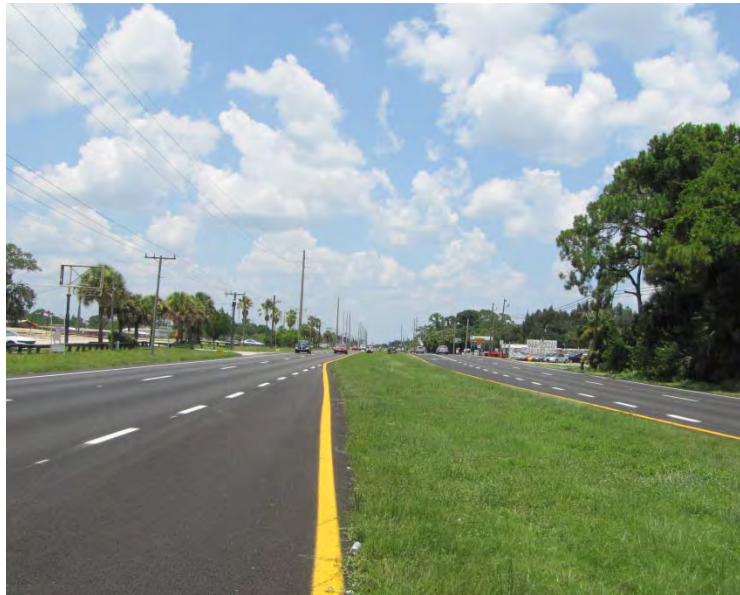
**Figure 23**

During the field review, multiple pedestrians were observed crossing US 1 near the Cocoa Flea Market (in the vicinity of **Figure 23**). With the Flea Market operational, there is a higher potential for conflicts between pedestrians attempting to cross US 1 and northbound/southbound traveling vehicles. Two pedestrian crashes, one being fatal, also occurred within this section.

Mid-Block between Spring Street and Cottrell Avenue	10	Pedestrian Crossing near Cocoa Flea Market	A concrete pedestrian refuge in the median to help facilitate east/west pedestrian movements should be considered.
Cottrell Avenue Intersection	12	Access Management/Turn Lanes	As discussed in <b>Issue #3</b> , a study should be performed to review closing/modifying these median openings. As part of this study, the volumes for the exclusive southbound right turn lane should be reviewed and removal of this right turn lane should be considered.
Cottrell Avenue Intersection	13	Lighting	As noted in <b>Issue #1</b> , lighting is justified throughout the study corridor and lighting is planned for construction during fiscal year 2017.
Port St. John Plaza Intersection	14	Driveway just South of Intersection	Consider reviewing the current radii on the southwest corner of the driveway and reducing the radii to slow right turning movements.

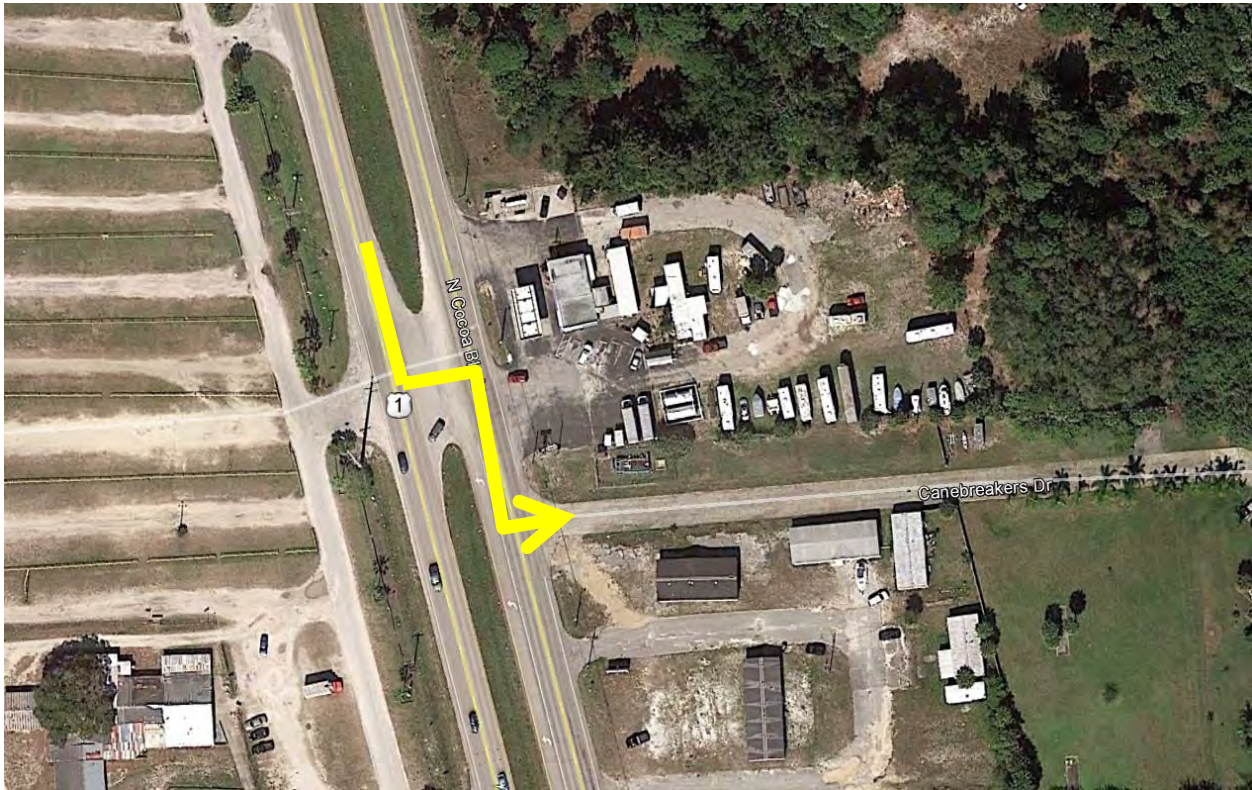
Figure 24

A southbound vehicle was observed driving through the full median opening, into the northbound travel lanes, in order to make a left turn onto Canebreakers Drive, as depicted in **Figure 24**. If a pedestrian/bicyclist is attempting to cross US 1 at Canebreakers Drive, they may not be expecting a wrong way driver coming from the north, thus leading to a non-motorist/motorist conflict.

Mid-Block between Spring Street and Cottrell Avenue	11	Median Opening just North of Canebreakers Drive	Consider shifting the full median opening south to align with Canebreakers Drive once the Flea Market property redevelops.
Port St. John Plaza Intersection	15	Pedestrian Facilities	Consider removing the continuous green lane in order to accommodate pedestrian movements east/west across the intersection. When sidewalks are constructed, marked crosswalks with pedestrian activated push buttons and signal heads should be considered across the west and south (if the continuous through lane is removed) legs of the Port St. John Plaza intersection. Once the sidewalks and crosswalks are constructed, the northbound bus stop located inside the Winn Dixie parking lot could be moved onto US 1 near the intersection. The southbound bus stop could also be moved closer to the intersection.
Fay Boulevard Intersection	19	Pedestrian Facilities	Consider the addition of a crosswalk on the north leg of the intersection as a long term improvement. Without pedestrian facilities on the northeast corner to connect to, it would be preferred to add the north leg crosswalk along with any future sidewalks on the east side of US 1 north of the Fay Boulevard intersection. Drainage patterns for the intersection should be reviewed near the north leg flume to help aid in the placement of the crosswalk.

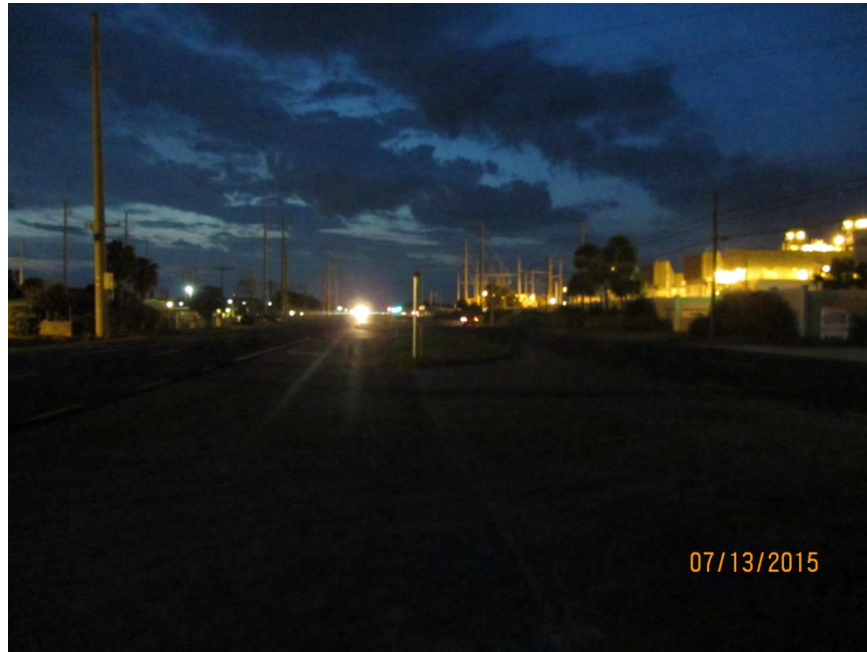
Figure 26

This location is a high priority for lighting due to all five pedestrian crashes at this intersection occurring at night, with three of those being fatal. This location had the highest number of nighttime crashes along the corridor. **Figure 26** displays the night condition of this location.

As noted in **Issue #1: Lighting**, lighting is justified throughout the study corridor and lighting is planned for construction during fiscal year 2017.

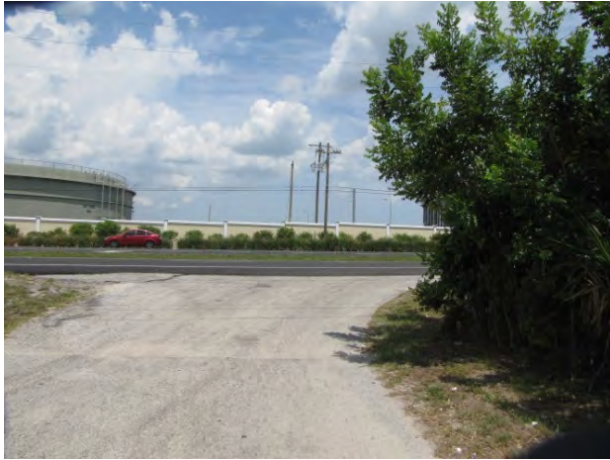
When approaching US 1 from the driveway just south of the Port St. John Plaza intersection driving eastbound, sight distance is limited looking south, as shown in **Figure 27** (south is to the right on the figure). If a motorist pulled up to US 1 and was looking left to make the right turn, it would be difficult to see a northbound pedestrian or bicyclist. One crash occurred at this intersection with a right turning vehicle and a northbound bicyclist riding on the shoulder. No stop sign was observed for this driveway, thus allowing for someone to speed up while making the right turn maneuver without necessarily looking south for pedestrians or bicyclists. This driveway is also a one-way street and the Do Not Enter sign, located on the south side of the driveway facing eastbound, was also faded and not visible for southbound vehicles possibly making a right turn from US 1 (**Figure 28**).

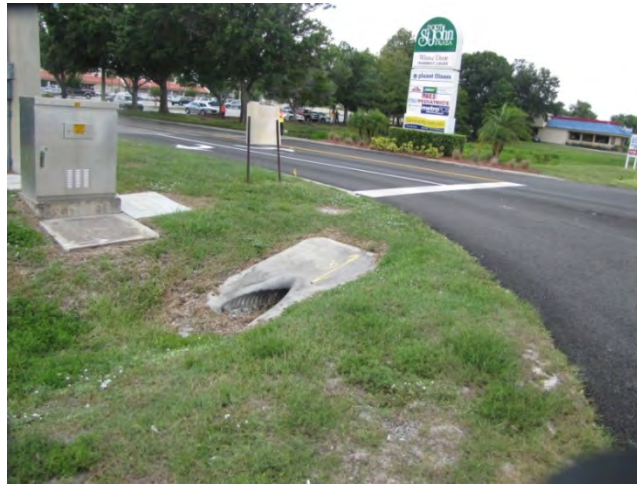
Figure 34

The west approach stop bar is even with the traffic controller cabinet, as displayed in **Figure 34**. When a motorist stops at the existing stop bar location to make an eastbound right turn, the traffic controller cabinet and the signal pole are blocking the view southbound. In most observed cases, the motorist disregarded the existing stop bar position (which is approximately 30' west of the edge of the southbound travel lane as shown in **Figure 35**) and pulled forward approximately 10-15 feet past the stop bar before stopping. There was one crash in which an eastbound right turning vehicle struck a northbound bicyclist at this intersection.

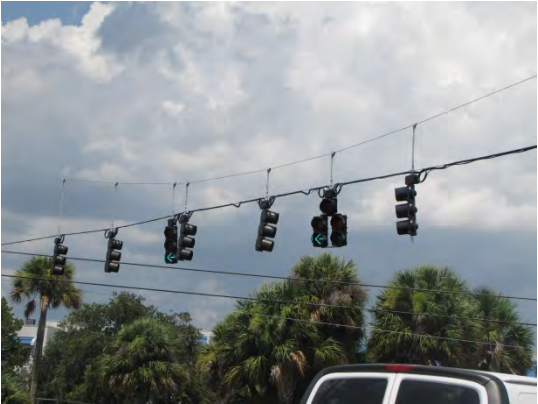
**Figure 40**

When the pedestrian phase is activated for the south leg of the intersection (conflicting with eastbound right turning vehicles), the eastbound right turn arrow will remain blank while the two left turn arrows will become green (**Figure 40**). The field review team observed multiple vehicles not yielding the right-of-way to the pedestrian in the crosswalk when the pedestrian had the walk symbol. A newly installed “Turning Vehicles Yield to Pedestrians” sign was observed on the approach, but this sign was disregarded more often than not. The driver does not realize when the signal is blank that they are supposed to yield to the pedestrian in the crosswalk.

For the observed conflicts between the eastbound right turning vehicles and the pedestrians in the south leg crosswalk, consider replacing the five section head with two (2) three section heads. One of those will be for the outside left turn lane while the other will control the eastbound right turn lane. As part of this change, the signal timing should be modified so when a pedestrian activates the walk symbol during the eastbound phase, the two left turn arrows will become green but the right turn arrow will remain red. Another consideration is to install a four section head which includes the flashing yellow arrow. The green arrow would display anytime the pedestrian phase was not active but the flashing yellow arrow would display when the pedestrian phase was active.

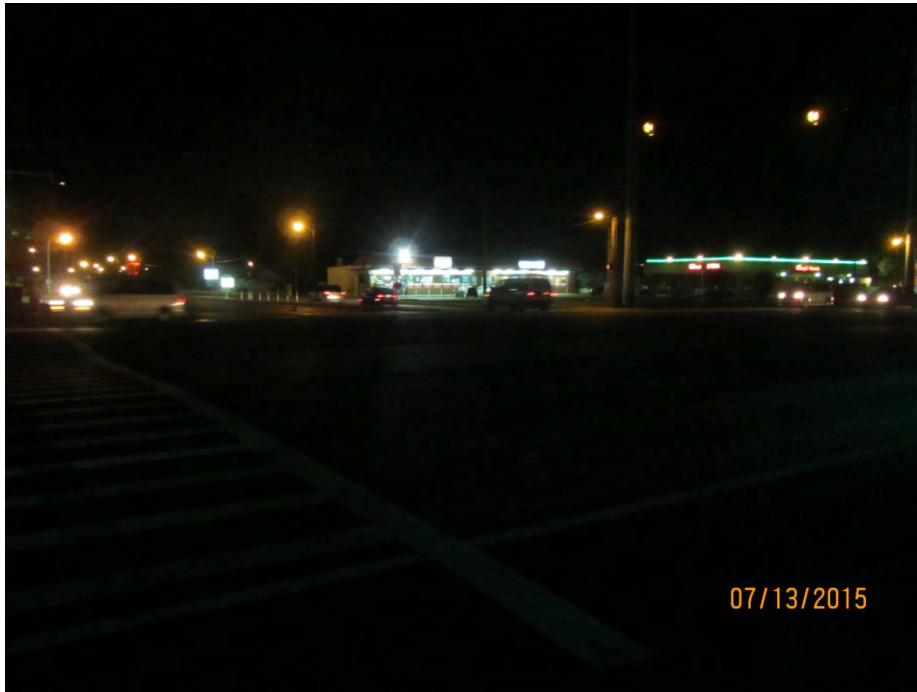
**Figure 41**

No intersection lighting is present (**Figure 41**). Pedestrians are not visible in the crosswalks during non-daylight conditions.

As noted in **Issue #1**, lighting will be installed from Camp Road to Fay Boulevard during fiscal year 2017. The Fay Boulevard intersection will be included in this lighting project.

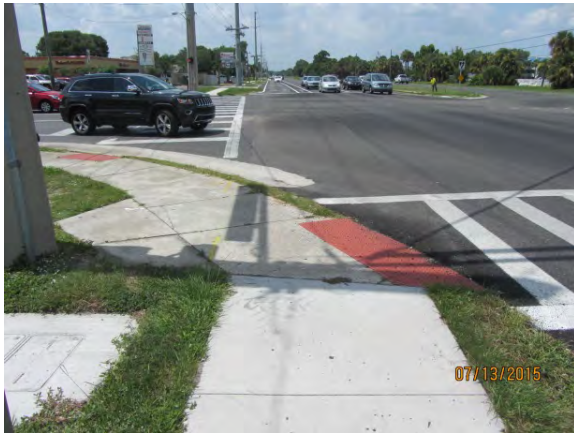
Figure 42

Eastbound right turning vehicles make it uncomfortable for a pedestrian standing on the southwest corner of the intersection (**Figure 42**). There is no vertical separation between the corner and the travel lane, with the asphalt being flush with the most of the pedestrian landing area for the south leg crosswalk. Some vehicles were observed cutting the corner close, making some of the field review team members stand 3-7 feet back from the roadway. Due to no vertical separation being present, the strain pole in the southwest corner is within the roadway clear zone.

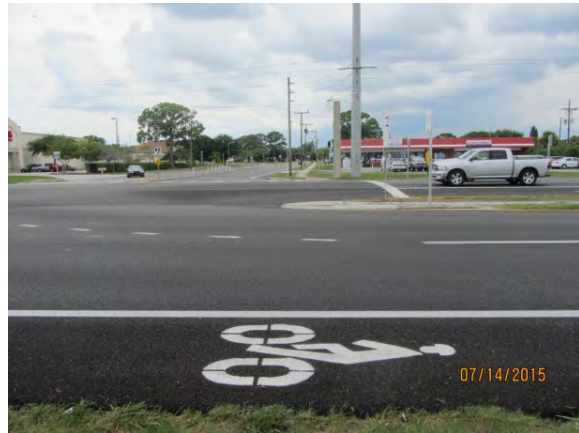
Figure 43

No pedestrian crosswalk was observed on the north leg of the intersection (**Figure 43**). Due to this being
