PEDESTRIAN / BICYCLE SAFETY REVIEW

US 1 / University Boulevard to New Haven Avenue

Pedestrian/Bicycle Safety Review Report for US 1 (Melbourne) from University Boulevard to New Haven Avenue

Field Review Dates: August 25th and 26th, 2015 (daytime/nighttime reviews and follow up meeting)

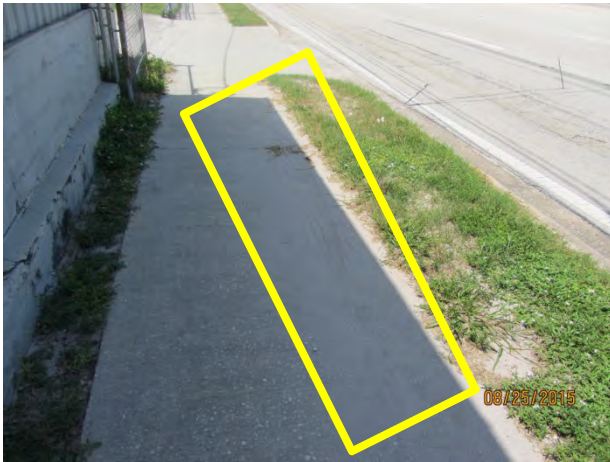
Figure 16

Along the corridor, multiple sidewalk locations were observed as having walkability issues due to sand partially (yellow area in **Figure 16**) or fully (**Figure 17**) covering the sidewalk. At these locations, the landscape buffer strip was raised approximately $\frac{1}{2}$ " to 1" higher than the sidewalk which does not allow for water to properly drain into the grass, thus creating the ponding/sand on the sidewalk.

Consider reducing the height of landscape strip to be level or just below the sidewalk and replace with new sod. Also consider raising the sidewalk to be level with the landscape strip. The lowered height of the buffer strip or the raised sidewalk option would allow for water to drain off the sidewalk into the landscape strip.

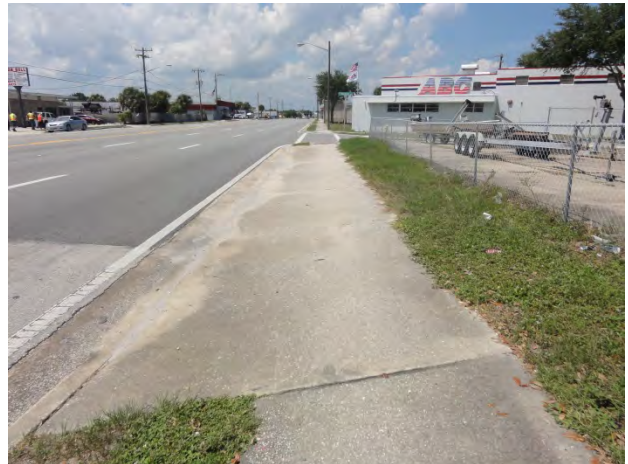
Figure 19

Along the study corridor, properties were observed as having multiple driveways onto US 1. Some of these properties were undeveloped parcels (**Figure 20**) while other properties currently do not have access to their driveways (**Figure 19** and **Figure 21**). A number of driveways were also noted to be longer than the 36' maximum driveway width as specified per FDOT Standard Index 515. While there was not a high amount of pedestrian/bicycle crashes at driveways (2 out of the 12 crashes), driveways are conflict points between pedestrians/bicyclists utilizing the sidewalk and vehicles exiting the property or turning from US 1. The higher the number of driveways along a corridor, the higher the potential for crashes between a pedestrian/bicycle utilizing the sidewalk and a vehicle exiting/entering a property.

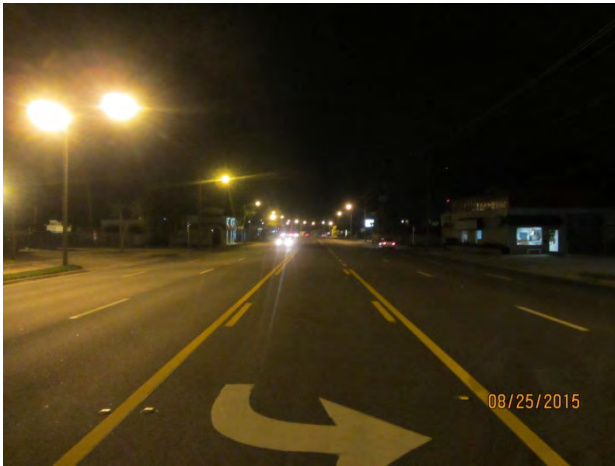
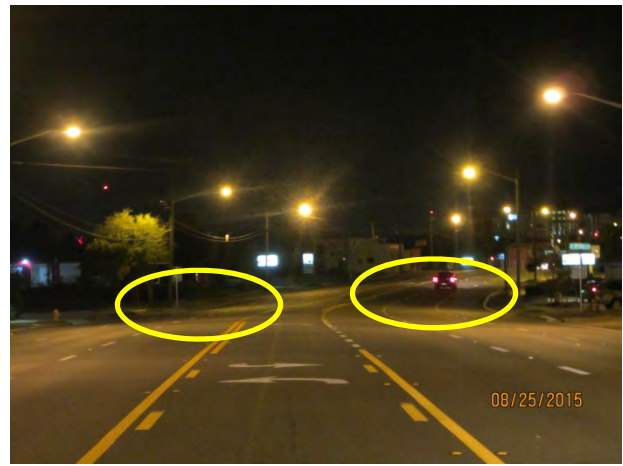
The field review team noted multiple lights were burnt out along the corridor contributing to the inconsistent lighting issue.

Even though overhead lighting is present along the corridor, the spacing of the lighting is inconsistent. With the inconsistent spacing, there are areas along the corridor where dark spots are present making it more difficult for motorists to see pedestrians/bicyclists. In total, six (6) of the 12 crashes occurred under dark lighting conditions with all three fatal crashes happening at night. Two of those six crashes involved pedestrians/bicyclists crossing the roadway between signalized intersections, with one of those being a fatal crash.

Consider contacting the operator/maintainer of the lighting system to replace the burnt out light bulbs along the corridor.

Consider a lighting uniformity study to review lighting consistency along the corridor. Providing consistent spacing of the lights along the corridor will make the pedestrians/bicyclists more visible during dark lighting conditions.

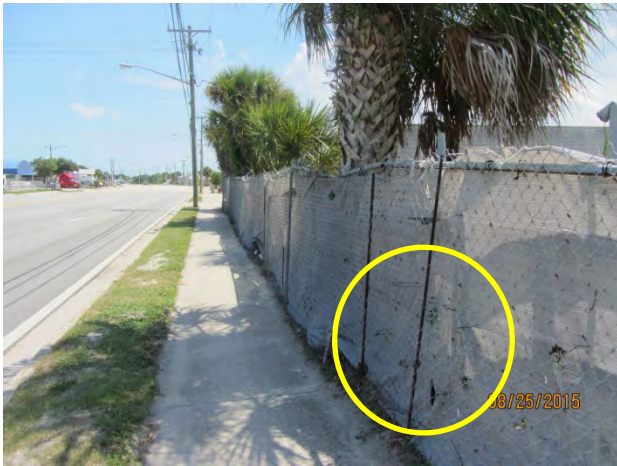
Figure 32

The Don Bell property fence line just south of Powell Avenue on the west side of the roadway has rusty wire ties poking through fence into the sidewalk as displayed in **Figure 32** and **Figure 33**. A metal pole was also observed sticking out of fence into the sidewalk as displayed in **Figure 34** and **Figure 35**. Protruding objects on the fence pose a hazard to pedestrians on the sidewalk.

Consider contacting City of Melbourne code enforcement to request the Don Bell property owner to remove the rusty wires and metal pole protruding into the sidewalk.

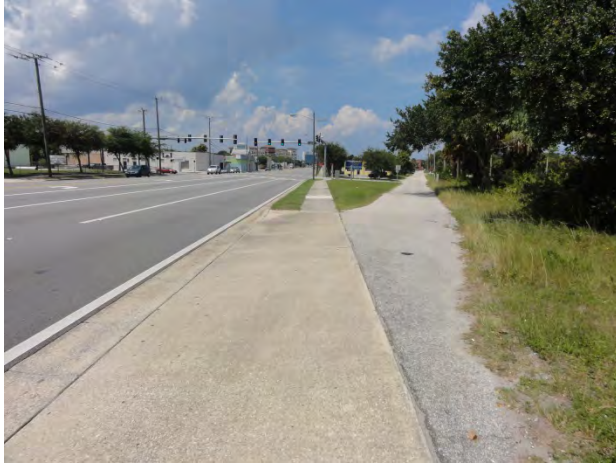
Figure 38

During the field review, multiple pedestrians were observed walking along Irwin Street south of Line Street. This roadway begins at a driveway from US 1 approximately 250' south of the Line Street intersection (**Figure 38**) and extends into Melbourne Riverview Park. City staff noted this section of Irwin Street is rarely utilized for vehicular traffic.

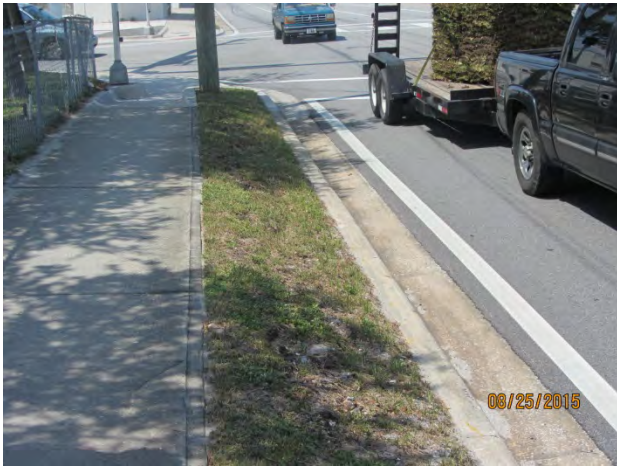
Figure 40

Immediately south (**Figure 40**) and north (**Figure 41**) of the Line Street intersection on the west side of the road, steep grades were observed from sidewalk to the back of the curb. If a pedestrian/bicyclist is utilizing the sidewalk in these locations, they may accidentally step/ride off the sidewalk onto the sloped grass or concrete areas and fall into the roadway.

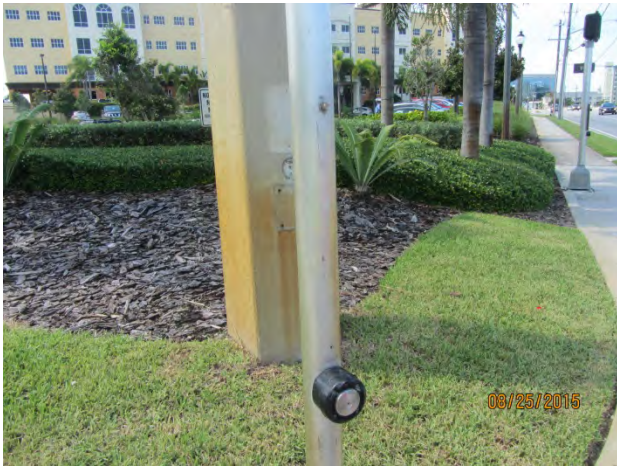
Figure 44

The push button signage on the northwest corner's pole was missing, as illustrated in **Figure 44**.

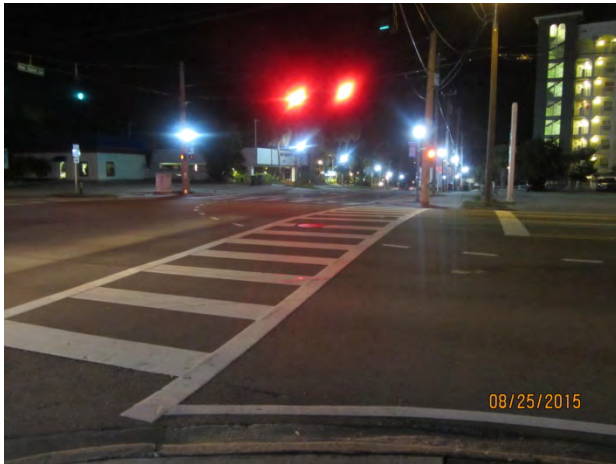
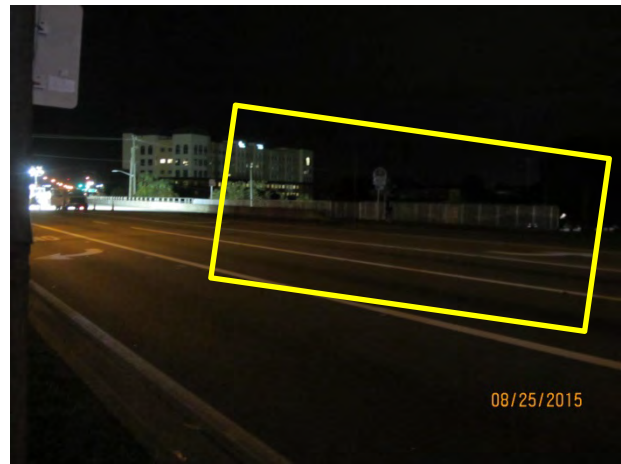
The street light bulb in the northwest corner was burnt out.

Contact the operator/maintainer of the lighting system to replace the burnt out light bulb on the northwest corner.

Consider upgrading the lighting at the intersection to meet the requirements of section 7.3.2.2 in Volume 1 of the FDOT PPM. This may require the existing lighting to be replaced.
