High Crash Corridors Analysis

Road Safety Audit Report for Wickham Road from Sarno Road to Parkway Drive

Project Title: Wickham Road Safety Audit - Sarno Road to Parkway Drive

Field Review Date: September 30th and October 1st, 2015 (AM/PM/afternoon/nighttime reviews and follow-up meeting)

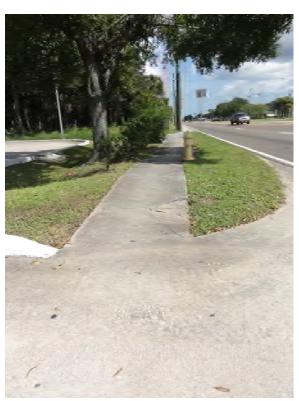
Figure 61

- The sidewalk is cracking and could present a barrier for a wheelchair pedestrian on the north side of Sarno Road, and east of the intersection with Wickham Road, as shown in **Figure 61**.

- o Consider replacing railing support on the east side of Wickham Road, in front of Chili's.
 - o Consider reconstructing the sidewalk on the north side of Sarno Road east of the intersection with Wickham Road to repair section with cracked concrete.

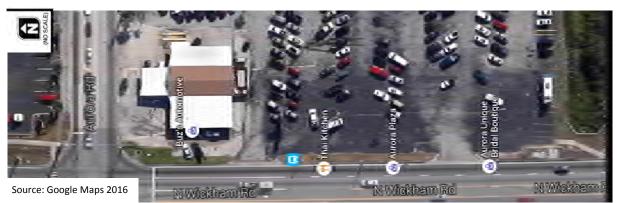
Figure 70 Discontinuous Sidewalk on the East Side near Aurora Road Intersection

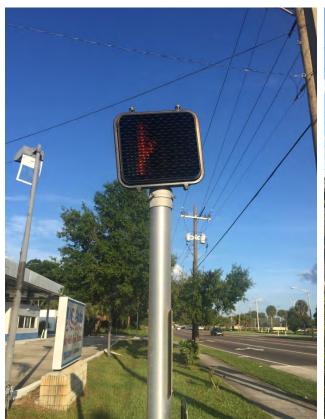
Figure 81

The pedestrian signal head on the northeast corner is crooked as shown in **Figure 81**. The pedestrian signal head has been struck and is cracked. The push button signage on the same pole has been scratched off as illustrated in **Figure 82**.

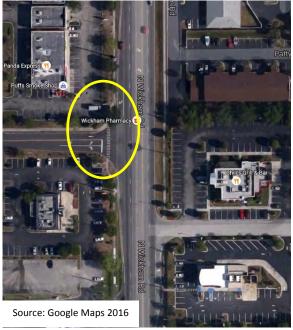
Figure 84

A full-access driveway on the west side of Wickham Road, approximately 500 feet north of Sarno Road, serves Walmart and several other retailers (shown in **Figure 83**). The eastbound left-turn movement onto Wickham Road conflicts with the northbound left-turn into the driveway. Given that northbound left-turns have right-of-way, the delay to exiting traffic at the driveway is heavily influenced by the northbound left-turn demand. Drivers were observed taking short gaps in traffic after having been delayed at this driveway. Some drivers were observed using the center TWLTL as a refuge before pulling into the northbound lanes, while some drivers were observed waiting for a simultaneous gap in both northbound and southbound traffic. **Figure 84** shows the eastbound approach at the driveway.

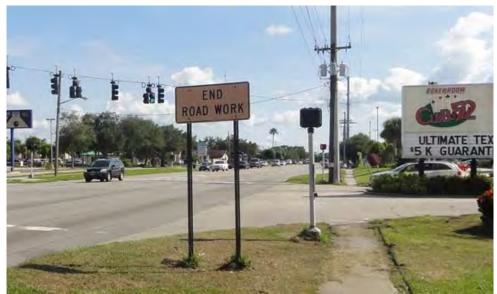
Figure 85

Issue #11: Maintenance to Remove Sign

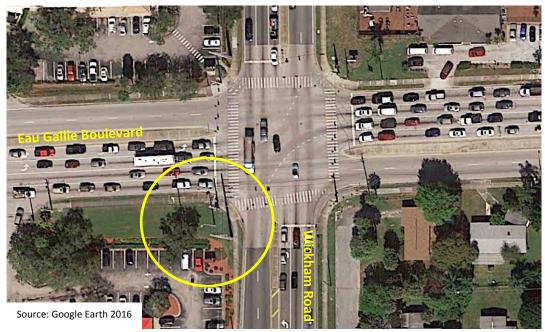
Figure 86

Issue #12: Eastbound Right-Turn Curb Return Radius

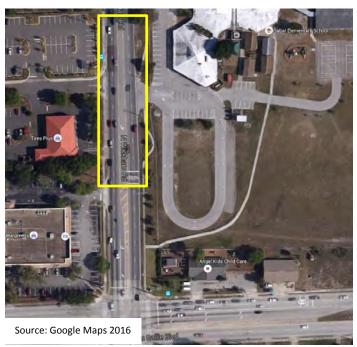
Figure 91 Aerial of School Zone for Sabal Elementary School

A School Zone is designated on Wickham Road in front of Sabal Elementary School (see **Figure 91**). The school zone for southbound traffic ends approximately 250 feet north of Eau Gallie Boulevard (shown in **Figure 92**). Drivers were observed accelerating after leaving the school zone up to the signal at Eau Gallie Boulevard to get through during the green phase. This behavior may contribute to rear-end crashes on the southbound approach at the signalized intersection where students cross Wickham Road.

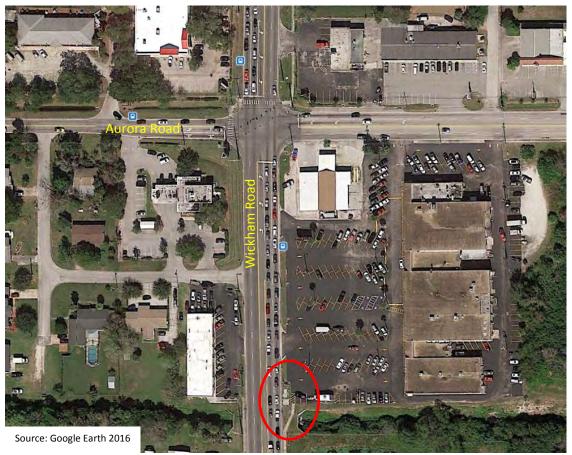
Figure 96

Issue #16: Incomplete Pedestrian Facilities

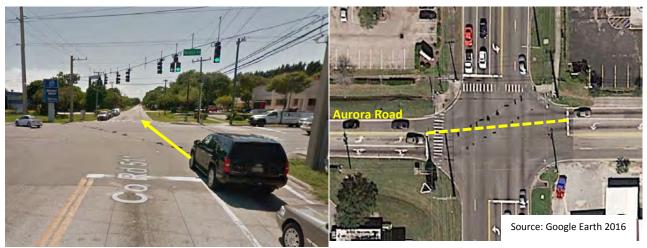
Figure 97 Figure 98

Issue #17: Westbound Through Movement Alignment

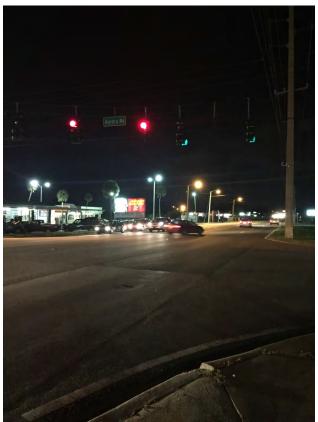
Figure 99

Issue #18: Lighting

• Repair/replace applicable street lights between Aurora Road and Lake Washington Road

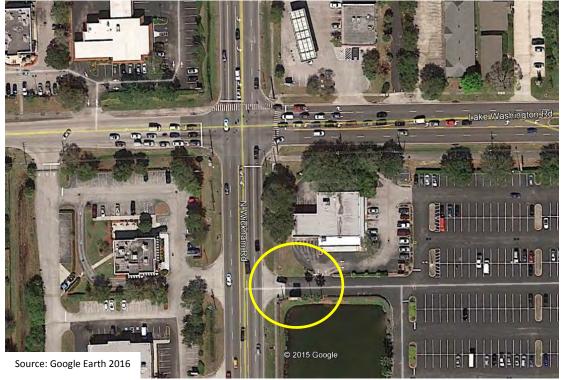
Figure 102

Issue #20: Driveway Turn Movement Conflicts

In the near-term, consider restricting the northernmost driveway on the southeast corner of the intersection to right-in/right-out only by installing a "pork chop" island.

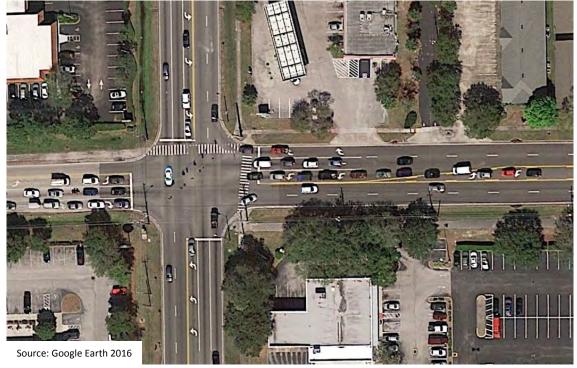
Figure 104

Issue #21: Westbound Lane Drop

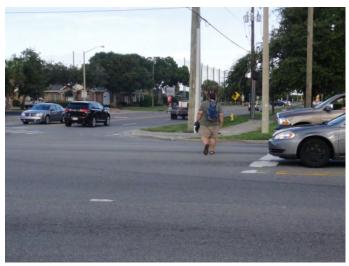
Figure 105

Issue #22: Incomplete Pedestrian Facilities

- Provide marked crossings on the west and south legs of the intersection and install necessary pedestrian signal equipment.
- Construct a sidewalk on the west side of Wickham Road in the vicinity of the intersection.

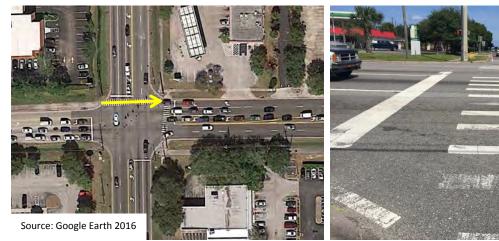
Figure 107 Figure 108

Issue #23: Pedestrian Crossing Alignment

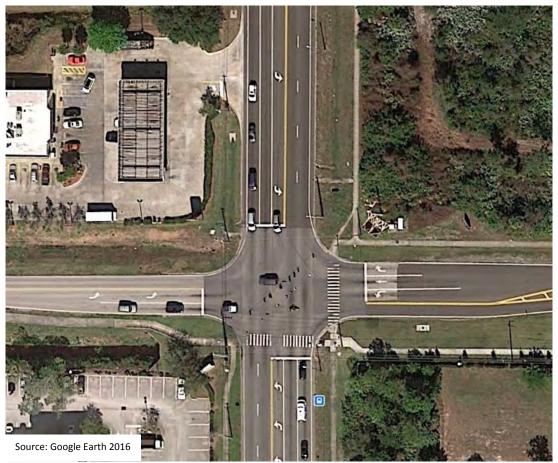
Figure 111 Aerial Photo Showing Existing Crosswalks at the Parkway Drive/Wickham Road Intersection
