WICKHAM ROAD

OPERATIONAL ANALYSIS

Final Report

Eau Gallie Boulevard to Lake Washington Road

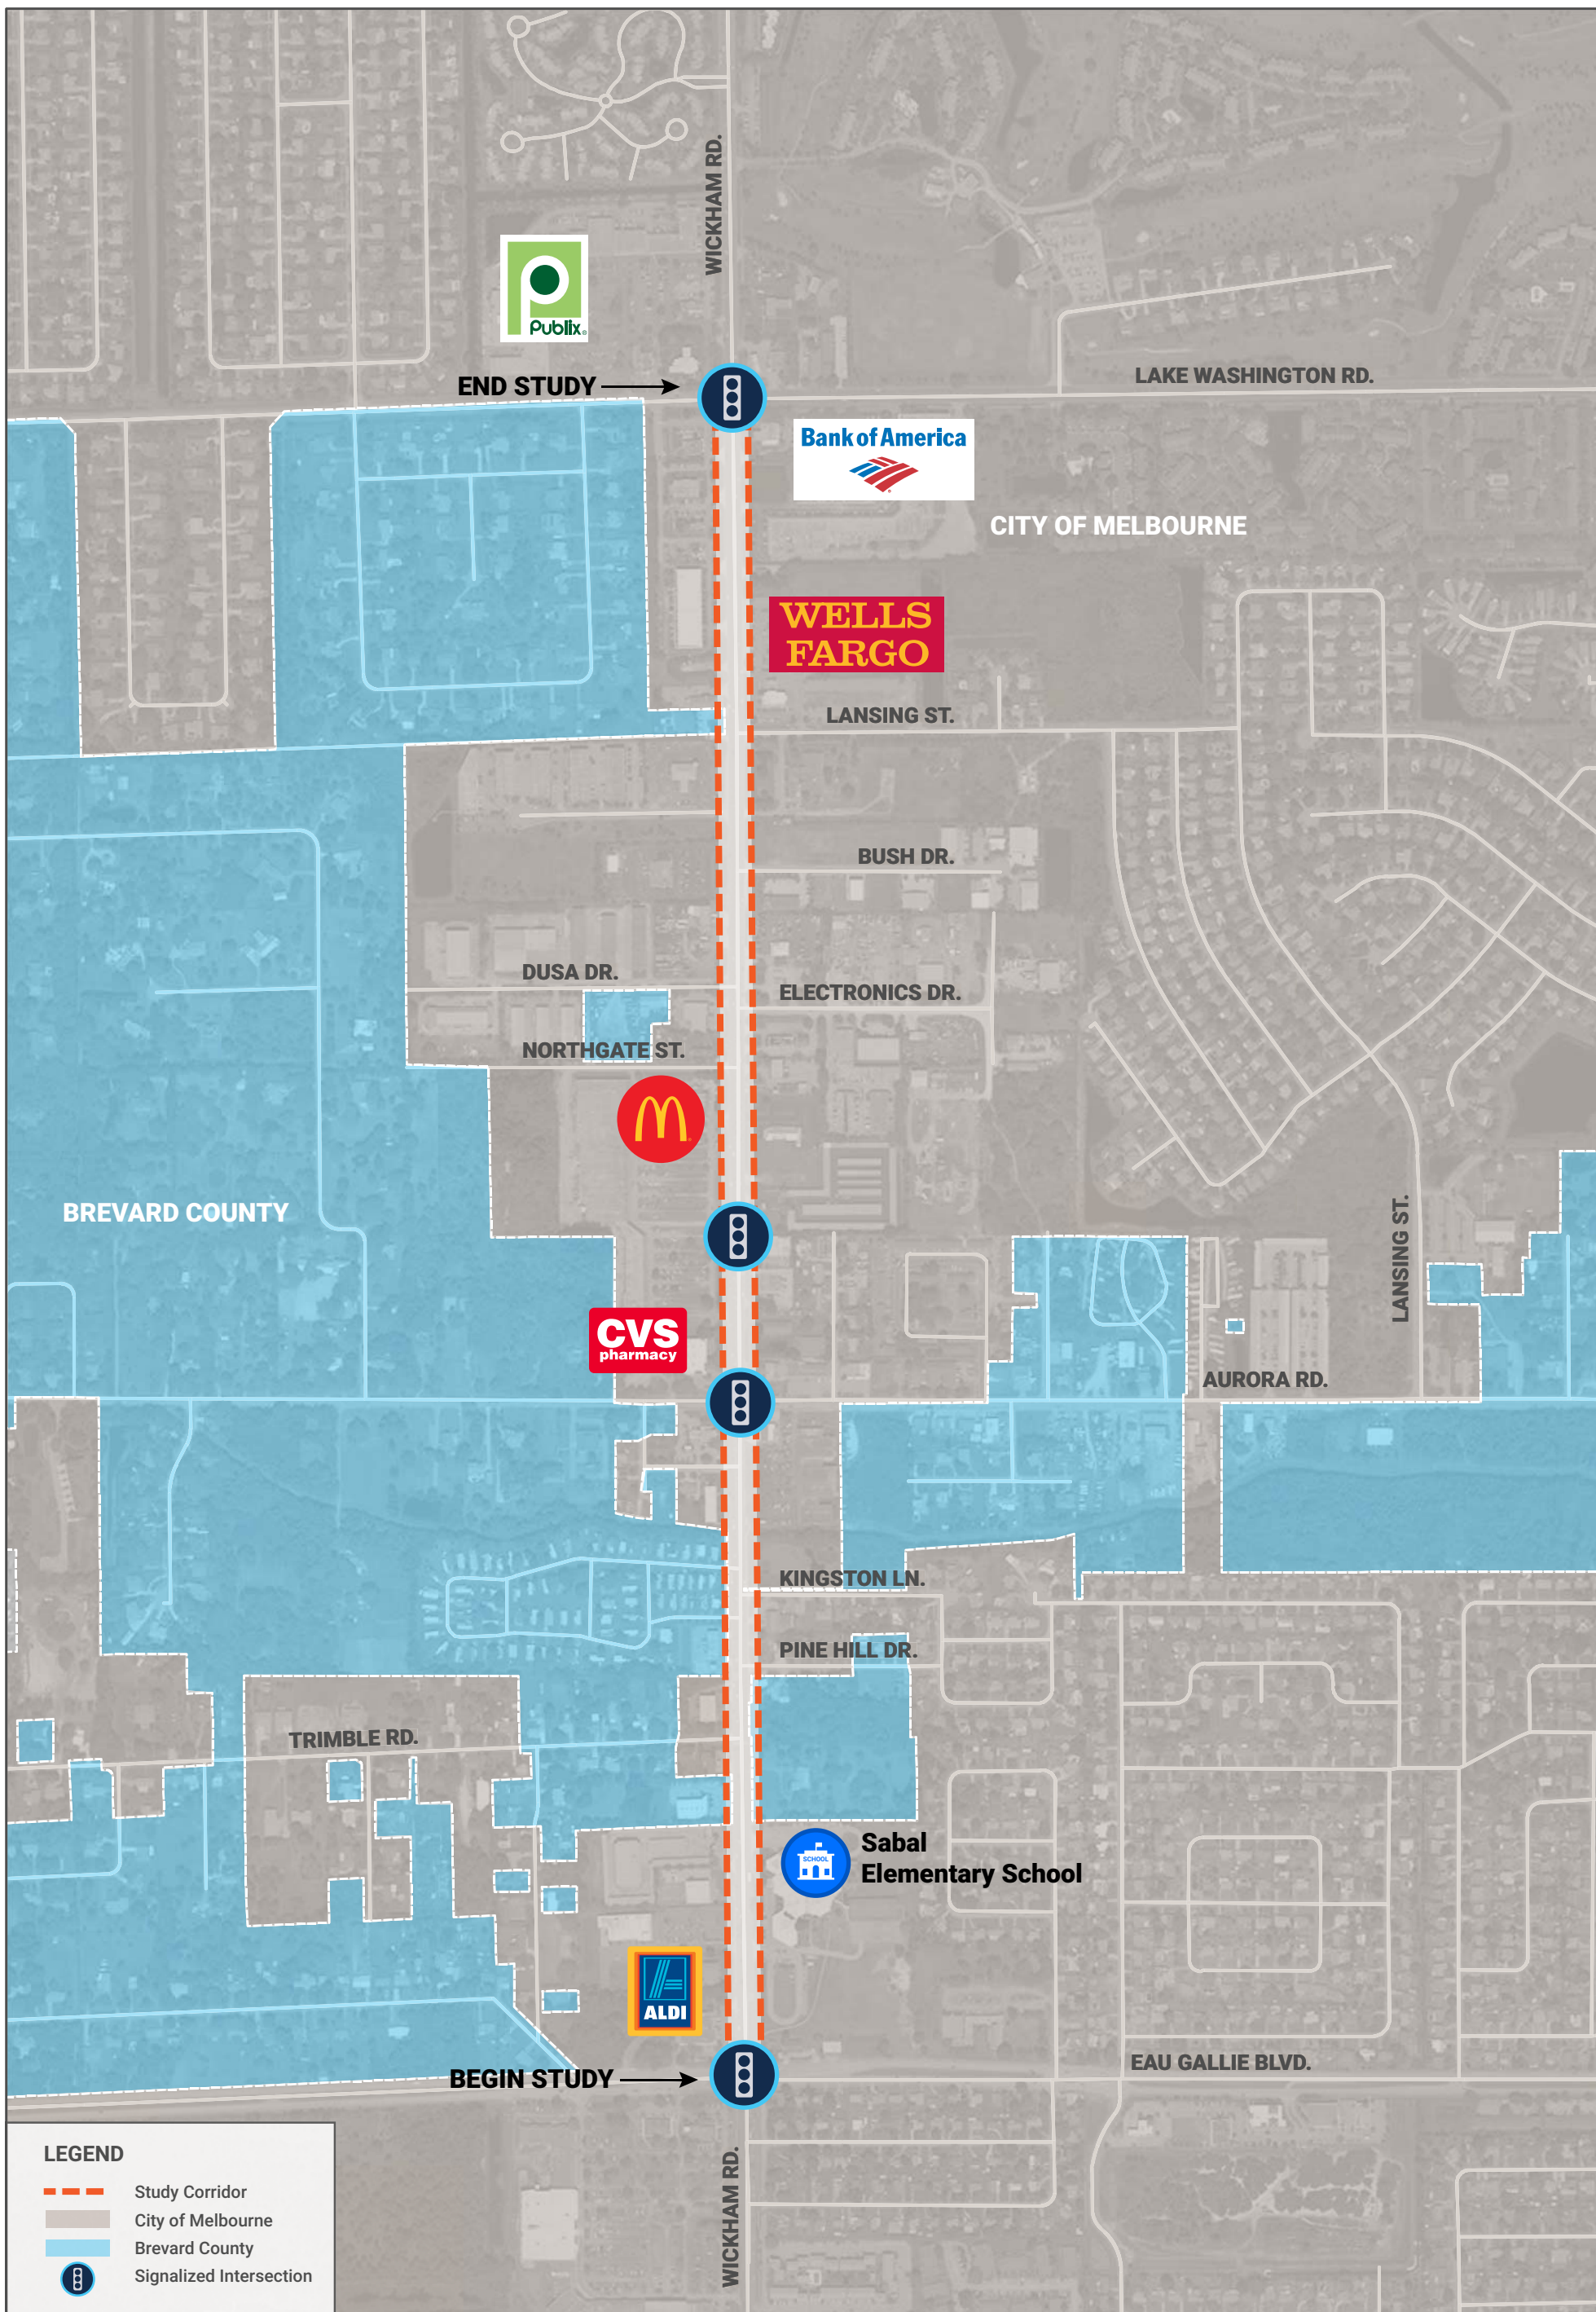
Wickham Road from Eau Gallie Boulevard to Lake Washington Road is classified as an urban principal arterial – other. The annual average daily traffic (AADT) along this section ranges from approximately 32,000 to 35,000 based on the counts collected in late 2016. Wickham Road is primarily surrounded by commercial/retail land uses along the length of the corridor. Residential land uses are present behind the commercial/retail development in the surrounding areas. The study corridor is illustrated in **Figure 1**. Wickham Road falls within the jurisdiction of both the City of Melbourne and Brevard County over the study corridor limits.

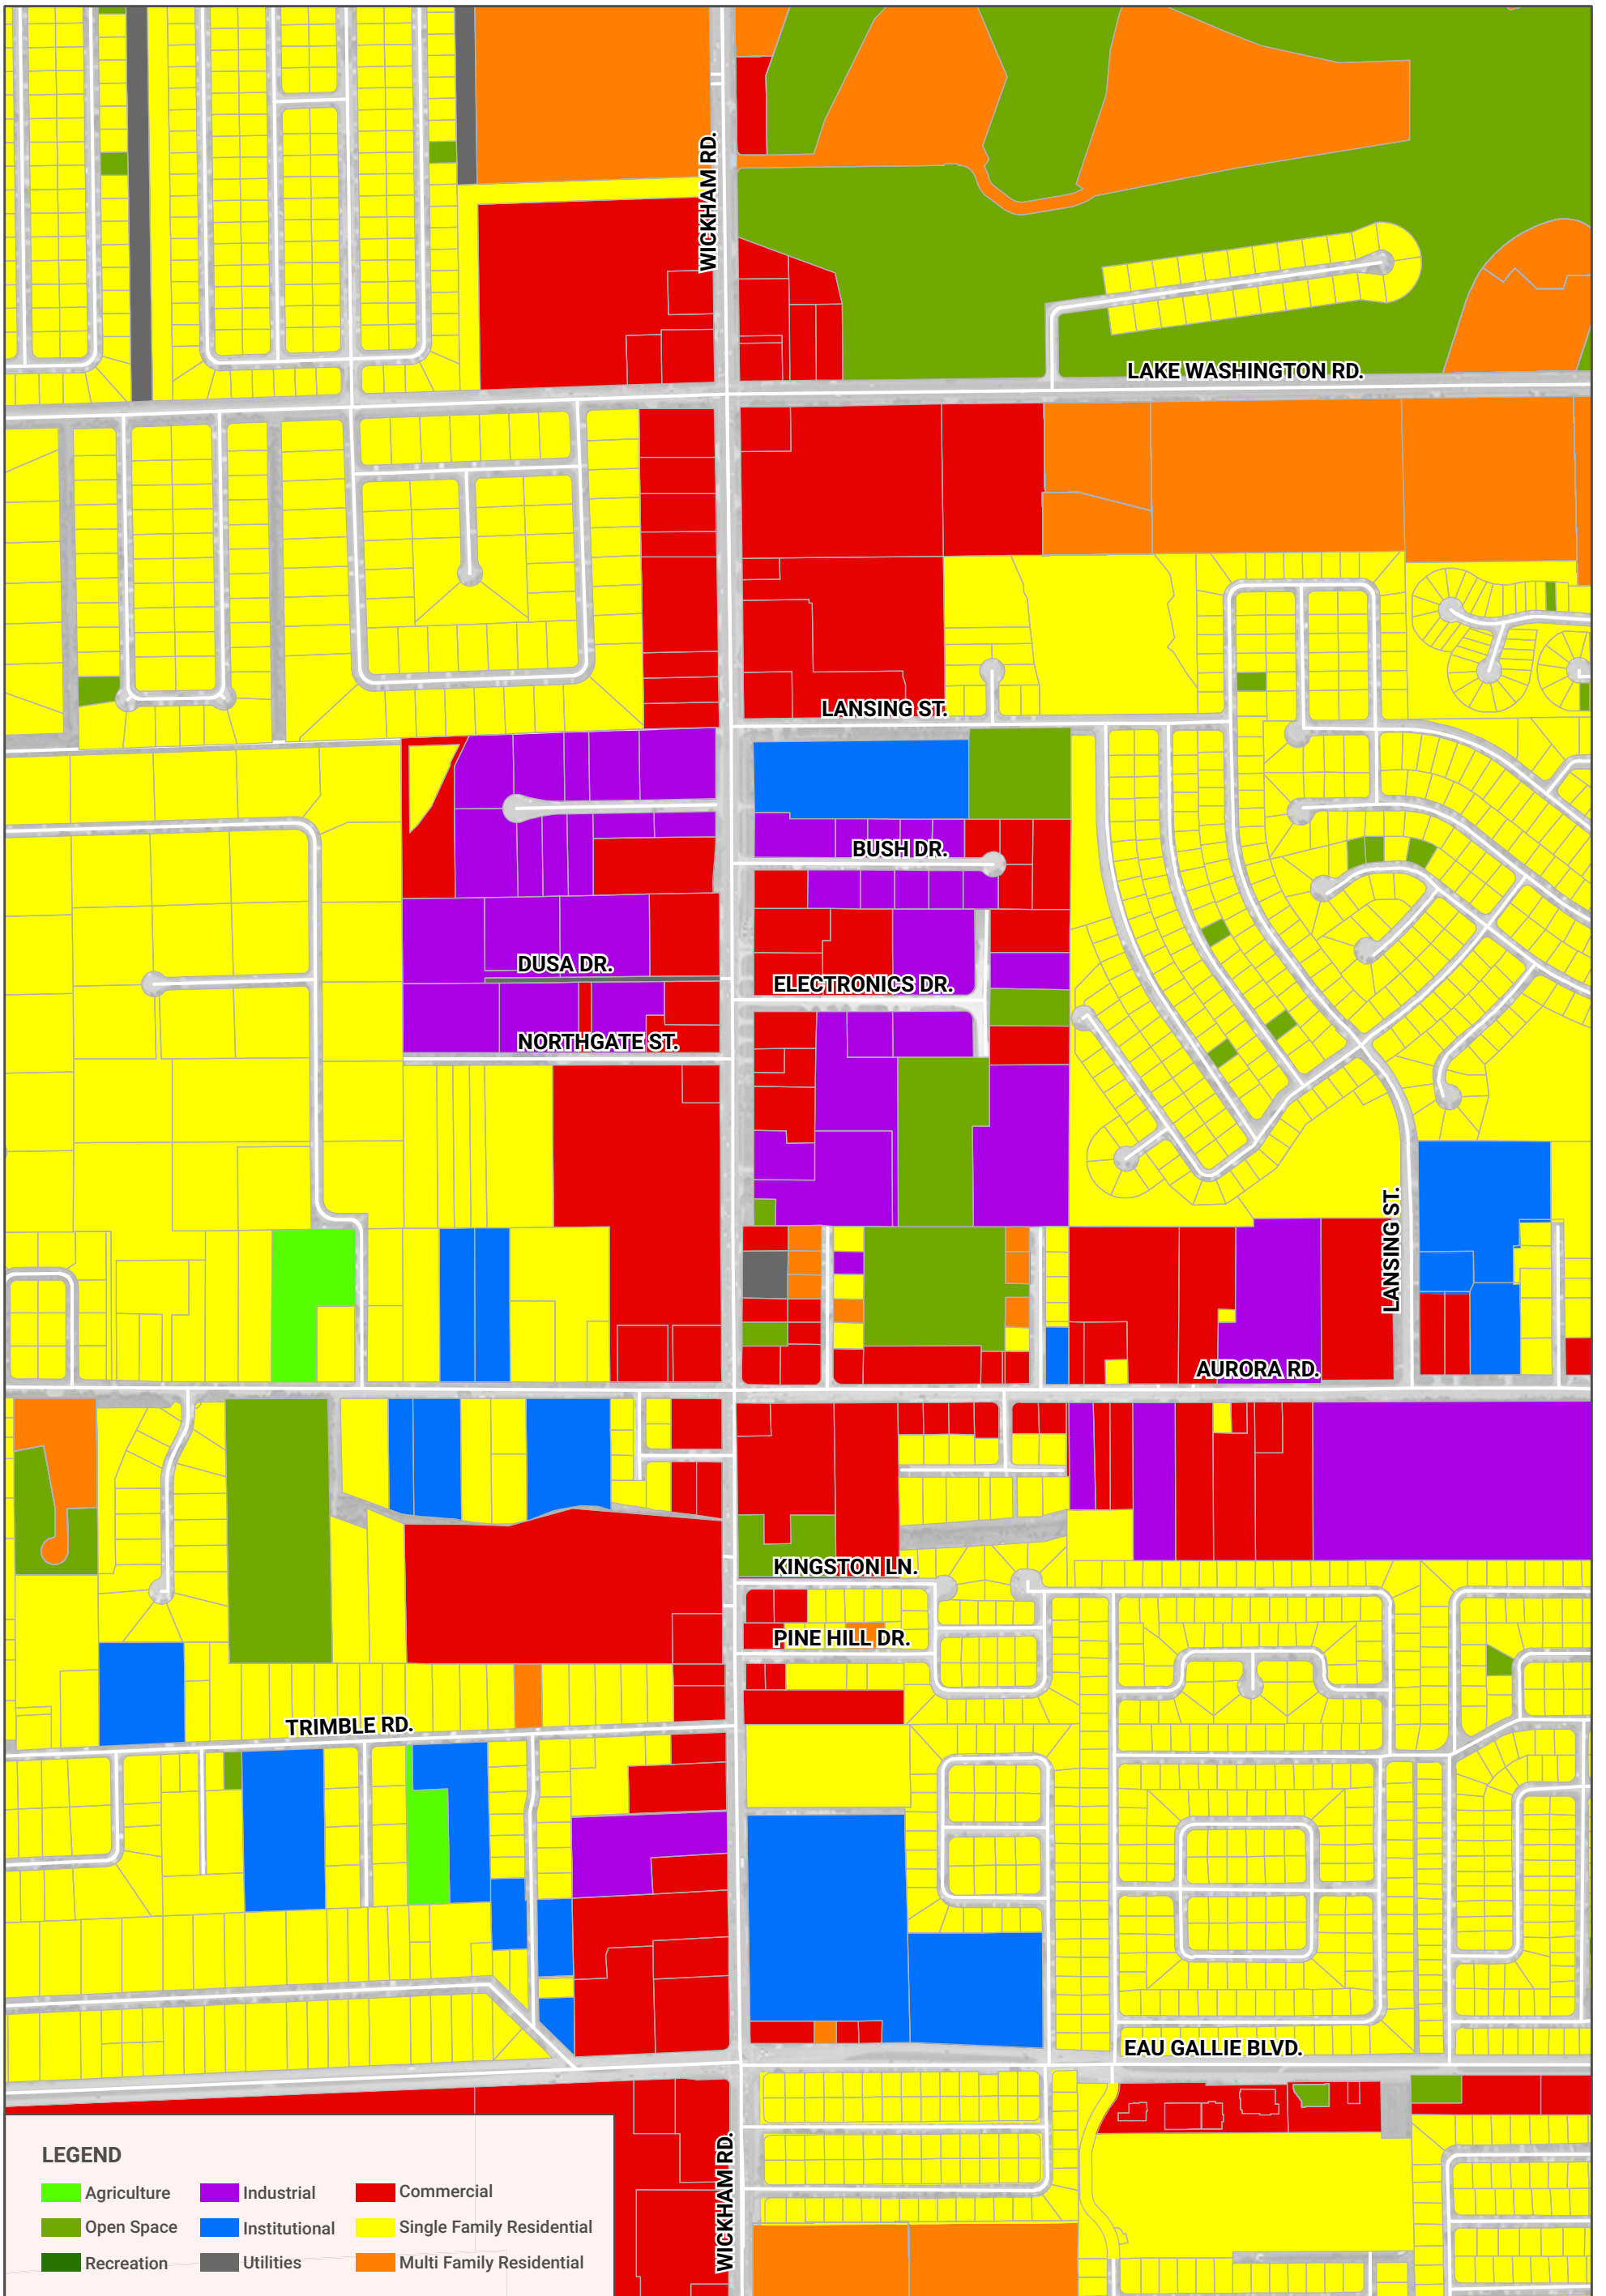
FIGURE 2
 Existing Land Use
 A-14

Figure 2 illustrates existing land use along the study corridor at the individual parcel level. There are distinct clusters of commercial and industrial land uses adjacent to both sides of Wickham Road. There are also large clusters of single family residential land uses to the east and west of Wickham Road.

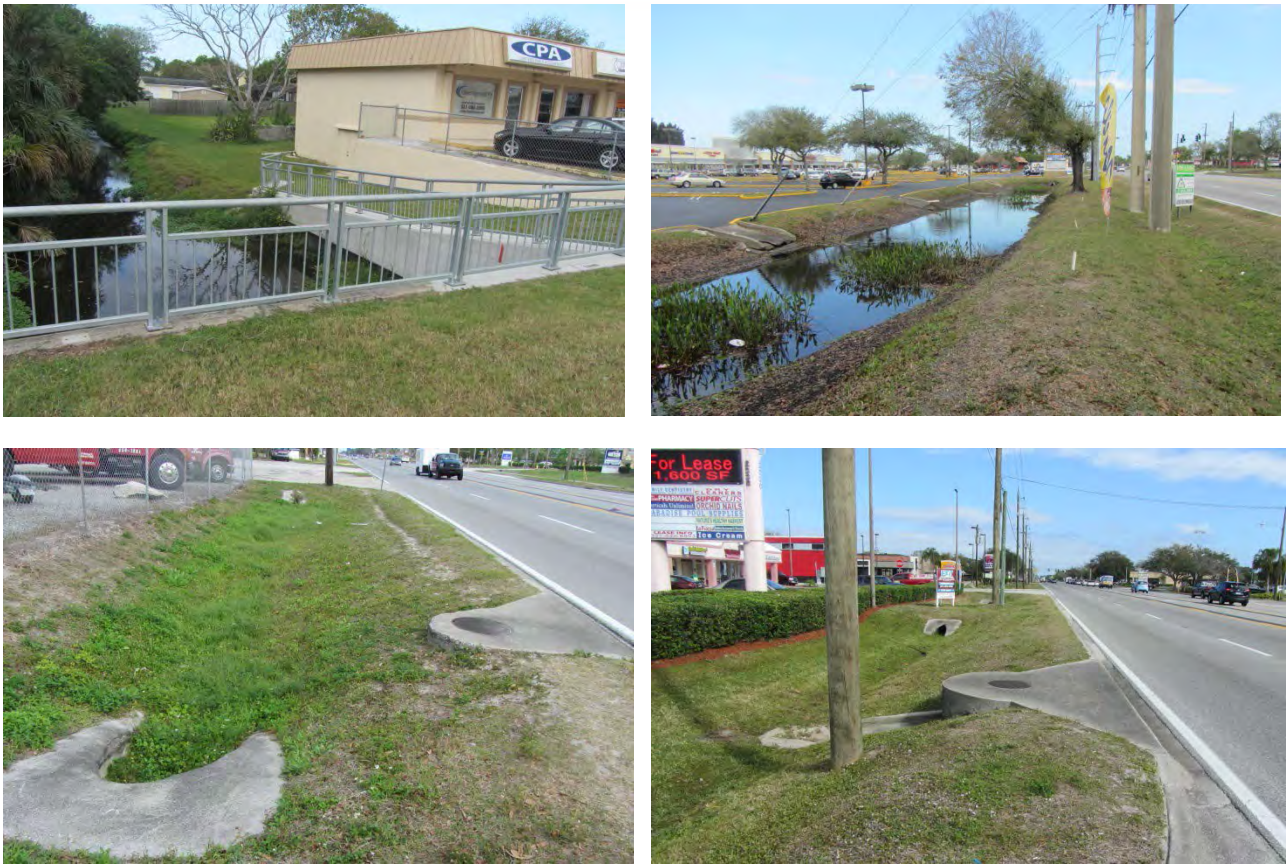
Figure 5: Existing Drainage Features along Wickham Road

Wickham Road has a closed drainage system with curb and gutter along the entire study corridor. The stormwater management facilities that provide water quality treatment for Wickham Road are limited to one existing FDOT and one Brevard County stormwater pond. No current relevant SJRWMD permits were found. A field review was conducted on Tuesday, February 28, 2017 and examples of existing drainage features are illustrated in **Figure 5**.

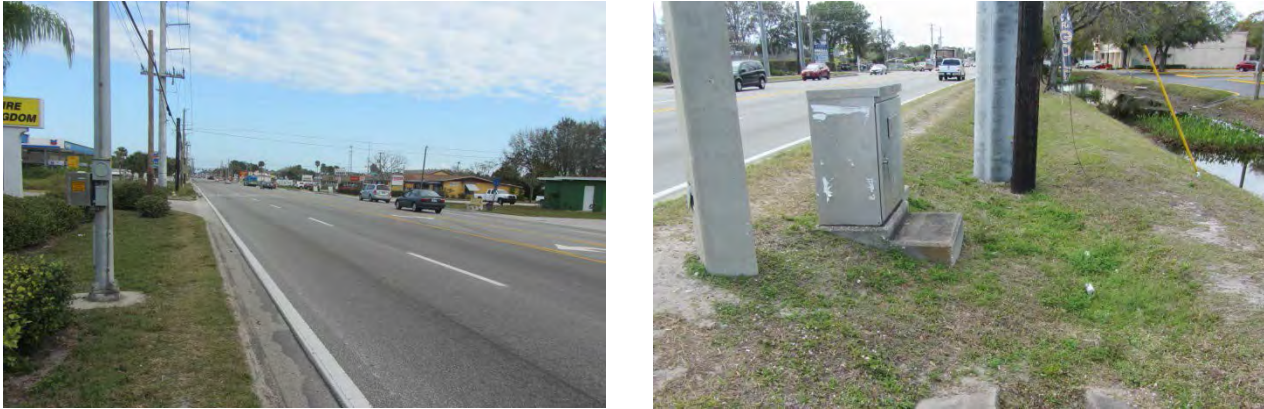
Figure 6: Adjacent Utilities along Wickham Road

Appendix C includes the list of utilities identified along the corridor based on the Sunshine One Call. The overhead utilities and transmission lines lie adjacent to the west side of Wickham Road for the majority of the study corridor (examples shown in **Figure 6**).

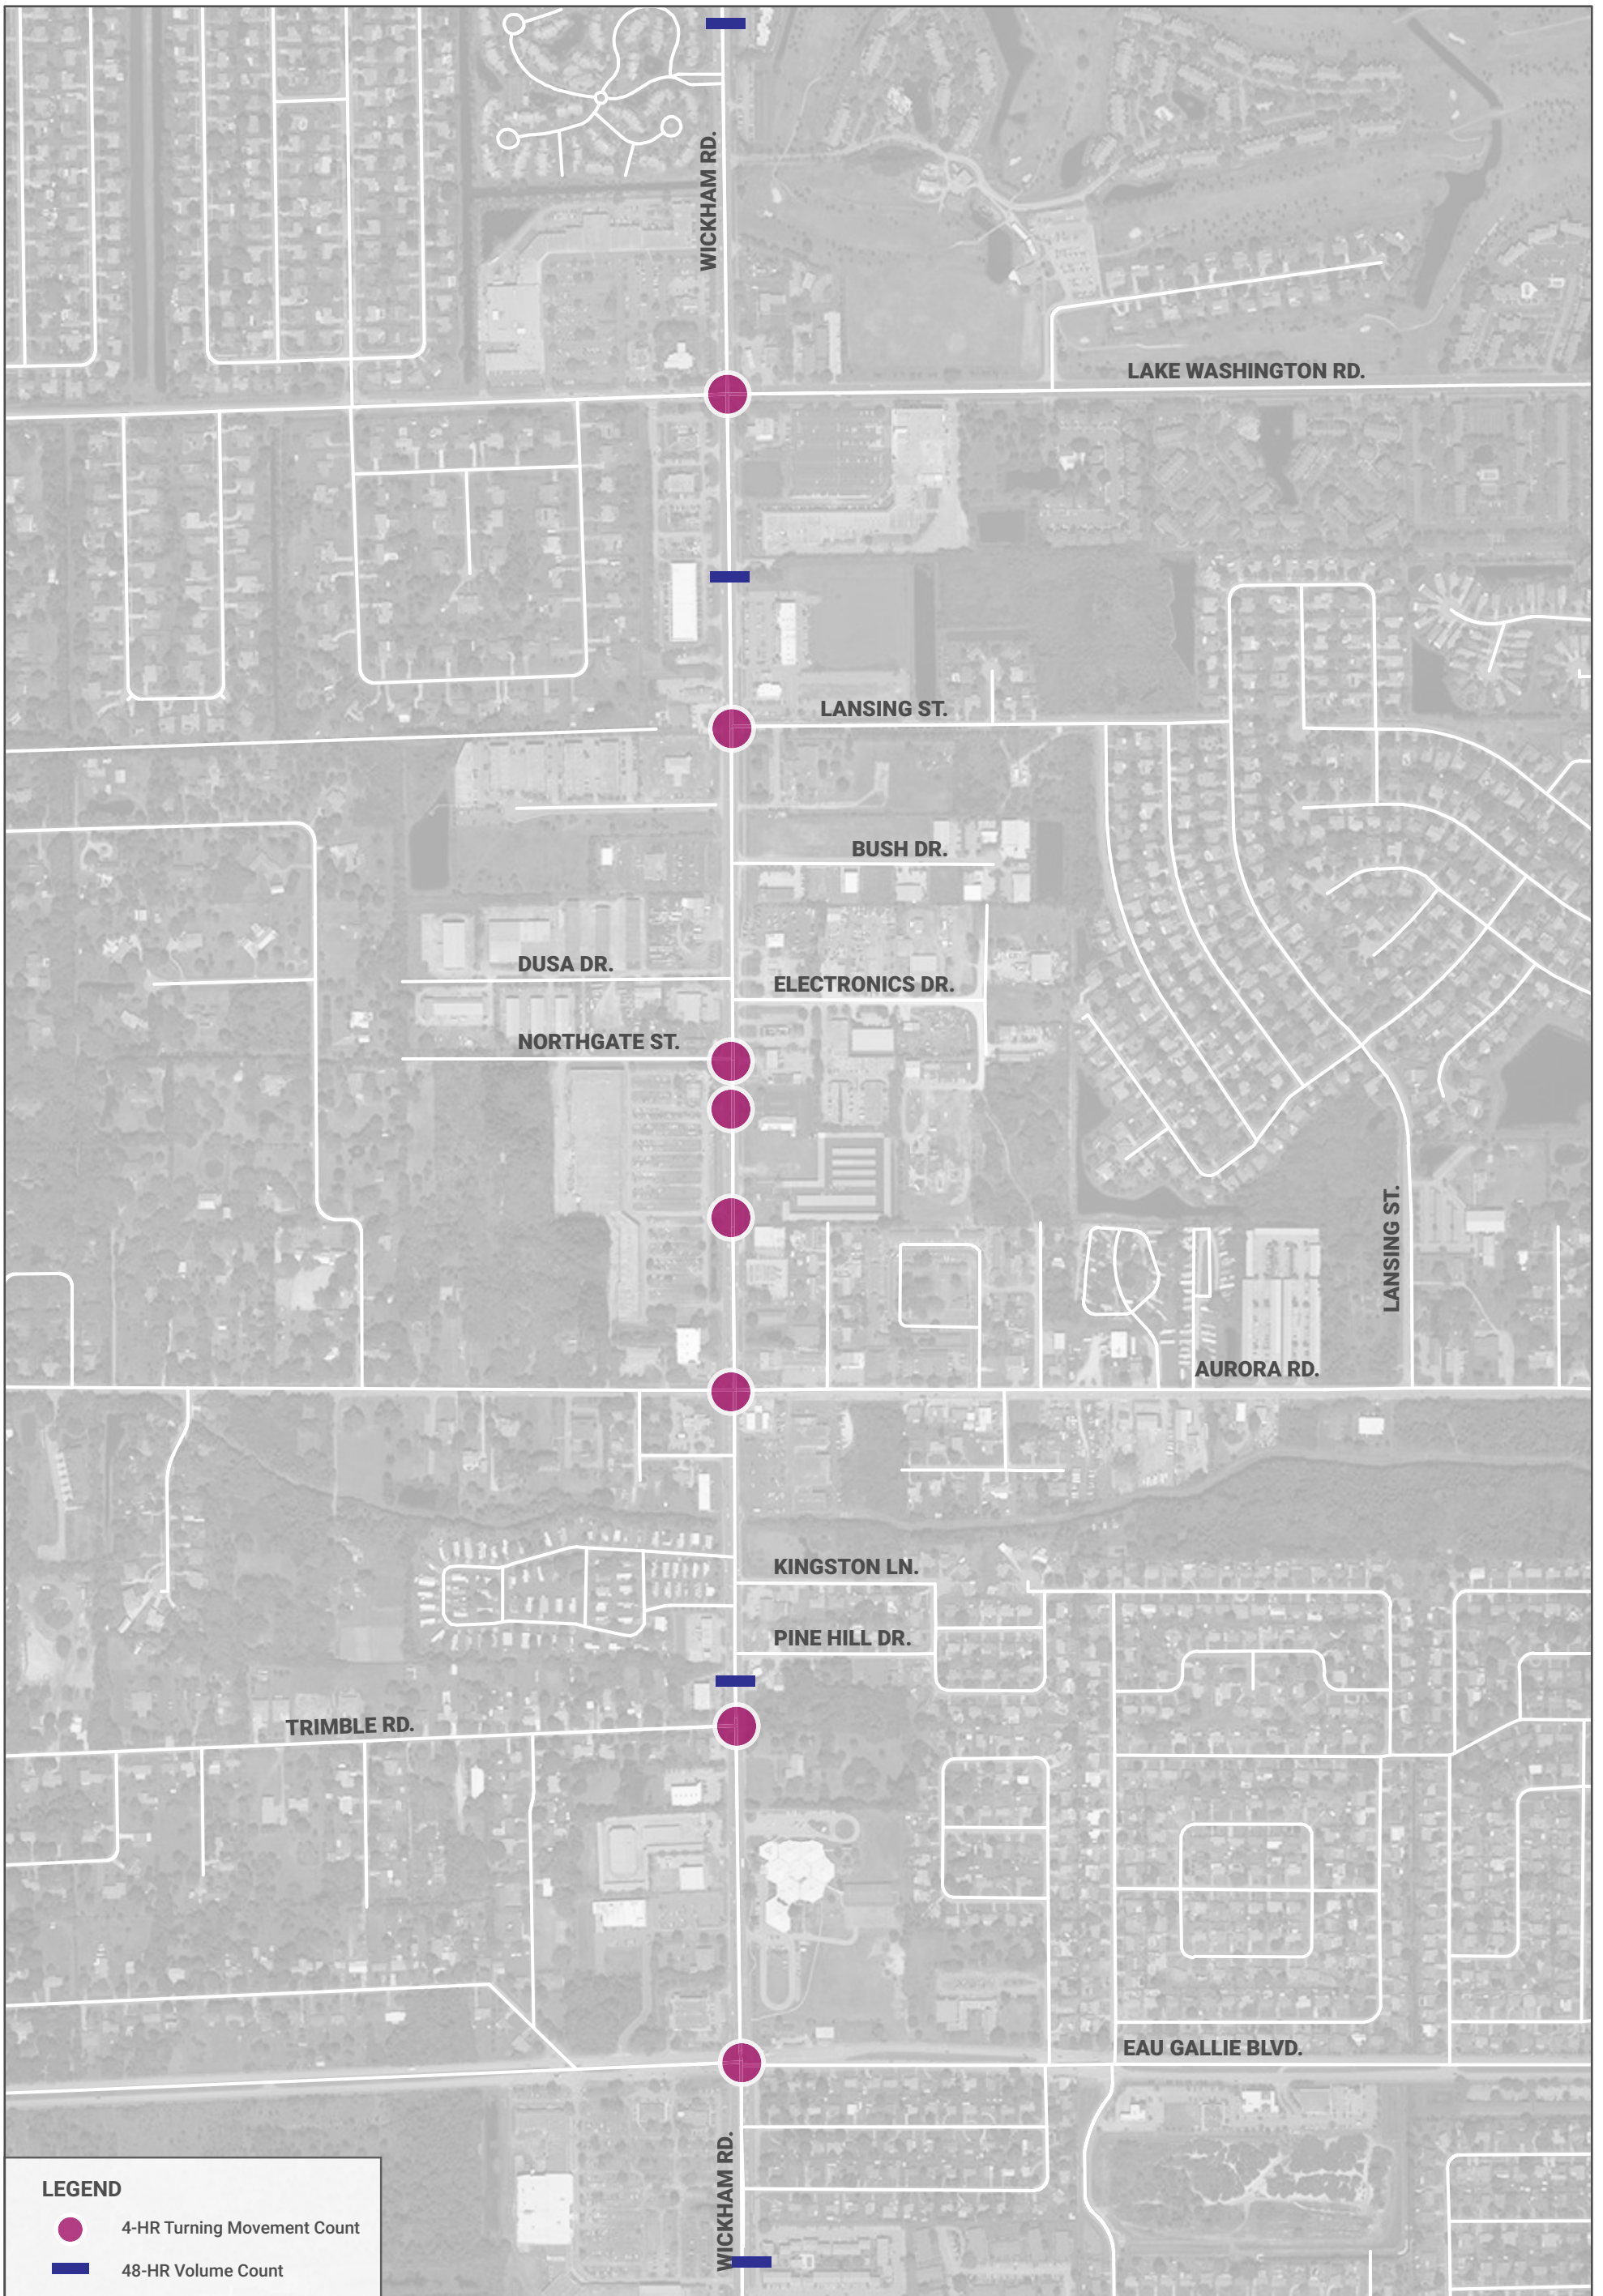
The TMC and volume counts were collected in November 2016 with the exception of the Northgate Plaza and Northgate Street intersections (collected in October/December 2015). The intersections where TMCs were taken will be projected for the future year analysis. The raw intersection and volume count data is provided in **Appendix D**. The locations of the volume counts and TMCs along the study corridor are illustrated in **Figure 11**.

- 48-Hour Volume Counts – October/November 2016
 - Wickham Road, south of Eau Gallie Boulevard
 - Wickham Road, between Trimble Road and Pine Hill Drive
 - Wickham Road, between Lansing Street and Lake Washington Road
 - Wickham Road, north of Lake Washington Road
- 4-hour Intersection Turning Movement Counts – October/December 2015 and November 2016
 - Eau Gallie Boulevard
 - Trimble Road (unsignalized)
 - Aurora Road
 - Northgate Plaza
 - Northgate Plaza – North Entrance (unsignalized)
 - Northgate Street (unsignalized)
 - Lansing Street (unsignalized)
 - Lake Washington Road

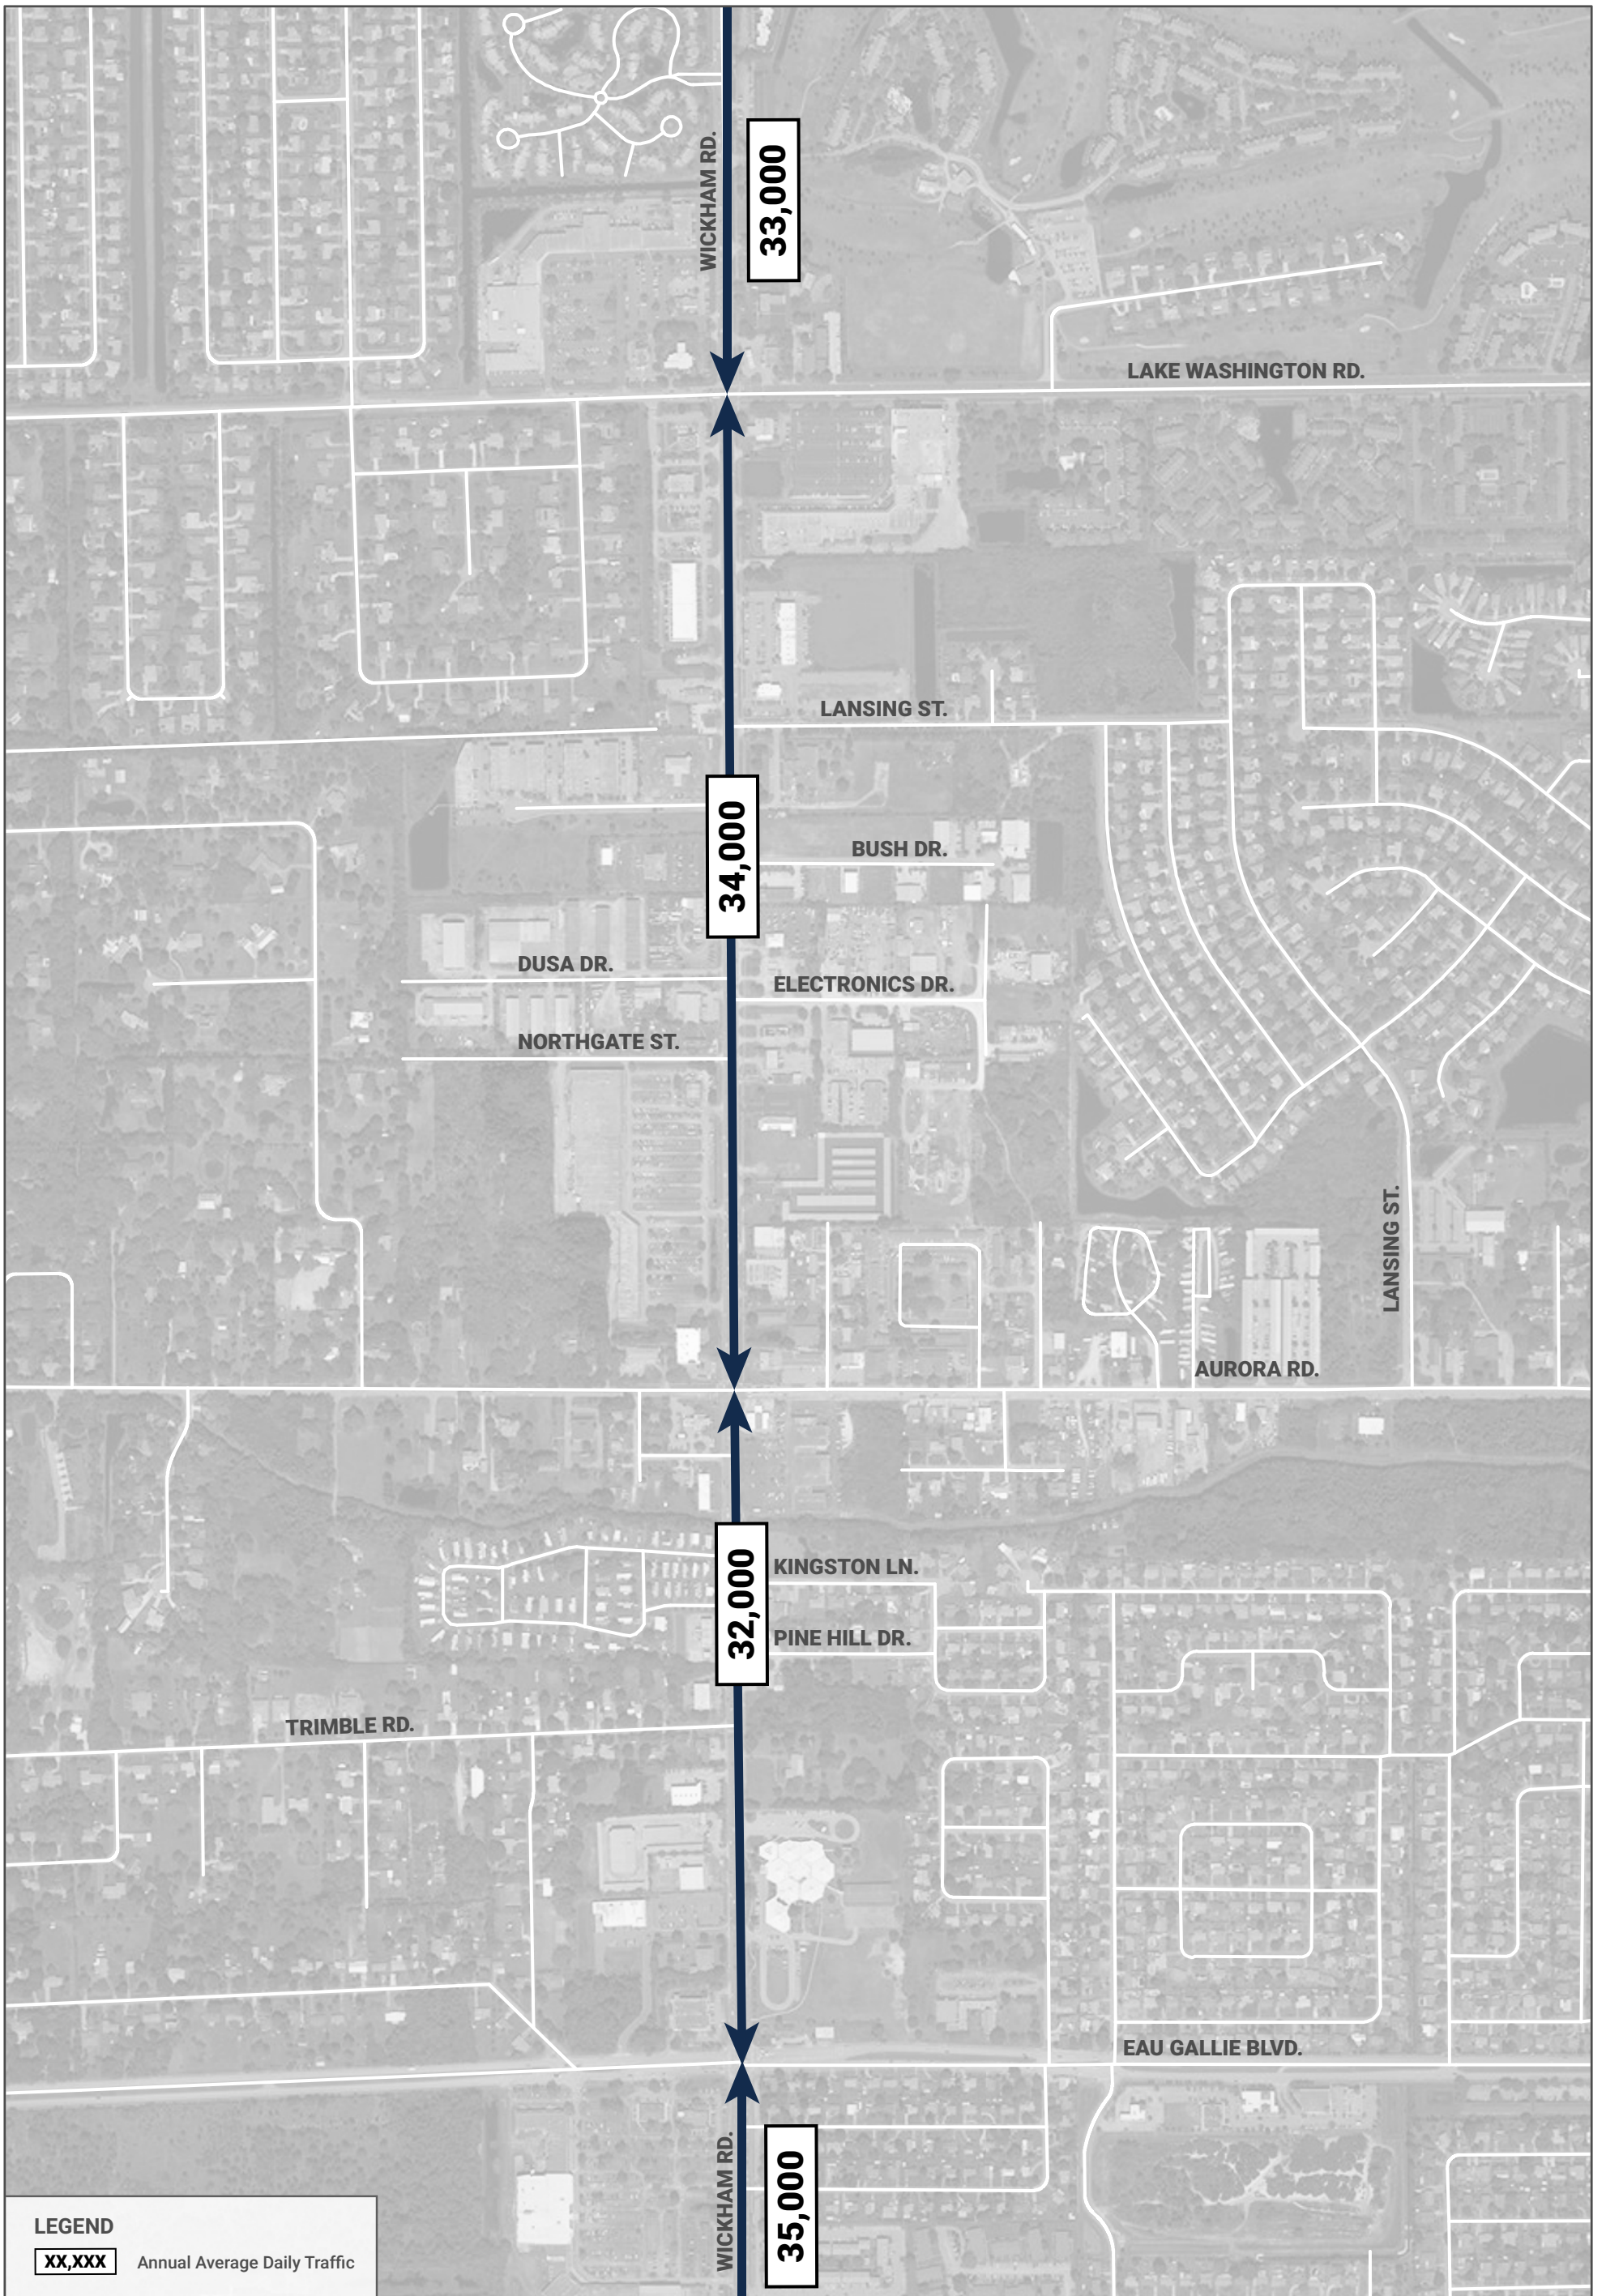
The volume counts and turning movement counts were adjusted using a seasonal adjustment factor (included in **Appendix E**), obtained from 2015 FDOT Florida Transportation Information (FTI) DVD, to estimate 2016 Annual Average Daily Traffic (AADT). An axle correction factor (included in **Appendix E**) was also applied to the volume counts. These seasonally adjusted AADT's and turning movement volumes were used for the existing conditions analysis. The existing 2016 segment AADT's along the study corridor are presented in **Table 1** and in **Figure 12**.

Roadway	48-Hour Volume Count Dates	ADT	Axle Adj. Factor	Seasonal Adj. Factor	AADT
South of Eau Gallie Boulevard	10/24/16 – 10/25/16	35,118	0.98	0.99	35,000
Between Trimble Road and Pine Hills Drive	11/28/16 – 11/29/16	32,378	0.98	0.99	32,000
Between Lansing Street and Lake Washington Road	10/24/16 – 10/25/16	34,178	0.98	0.99	34,000
North of Lake Washington Road	10/25/16 – 10/26/16	33,053	0.98	0.99	33,000

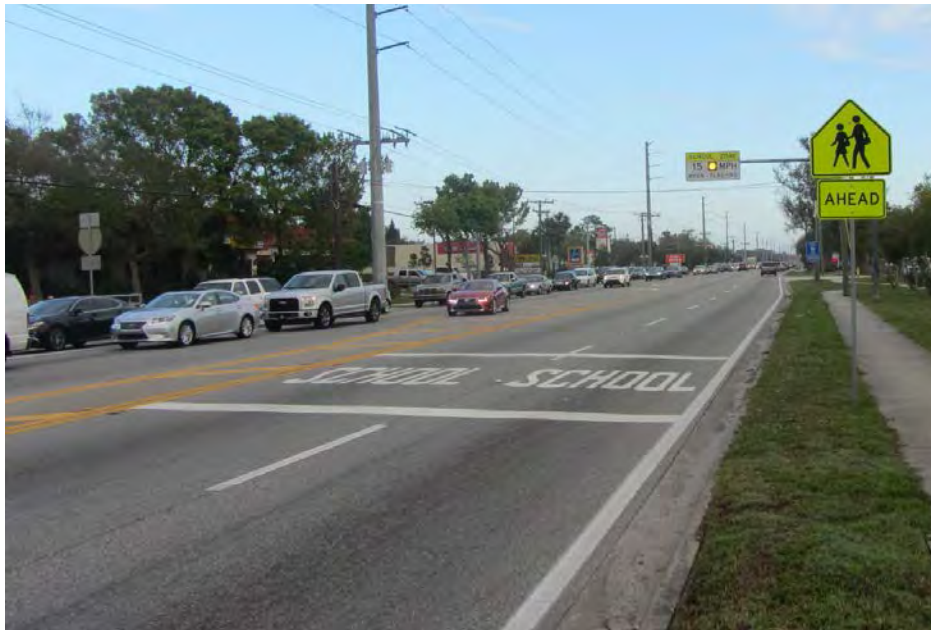
Figure 13: Southbound Queuing along Wickham Road – AM Peak Hour

- Southbound queuing along Wickham Road at the Eau Gallie Boulevard intersection extended approximately 1,200 feet to Trimble Road (**Figure 13**).

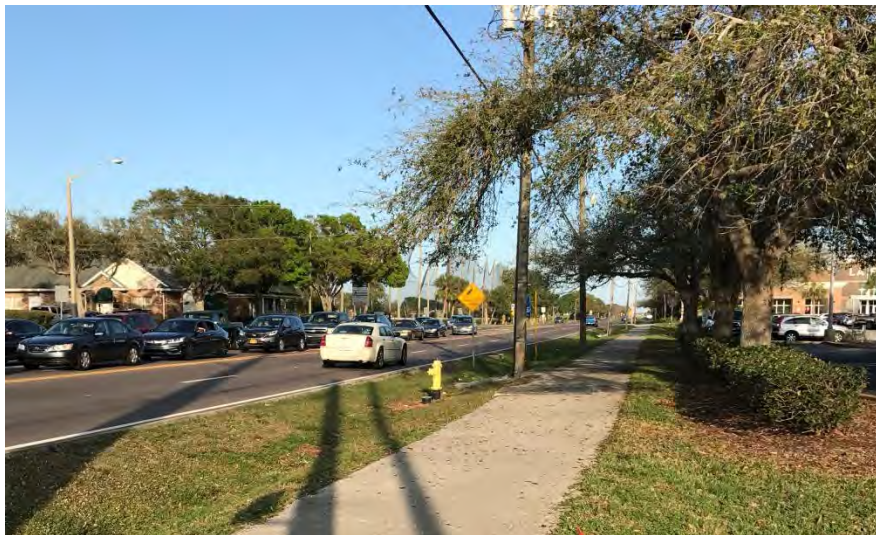
Figure 14: Westbound Queuing along Lake Washington Road – PM Peak Hour

- Similar westbound queuing along Lake Washington Road was present during the PM peak hour as the AM –
 - Westbound queues were observed extending over 500 feet along Lake Washington Road (**Figure 14**).

- The current green time allocated to the left-turn phase did not serve all of the queued vehicles.

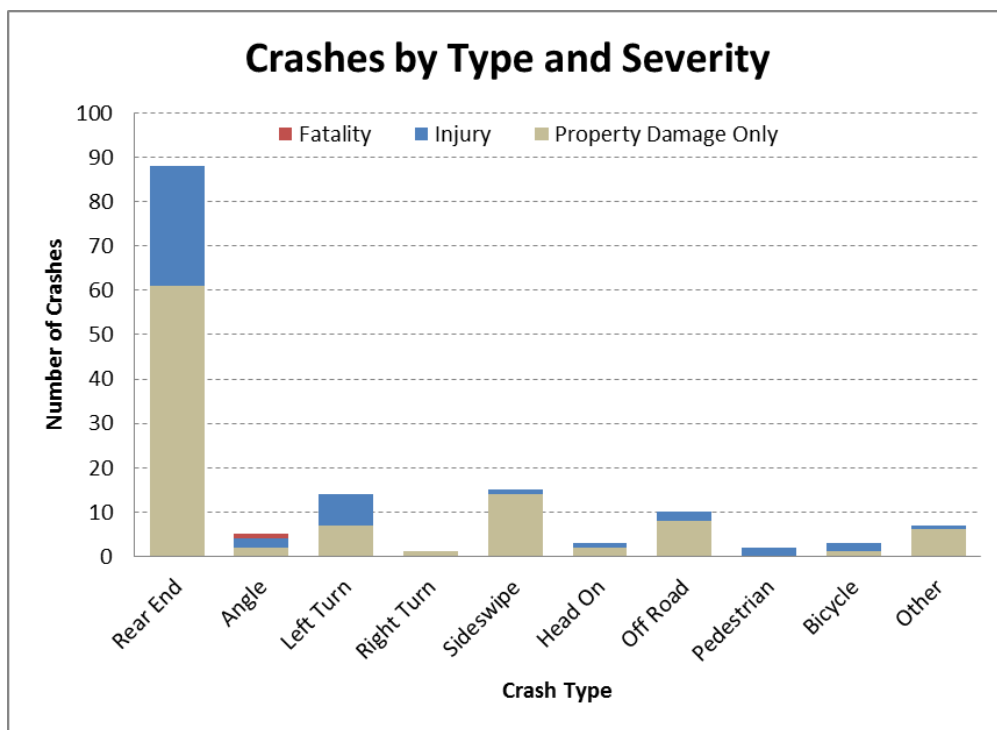
Figure 22: Crashes by Type and Severity (Wickham Road/Eau Gallie Boulevard)

The signalized intersection of Wickham Road and Eau Gallie Boulevard accounted for 148 (22 percent) of the crashes along the Wickham Road study corridor. **Figure 22** displays the observed crashes at the intersection by crash type and severity. The highest observed crash type at the intersection was rear end, comprising approximately 60 percent of the intersection crashes. Sideswipe and left-turn crashes were the next most common crashes (10 percent each) at this intersection. Two pedestrian and three bicycle crashes, resulting in four injuries were reported at this intersection. One fatal angle crash occurred in 2014. A more detailed summary of the 2011 to 2015 Wickham Road/Eau Gallie Boulevard crash data set in tabular and graphical format is provided in **Appendix I**.
