WICKHAM ROAD

OPERATIONAL ANALYSIS

Final Report

Eau Gallie Boulevard to Lake Washington Road

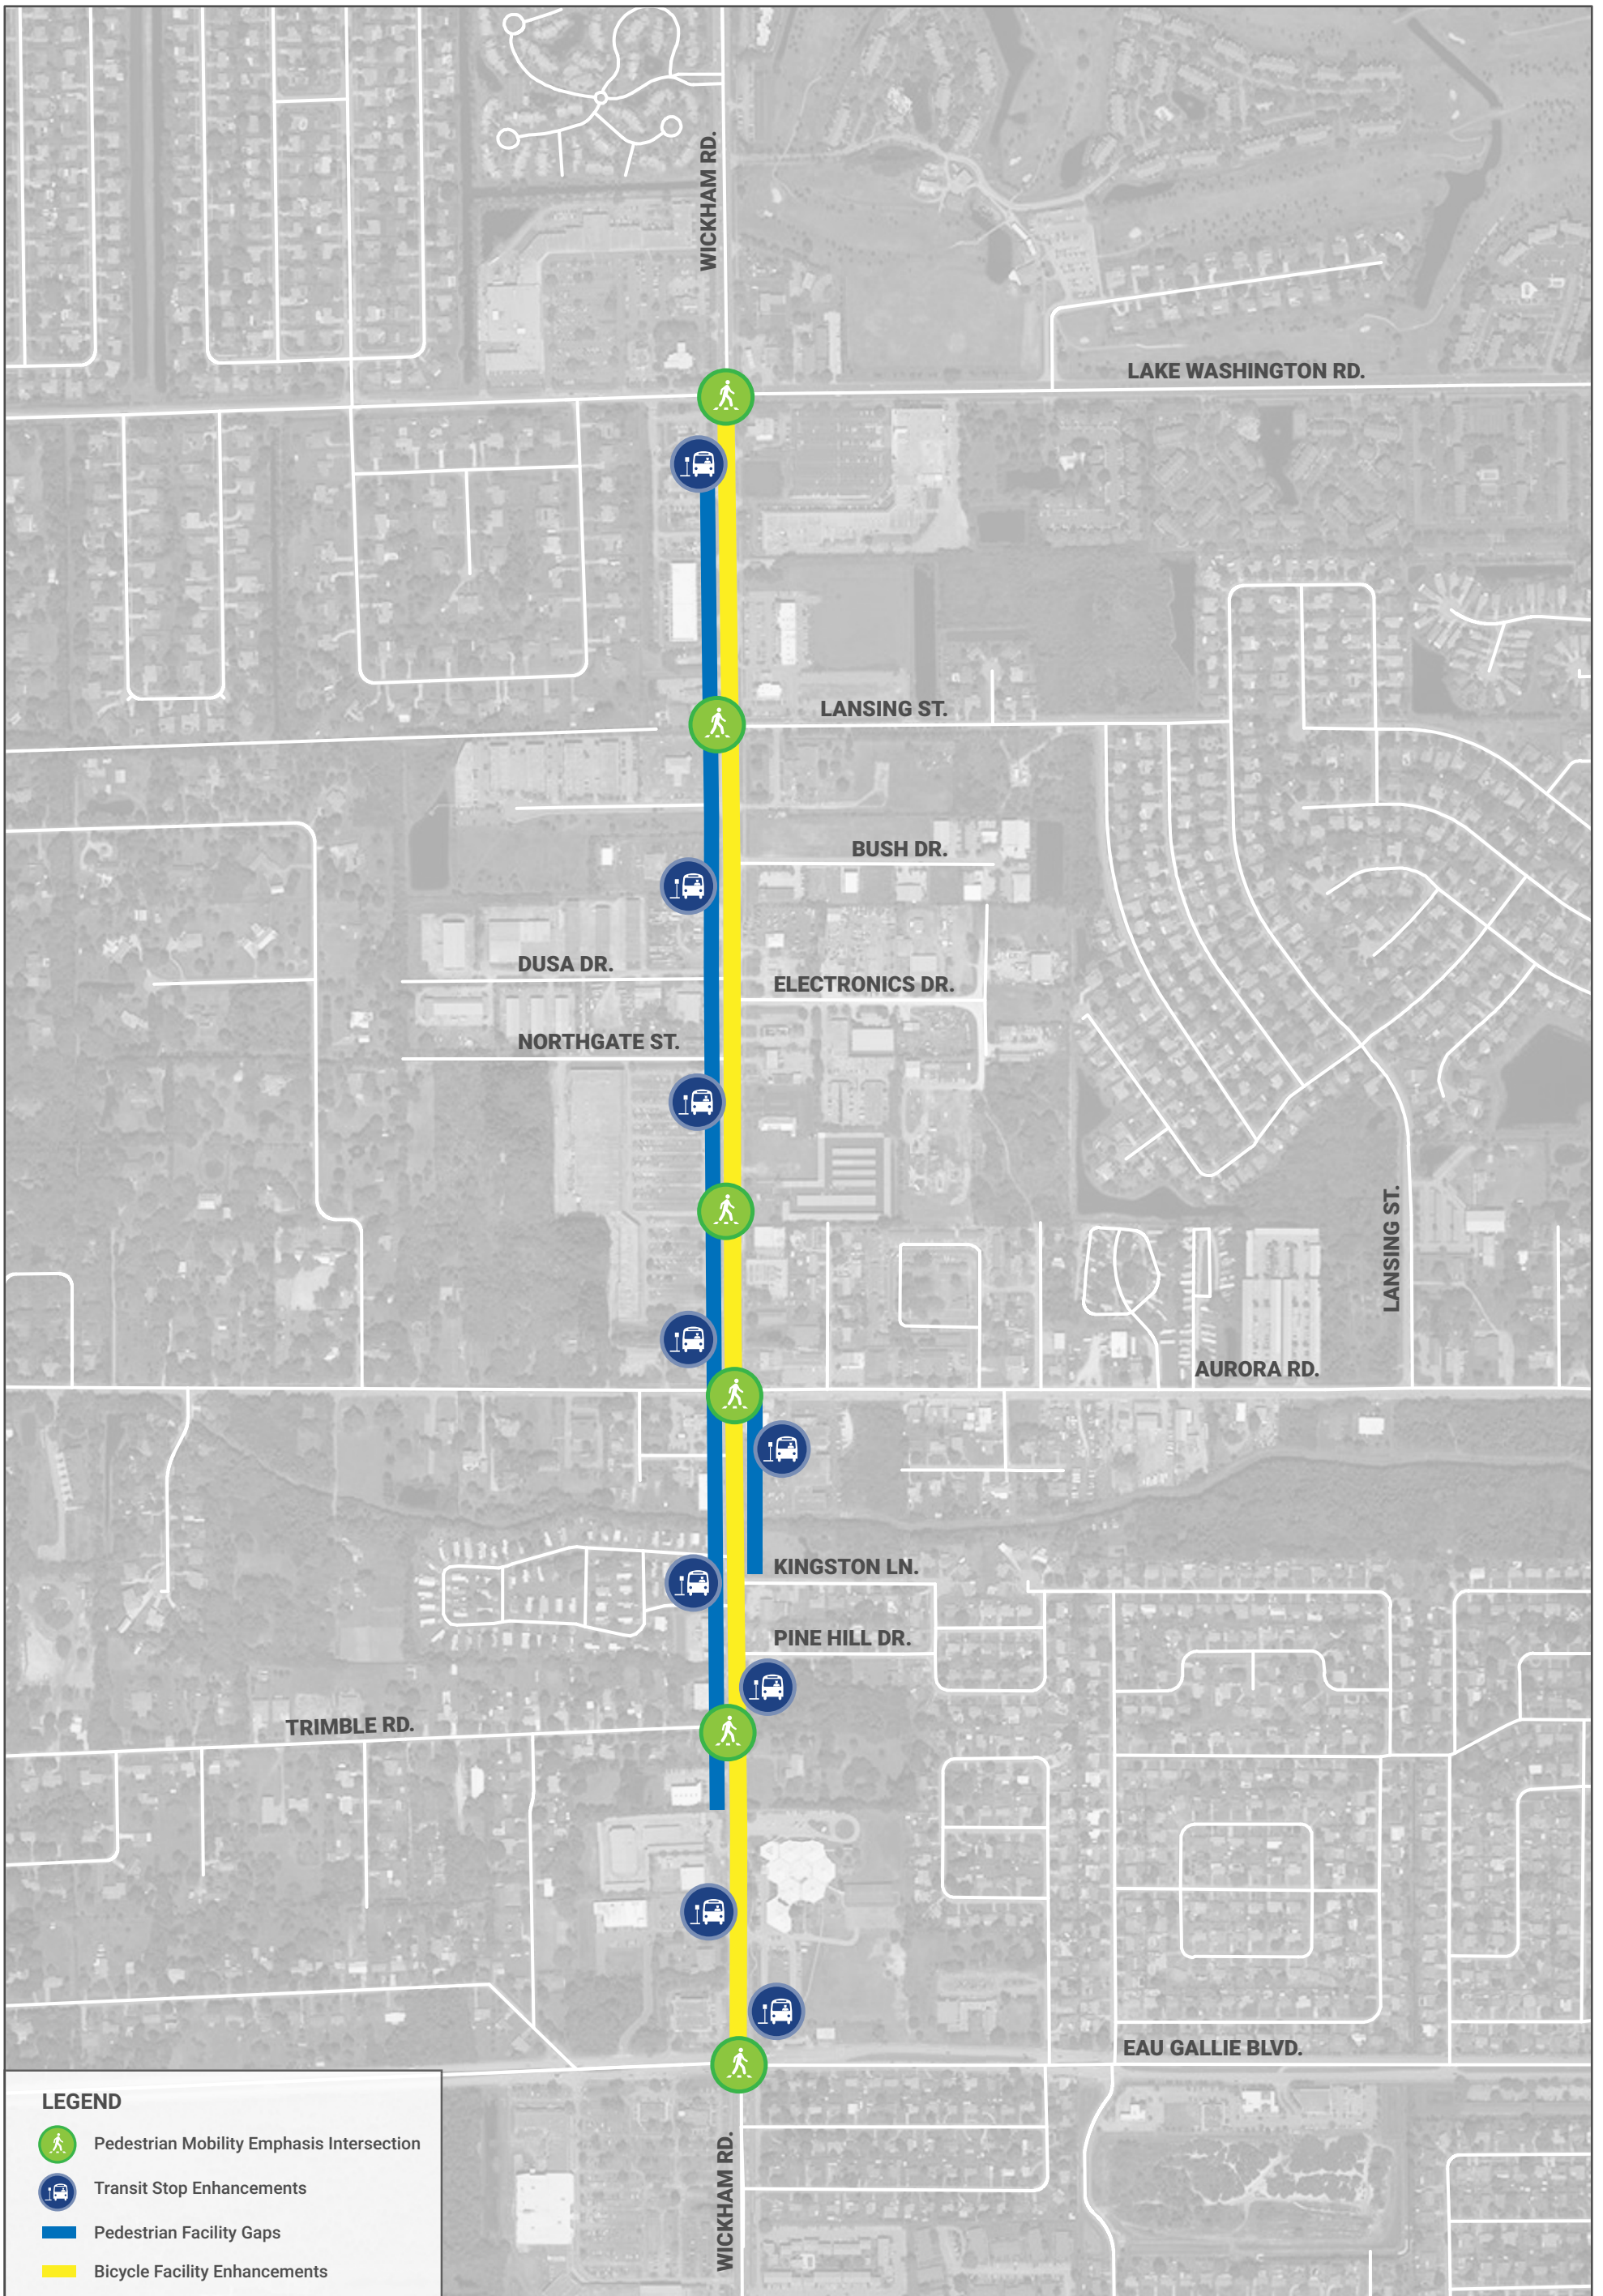
- Transit stop improvements were identified for the stops along Wickham Road as part of a Space Coast Area Transit ADA assessment:
 - Non-compliant boarding and alighting areas and a lack of detectable warning surfaces were common identified issues.

The pedestrian, bicycle, and transit issues and opportunities are summarized in **Figure 26**.

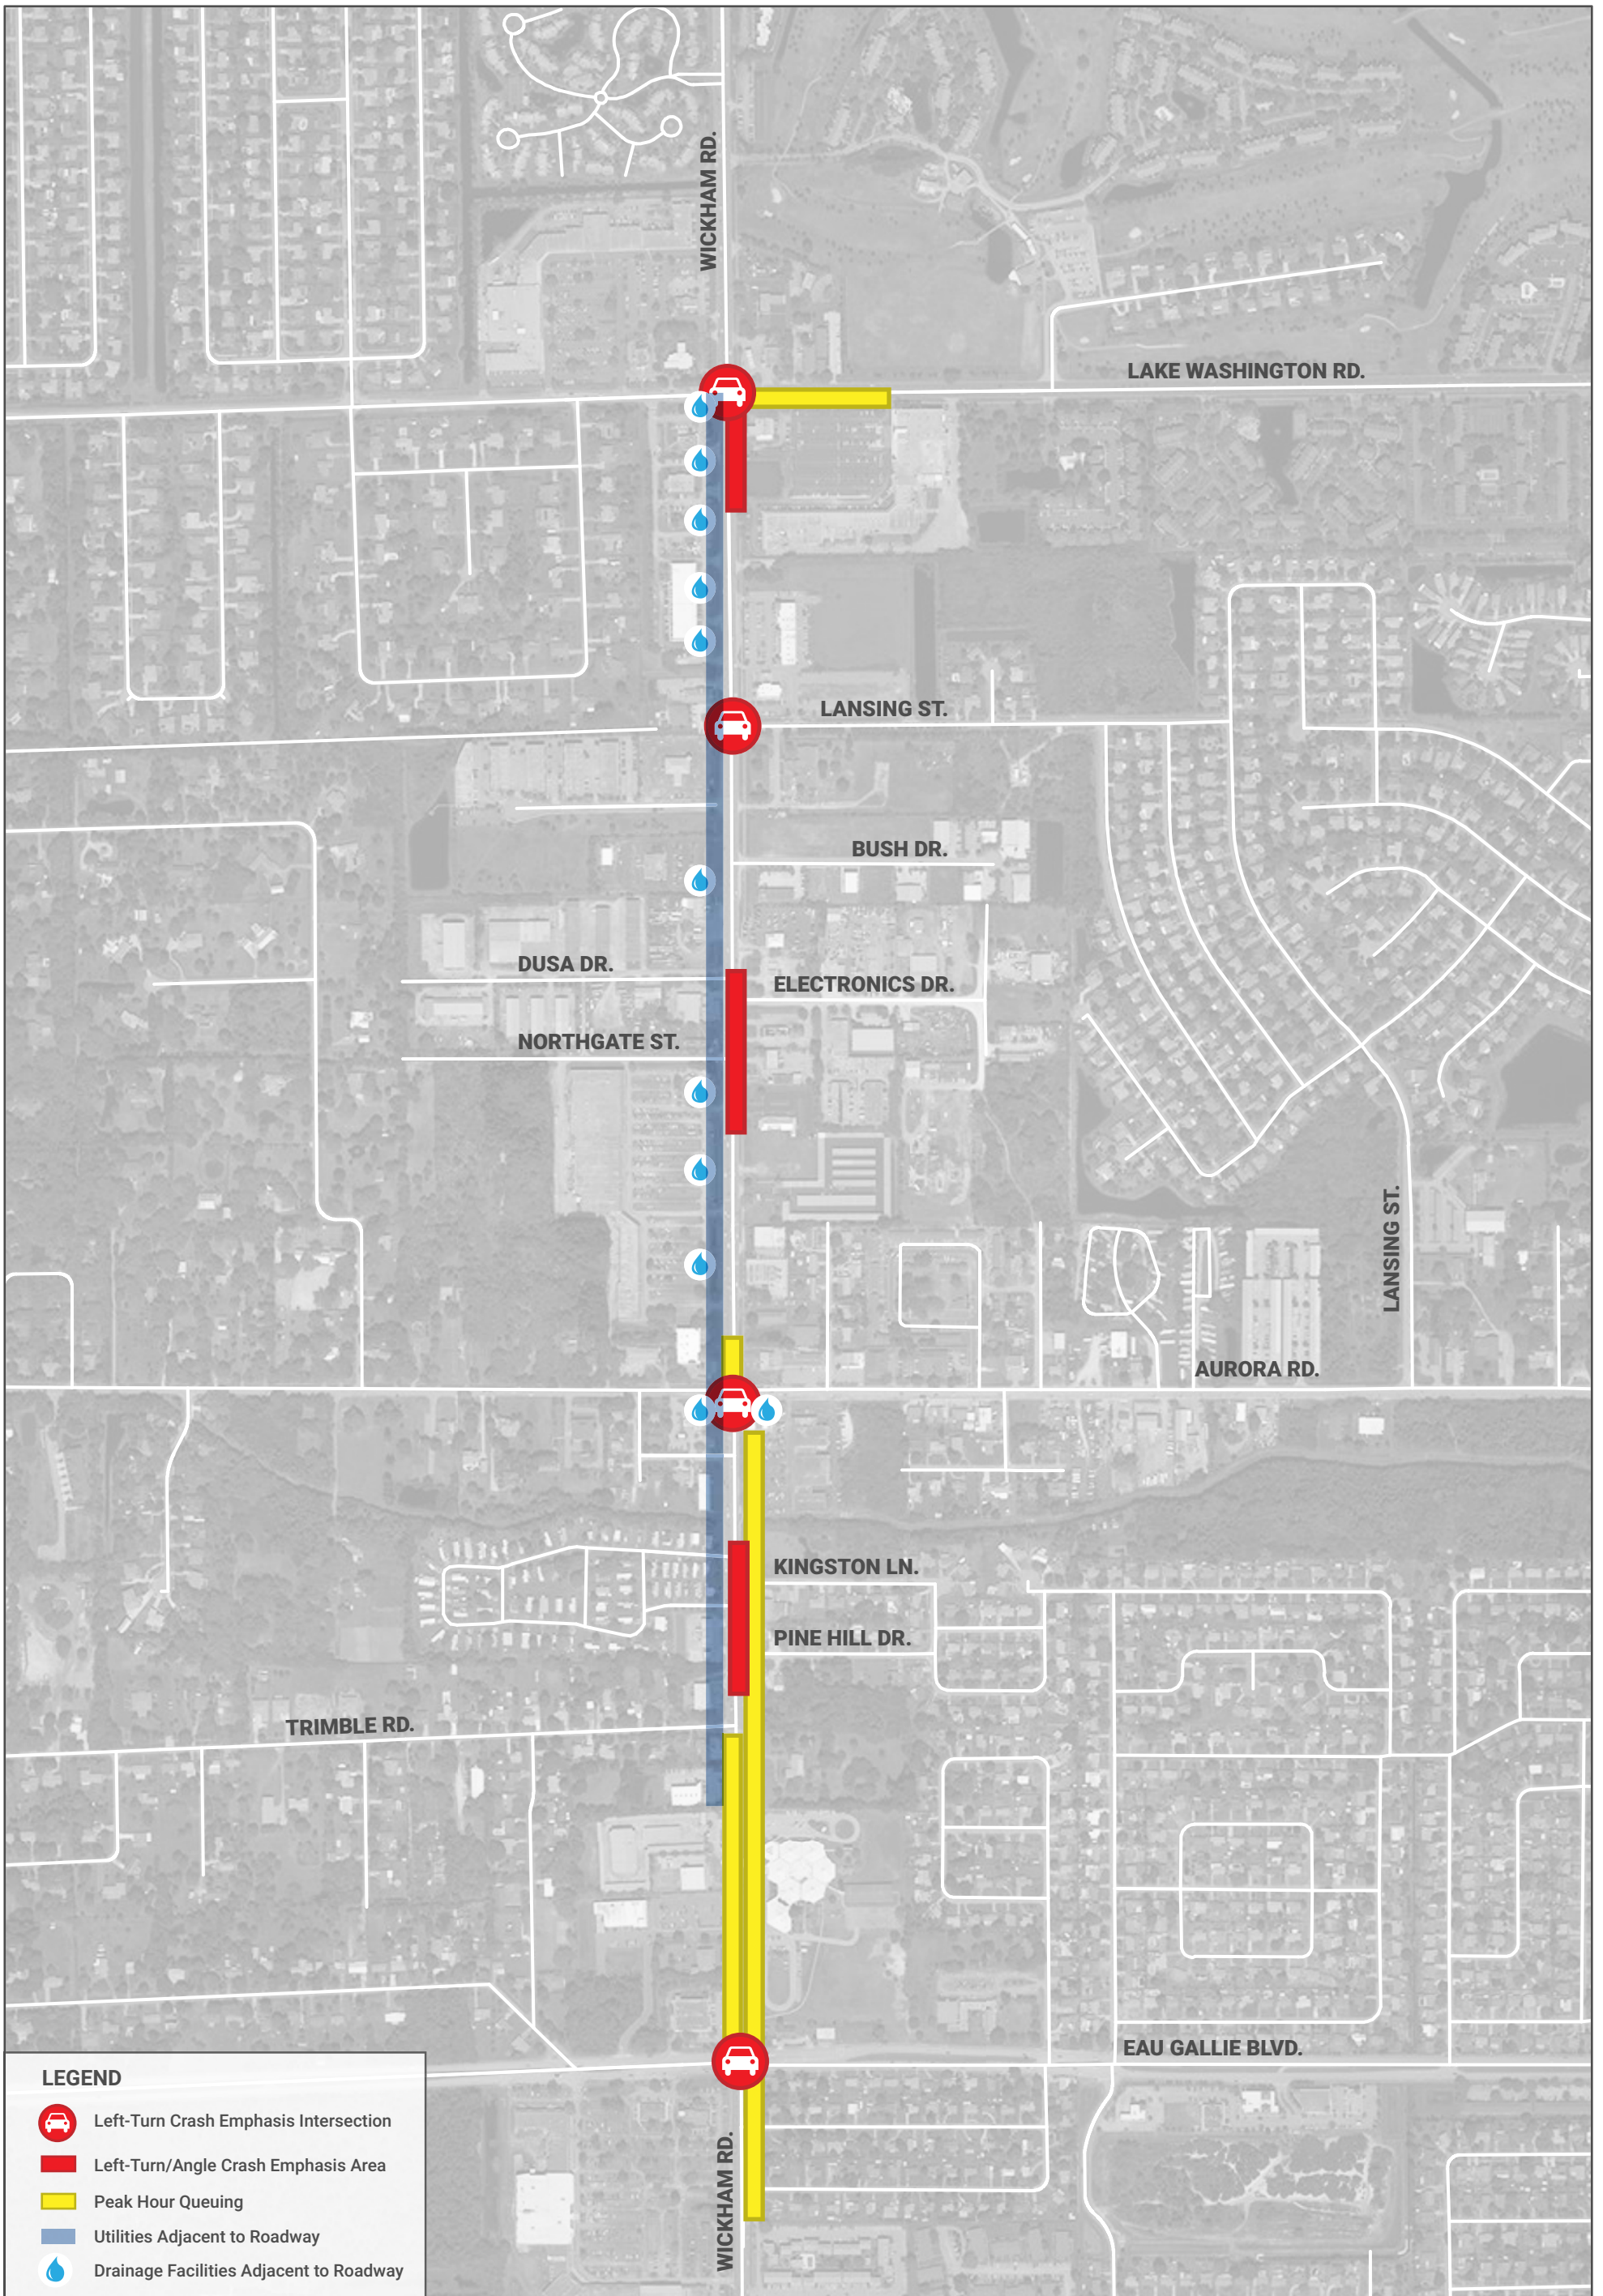
VEHICULAR, DRAINAGE, AND UTILITY ISSUES AND OPPORTUNITIES

- Safety along the corridor is a concern with a total of 667 reported crashes from 2011 to 2015, 187 of which (28 percent) resulted in at least one injury and five (5) of which resulted in at least one fatality:
