SCHOOL ROUTES ANALYSIS

CROTON ELEMENTARY SCHOOL

GRAPHICAL SUMMARY REPORT

JULY 2020

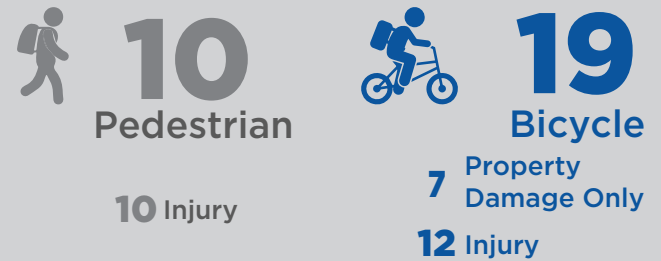
School Aged Bicycle & Pedestrian Crashes within Study Area

2014 to 2018 Crashes from University of Florida's Signal Four Analytics Database
