SCHOOL ROUTES ANALYSIS

GOLFVIEW ELEMENTARY MAGNET SCHOOL

ASSESSMENT & IMPLEMENTATION REPORT

JULY 2023

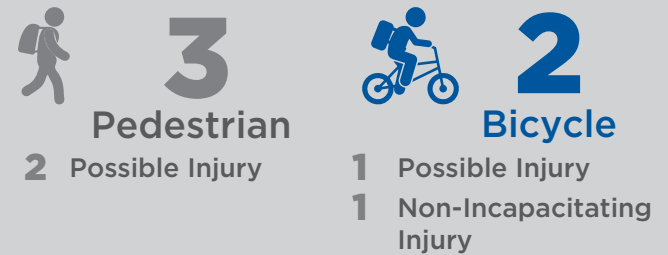
School Aged Bicycle & Pedestrian Crashes within Study Area

August 2016 to July 2022 Crashes from University of Florida's Signal Four Analytics Database

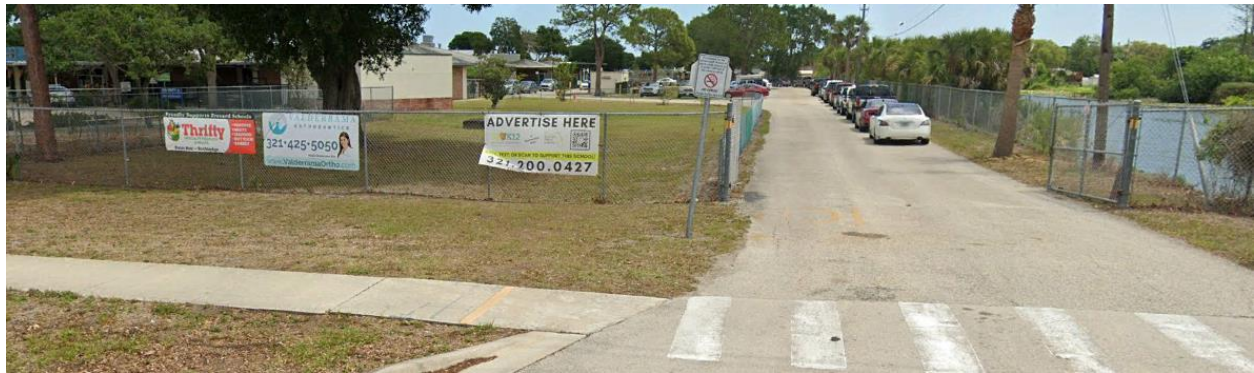
Location	School Campus
Type	Sign/Signal
Issues	There are security concerns at the southernmost driveway along SR 519 (Fiske Boulevard). School staff noted that when the gate is open at this driveway for deliveries, someone could enter and have access to the school campus. Parents were also observed queueing on SR 519 (Fiske Boulevard) for student pick-up in the afternoon.
Recommendations	Consider improving school security by installing an interior fence around the school buildings so that if anyone breaches the exterior fence, they will not have access to the school buildings. Leave the gate at the southern driveway to the school campus open throughout the school day to provide for deliveries and reduce queueing on SR 519 (Fiske Boulevard) during parent pick-up times.

Existing Southern Driveway with Gate

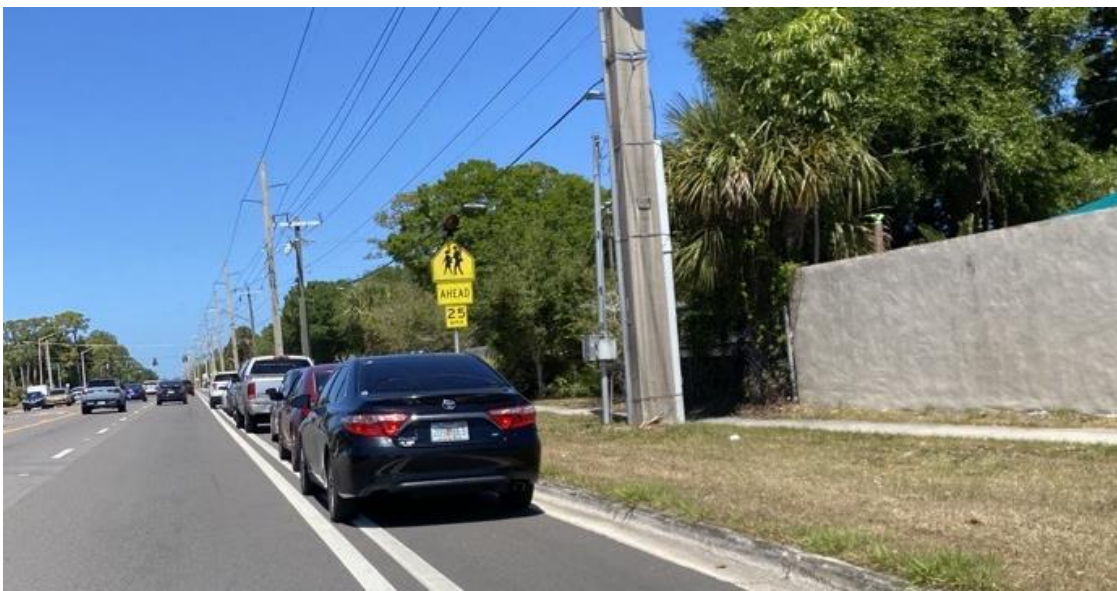
Location	School Campus
Type	Maintenance
Issue	Queuing was observed on SR 519 (Fiske Boulevard) during afternoon pick-up peak-period.
Recommendation	In the afternoon peak-period open the gate at 1:30 PM to reduce queuing on SR 519 (Fiske Boulevard).

Observed Queuing in Bicycle Lane along SR 519 (Fiske Boulevard) at 1:50 PM

Implementation Timeframe	Maintenance
 	Estimated Project Cost	None
 	Right-of Way Needed?	No
 	Drainage or Utility Impact?	No
 	Responsible Agency	Brevard Public Schools

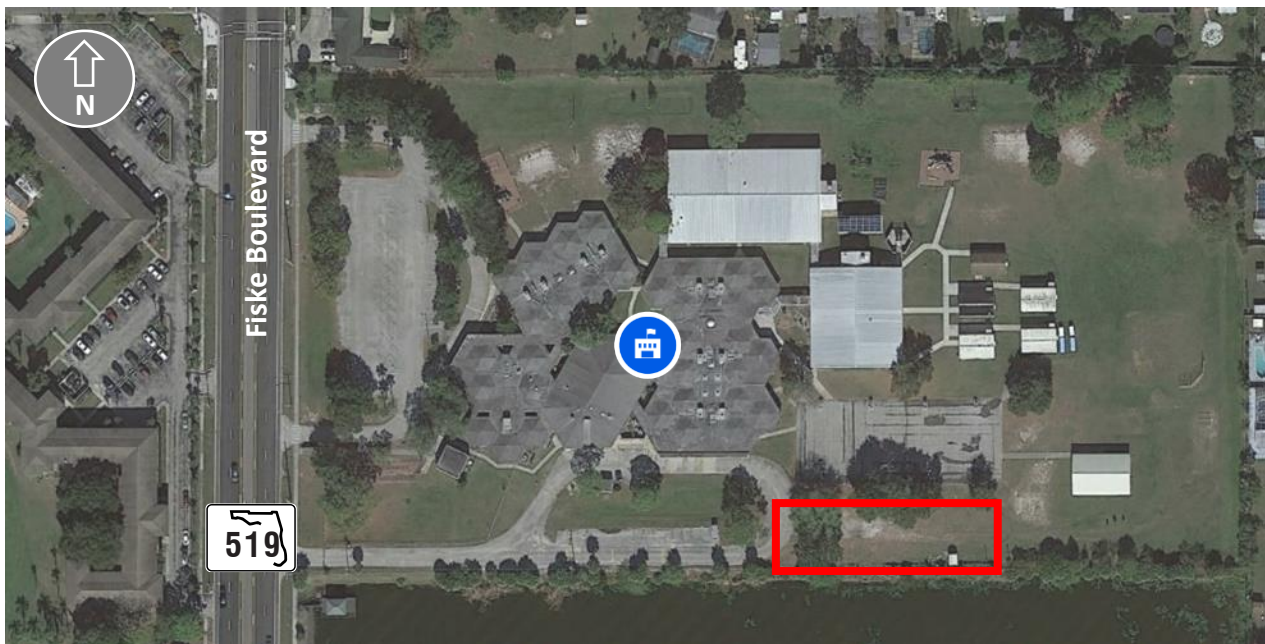
Location	School Campus
Type	Roadway
Issue	Staff were observed parking in the grass to the east of the parent drop-off/pick-up loop.
Recommendation	Add more paved staff parking and lighting at the southeast corner of the school campus.

Proposed Parking Lot Location

Implementation Timeframe	Long-Term
 	Estimated Project Cost*	\$275,000 to \$325,000
 	Right-of Way Needed?	No
 	Drainage or Utility Impact?	Yes
 	Responsible Agency	Brevard Public Schools

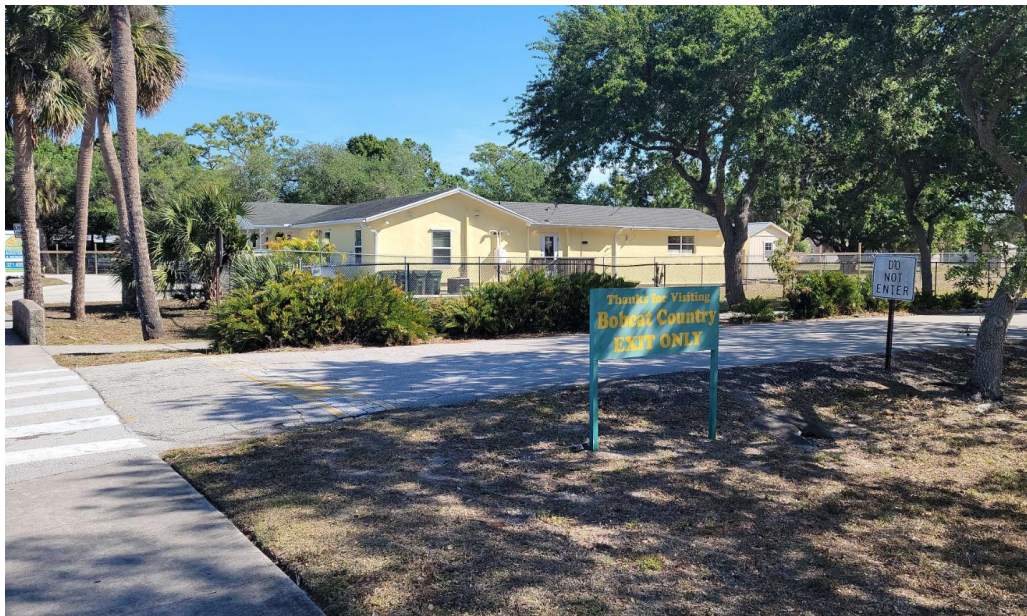
Location	School Campus
Type	Sign/Signal
Issue	There are concerns with wrong way drivers in both the bus/daycare van/Pre-K and K-6 parent drop-off/pick-up loops.
Recommendation	Enhance pavement markings and add signage to discourage wrong way driving behavior at the two drop-off/pick-up loops.

Existing “Do Not Enter” Signage at the Northernmost Driveway

Implementation Timeframe	Maintenance
 	Estimated Project Cost	<\$10,000
 	Right-of Way Needed?	No
 	Drainage or Utility Impact?	No
 	Responsible Agency	Brevard Public Schools

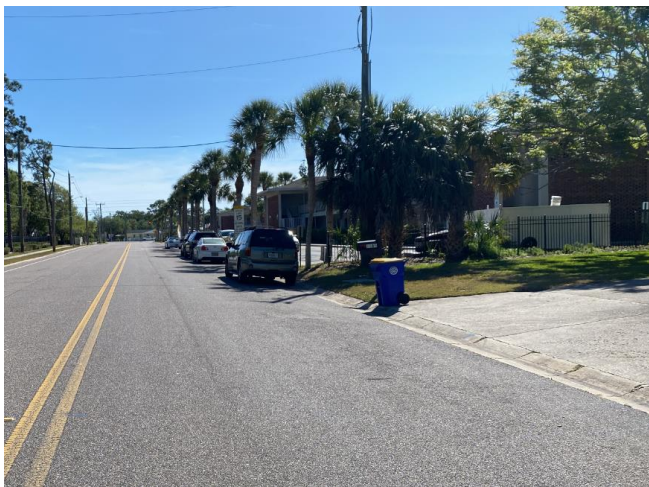
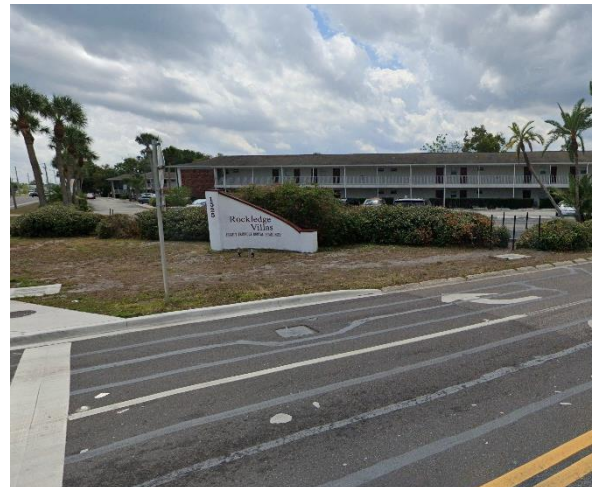
Location	St. Andrews Drive
Type	Sidewalk
Issue	There is a sidewalk gap along the south side of St. Andrews Drive. Students were observed walking in the street along the south side of St. Andrews Drive and through the Rockledge Villas Apartments parking lot. There is a fence that was recently installed to block students walking through the parking lot so many of them are forced to walk in the street.
Recommendation	Fill sidewalk gaps on the north side of St. Andrews Drive from Wentworth Circle to Naples Circle and on the south side of St. Andrews Drive from Wentworth Circle to SR 519 (Fiske Boulevard).

Existing Sidewalk Gaps along St. Andrews Drive

Implementation Timeframe	Long-Term
 	Estimated Project Cost*	\$365,000 to \$430,000
 	Right-of Way Needed?	Potential
 	Drainage or Utility Impact?	Potential
 	Responsible Agency	City of Rockledge

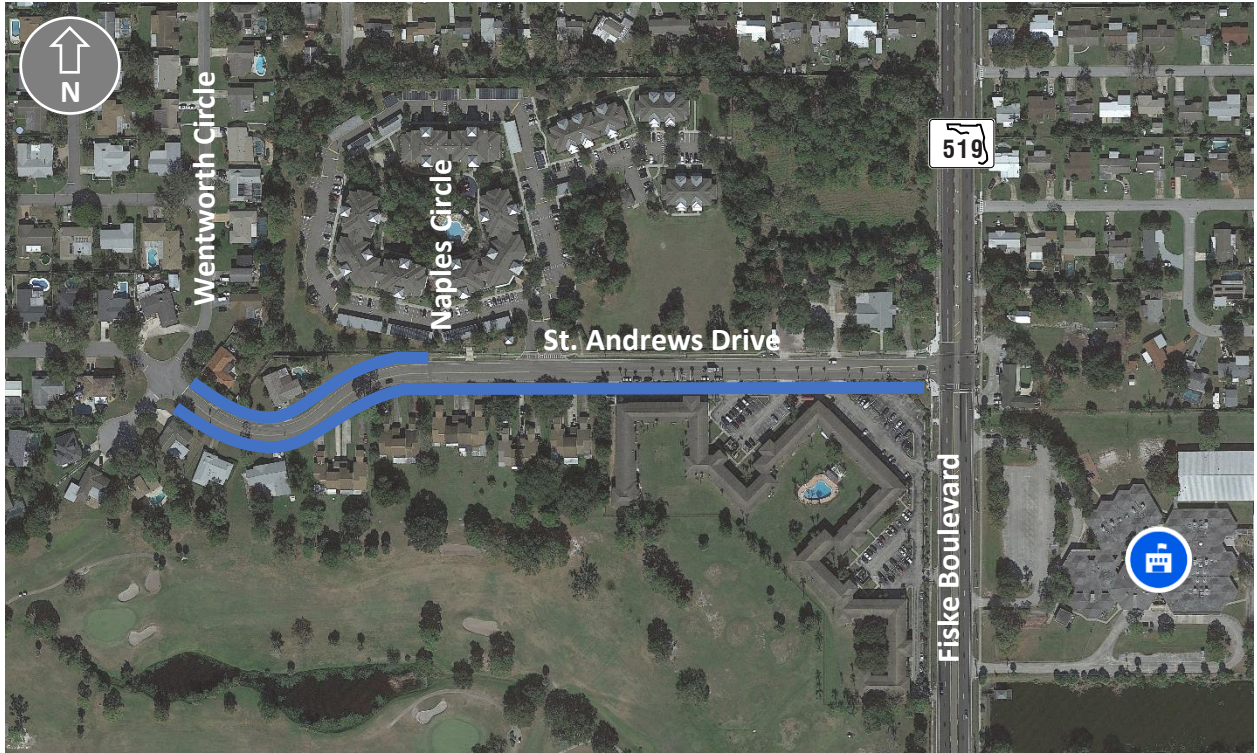
Proposed Sidewalks along St. Andrews Drive

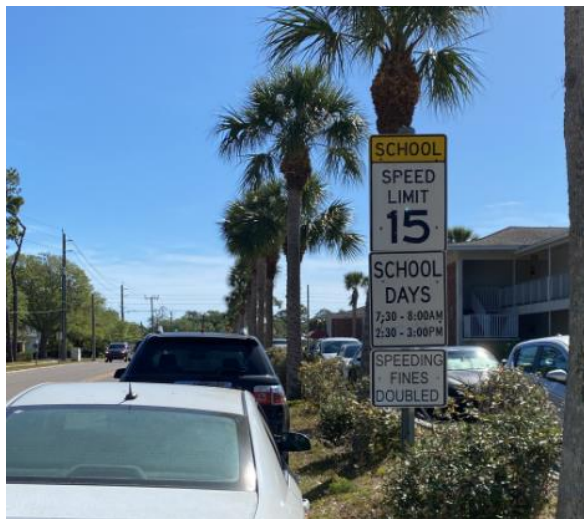
Location	St. Andrews Drive
Type	Sign/Signal
Issue	The school zone signage/pavement markings along St. Andrews Drive does not meet current standards.
Recommendation	Add flashing beacon signage for the school zone along St. Andrews Drive. Restripe pavement markings, add advance school zone warning signs, and add “End School Zone” signage.

Existing School Zone on St. Andrews Drive

Implementation Timeframe	Near-Term
 	Estimated Project Cost	\$30,000 to \$40,000
 	Right-of Way Needed?	No
 	Drainage or Utility Impact?	No
 	Responsible Agency	City of Rockledge

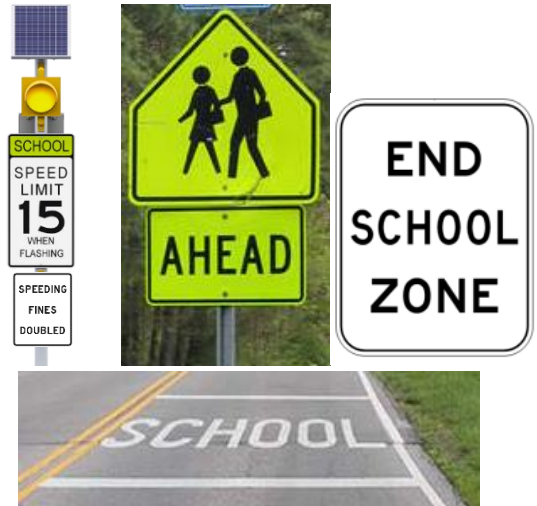
Proposed Flashing Beacon, Marked School Crossing, End School Zone, and School Pavement Markings

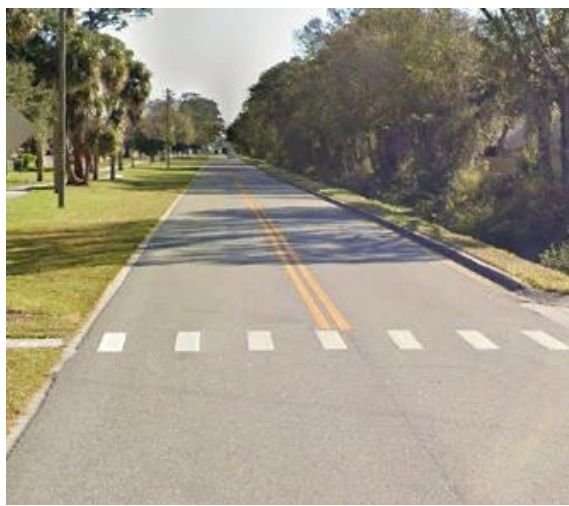
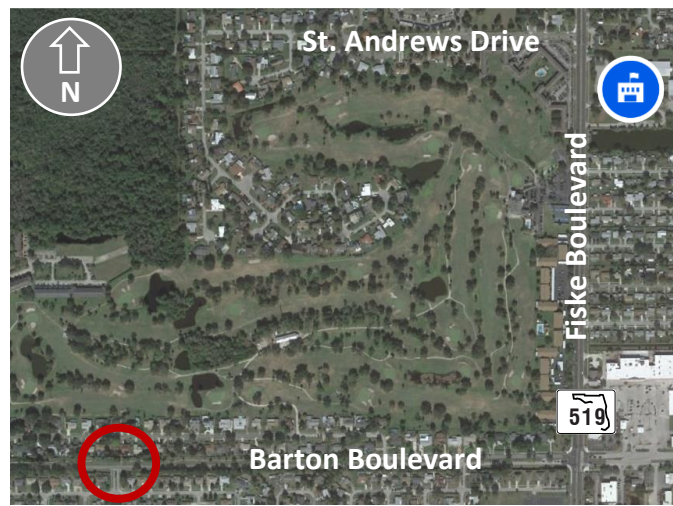
Location	Barton Boulevard & Barrington Circle
Type	Sign/Signal
Issue	There is a midblock crossing across Barton Boulevard in a residential neighborhood.
Recommendation	Add a rapid rectangular flashing beacon (RRFB) at the existing crosswalk.

Existing Crossing at Barton Boulevard & Barrington Circle

Implementation Timeframe	Near-Term
 	Estimated Project Cost*	\$45,000 to \$60,000
 	Right-of Way Needed?	No
 	Drainage or Utility Impact?	Potential
 	Responsible Agency	City of Rockledge

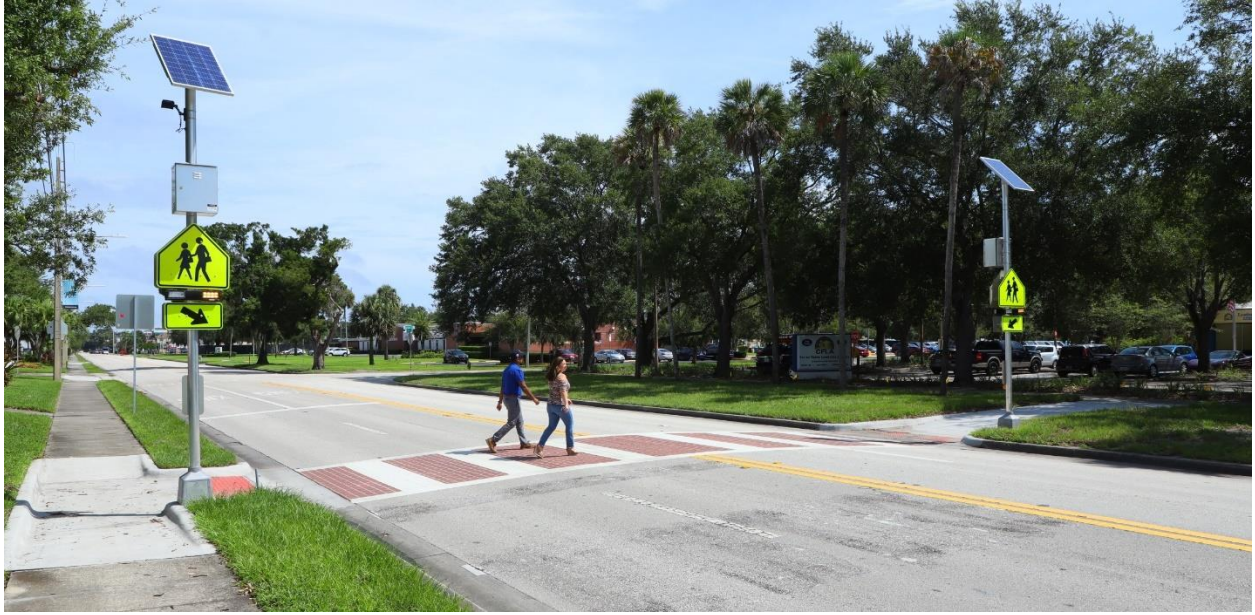
Typical Midblock Crossing with RRFB

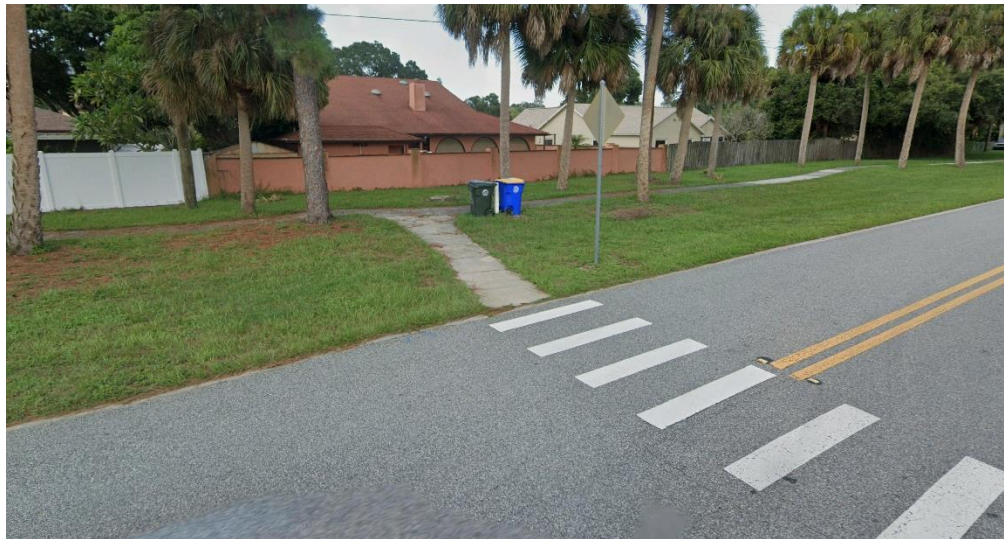
Location	Barton Boulevard and St. Andrews Drive
Type	Sidewalk
Issue	Pedestrian ramps along Barton Boulevard and St. Andrews Drive do not meet current standards.
Recommendation	<p>Install/upgrade pedestrian ramps to meet current standards along:</p> <ul style="list-style-type: none"> • Barton Boulevard from Bluegrass Lane to US 1; and • St. Andrews Drive from just west of Naples Circle to SR 519 (Fiske Boulevard).

Existing Ramps on Barton Boulevard and St. Andrews Drive

Implementation Timeframe	Long-Term
 	Estimated Project Cost*	\$100,000 to \$120,000
 	Right-of Way Needed?	No
 	Drainage or Utility Impact?	Potential
 	Responsible Agency	City of Rockledge and FDOT

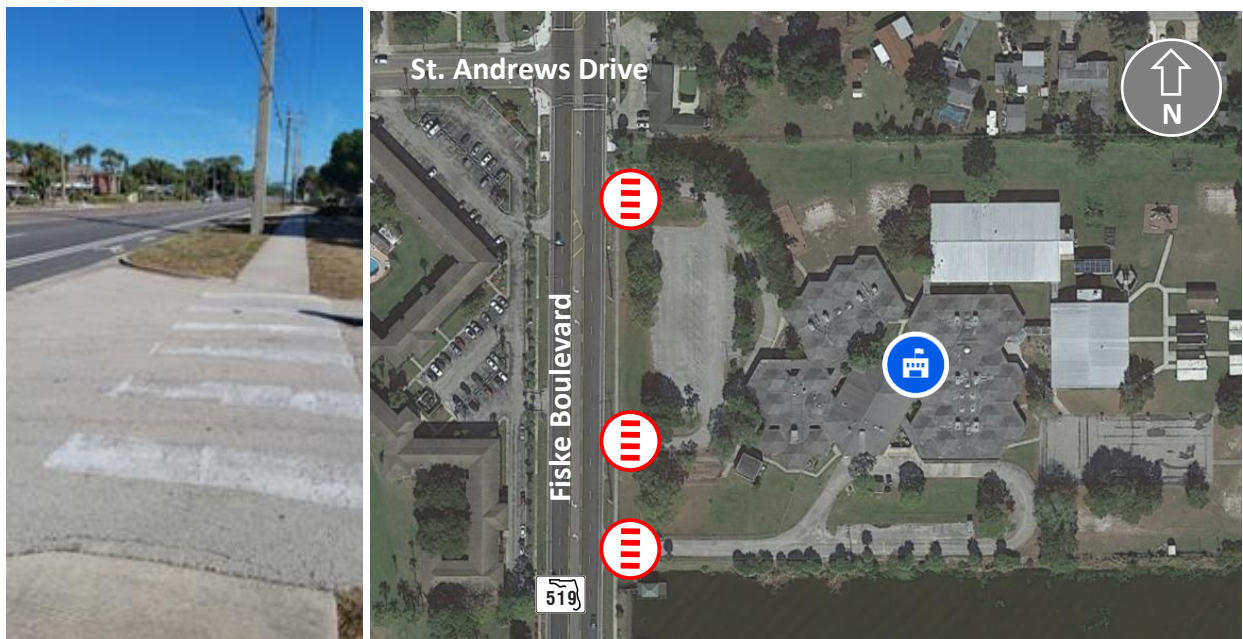
Location	School Campus
Type	Crossing
Issue	Crosswalk markings at the school campus are faded and vehicles were observed stopping in the crosswalks.
Recommendation	Add high-visibility crosswalks at school driveways.

Existing Crosswalks at School Driveways and Proposed Crosswalk Locations

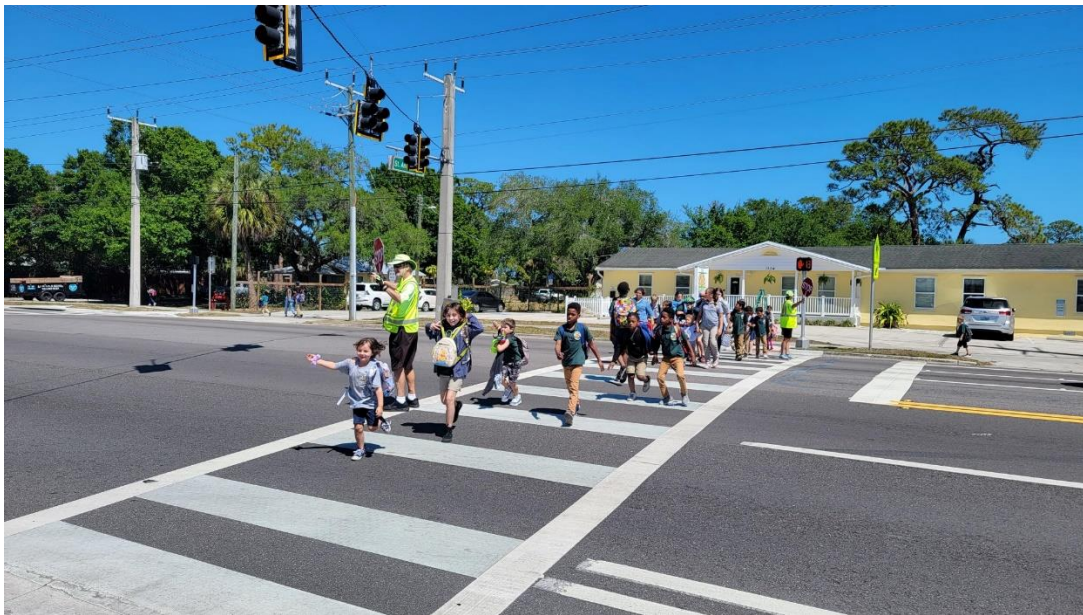
Location	SR 519 (Fiske Boulevard) & St. Andrews Drive
Type	Sign
Issue	Large groups of students were observed crossing SR 519 (Fiske Boulevard) & St. Andrews Drive. The crossing guards noted that students do not have enough time to cross in both the morning and afternoon peak-periods.
Recommendation	Conduct a signal timing study to evaluate the feasibility of increasing the pedestrian crossing time to allow all bicyclists and pedestrians to cross.

Students Crossing SR 519 (Fiske Boulevard) & St. Andrews Drive

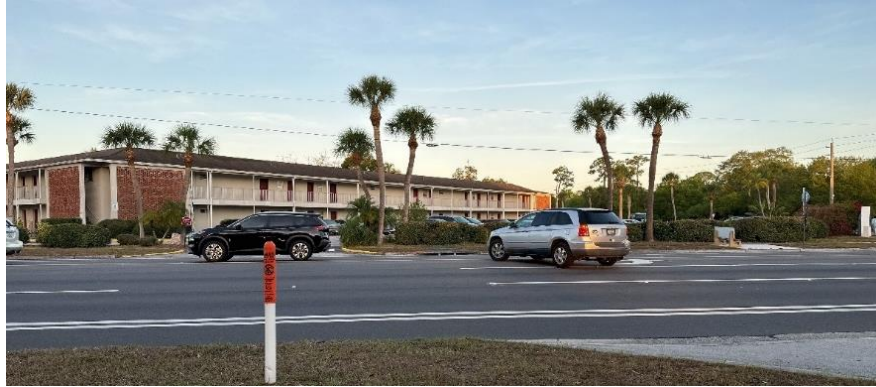
Location	SR 519 (Fiske Boulevard) & Northern and Southern School Campus Driveways
Type	Roadway/Enforcement
Issue	<p>Parents exiting left out of the northern school driveway onto SR 519 (Fiske Boulevard) turn into the northbound left turn lane and center two-way left-turn lane (TWLTL) before merging with southbound traffic along SR 519 (Fiske Boulevard). This creates conflicts with northbound traffic and any vehicles making the northbound left turn at St. Andrews Drive. Conflicts were also observed between vehicles turning into the middle driveway on SR 519 (Fiske Boulevard) and pedestrians and bicyclists crossing the school driveways.</p>
Recommendation	<p>Restrict left turn traffic at the northern school driveway by:</p> <ul style="list-style-type: none"> • Installing a traffic separator in the SR 519 (Fiske Boulevard) median between the inside southbound travel lane and the northbound left turn lane at St. Andrews Drive; • Constructing a “porkchop” island for the northernmost driveway, forcing vehicles to make a right turn only; • Recirculating the bus/daycare van/Pre-K loop back through the staff parking area and loop those vehicles to exit out of the middle driveway if they want to left turn onto SR 519 (Fiske Boulevard); and • Widening the roadway leading from/to the middle driveway so it can accommodate two-way traffic, including the wider turning movements for buses. <p>Employ two crossing guards at the middle driveway to facilitate the left turn movement.</p>

Vehicle Turning Left into TWLTL onto SR 519 (Fiske Boulevard) from the Northern Driveway

Implementation Timeframe	Near-Term
 	Estimated Project Cost	Further Study Required for Roadway Design
 	Right-of Way Needed?	No
 	Drainage or Utility Impact?	No

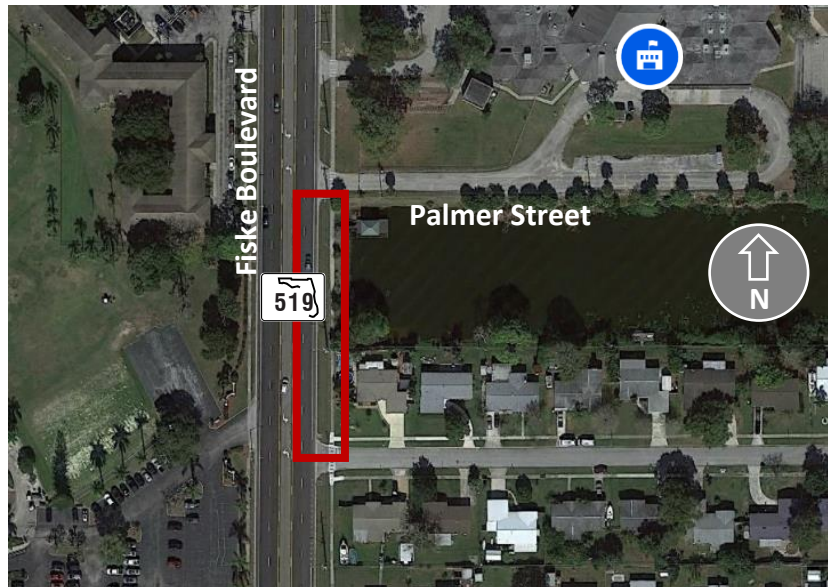
Location	SR 519 (Fiske Boulevard)
Type	Sign
Issue	Queueing was observed in the bike lane along SR 519 (Fiske Boulevard) waiting for parent pick-up in the afternoon peak period. This presents safety concerns for bicyclists and for other vehicles travelling north along the roadway.
Recommendation	Add “No Parking or Standing” signage on the east side of SR 519 (Fiske Boulevard) from Palmer Street to the southern driveway to the school.

“No Parking Anytime” Signs and Parking Sign Limits

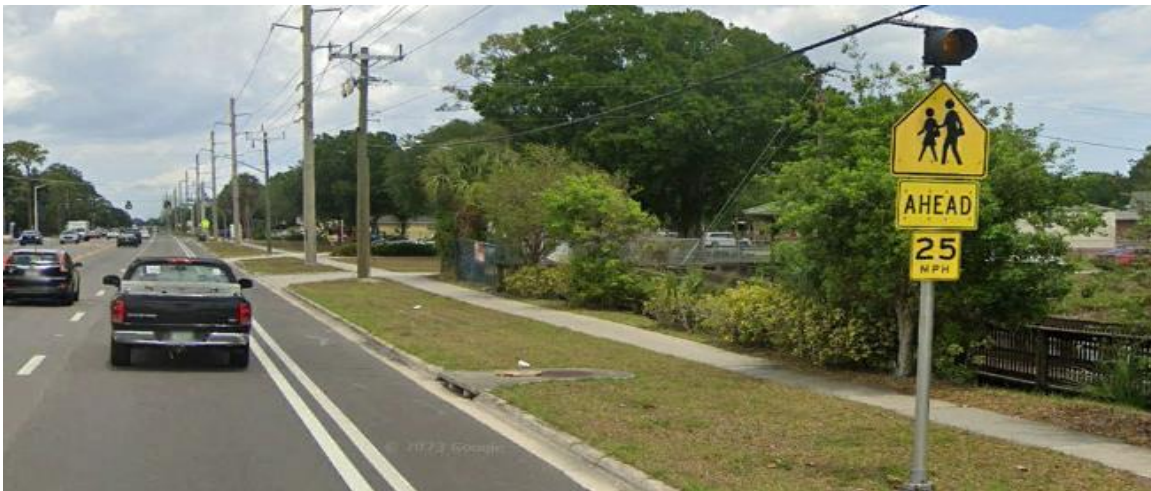
Location	SR 519 (Fiske Boulevard)
Type	Sign
Issue	There are flashing pedestrian warning signs (25 MPH) along SR 519 (Fiske Boulevard). However, these signs are not enforceable for vehicles traveling over 25 MPH. Students were observed walking and biking along and across SR 519 (Fiske Boulevard) during student drop-off/pick-up times.
Recommendation	Conduct a school zone analysis to determine if a school zone is justified along SR 519 (Fiske Boulevard) near the school campus. If justified, add flashing beacon signage along SR 519 (Fiske Boulevard). Restripe pavement markings and add advance school zone warning signs.

Existing Pedestrian Warning Signs along SR 519 (Fiske Boulevard)

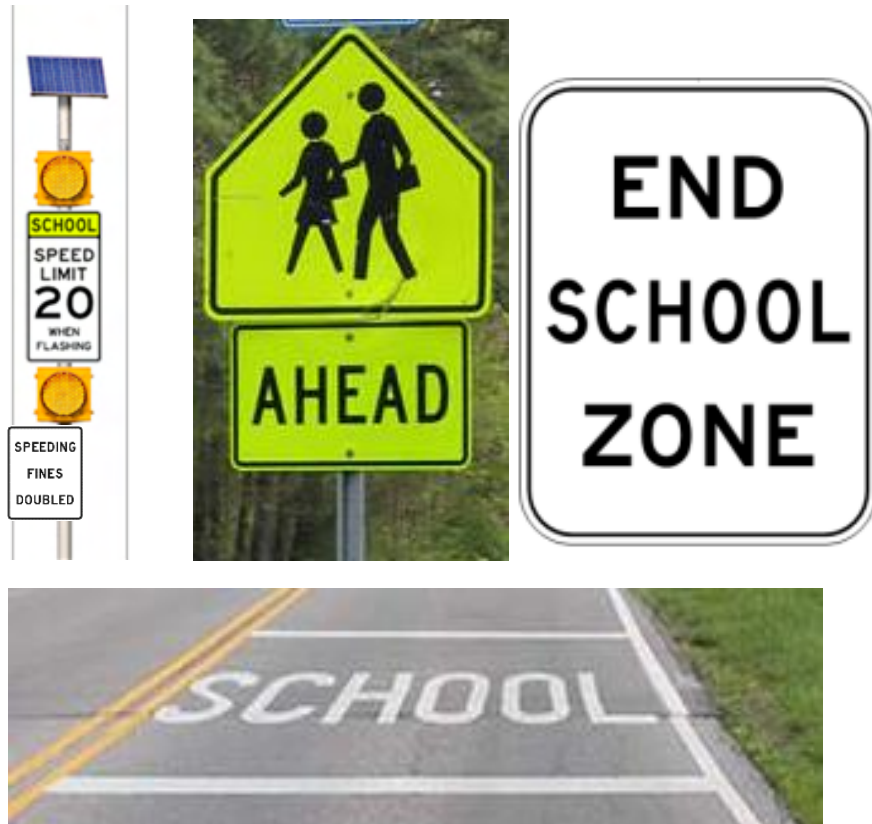
Example of Flashing Beacon, Marked School Crossing, End School Zone, and School Pavement Markings
