SCHOOL ROUTES ANALYSIS

RONALD MCNAIR MAGNET MIDDLE SCHOOL

GRAPHICAL SUMMARY REPORT

JULY 2023

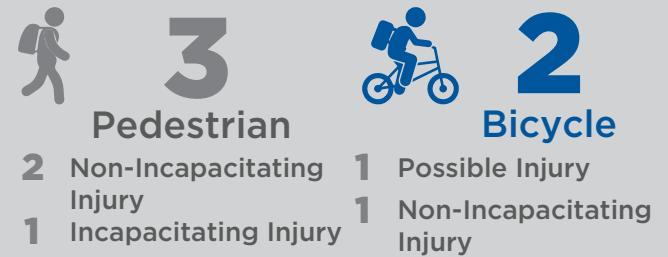
School Aged Bicycle & Pedestrian Crashes within Study Area

August 2016 to July 2022 Crashes from University of Florida's Signal Four Analytics Database
