# SCHOOL ROUTES ANALYSIS

## CROTON ELEMENTARY SCHOOL

### ASSESSMENT & IMPLEMENTATION REPORT

JULY 2020

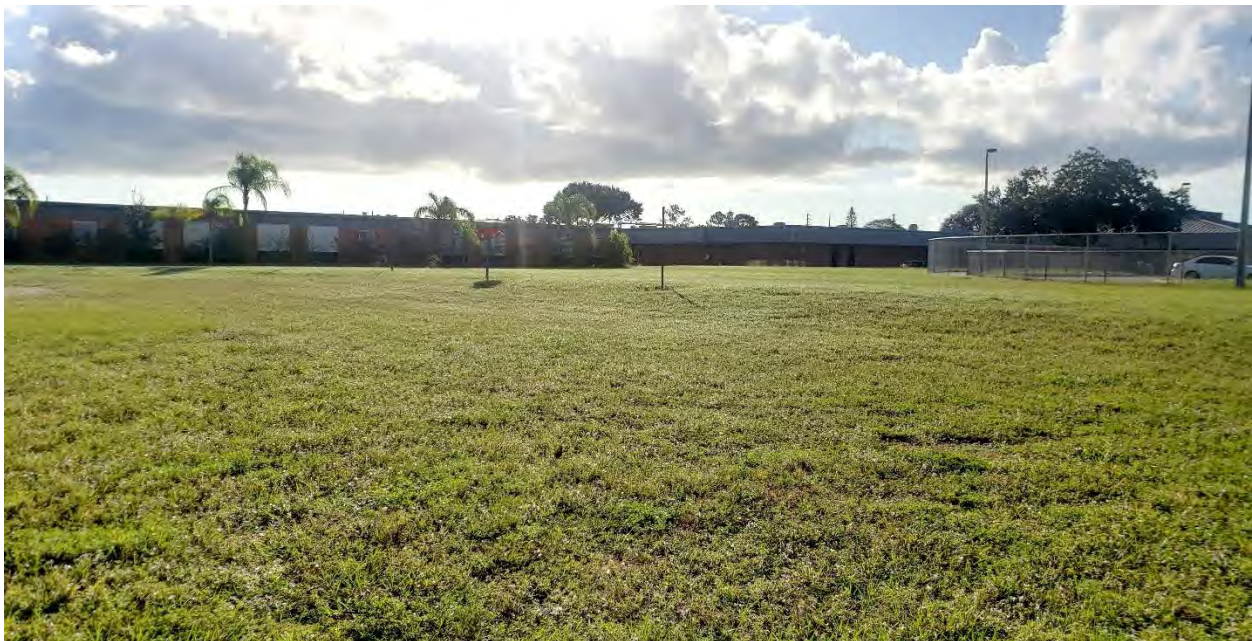
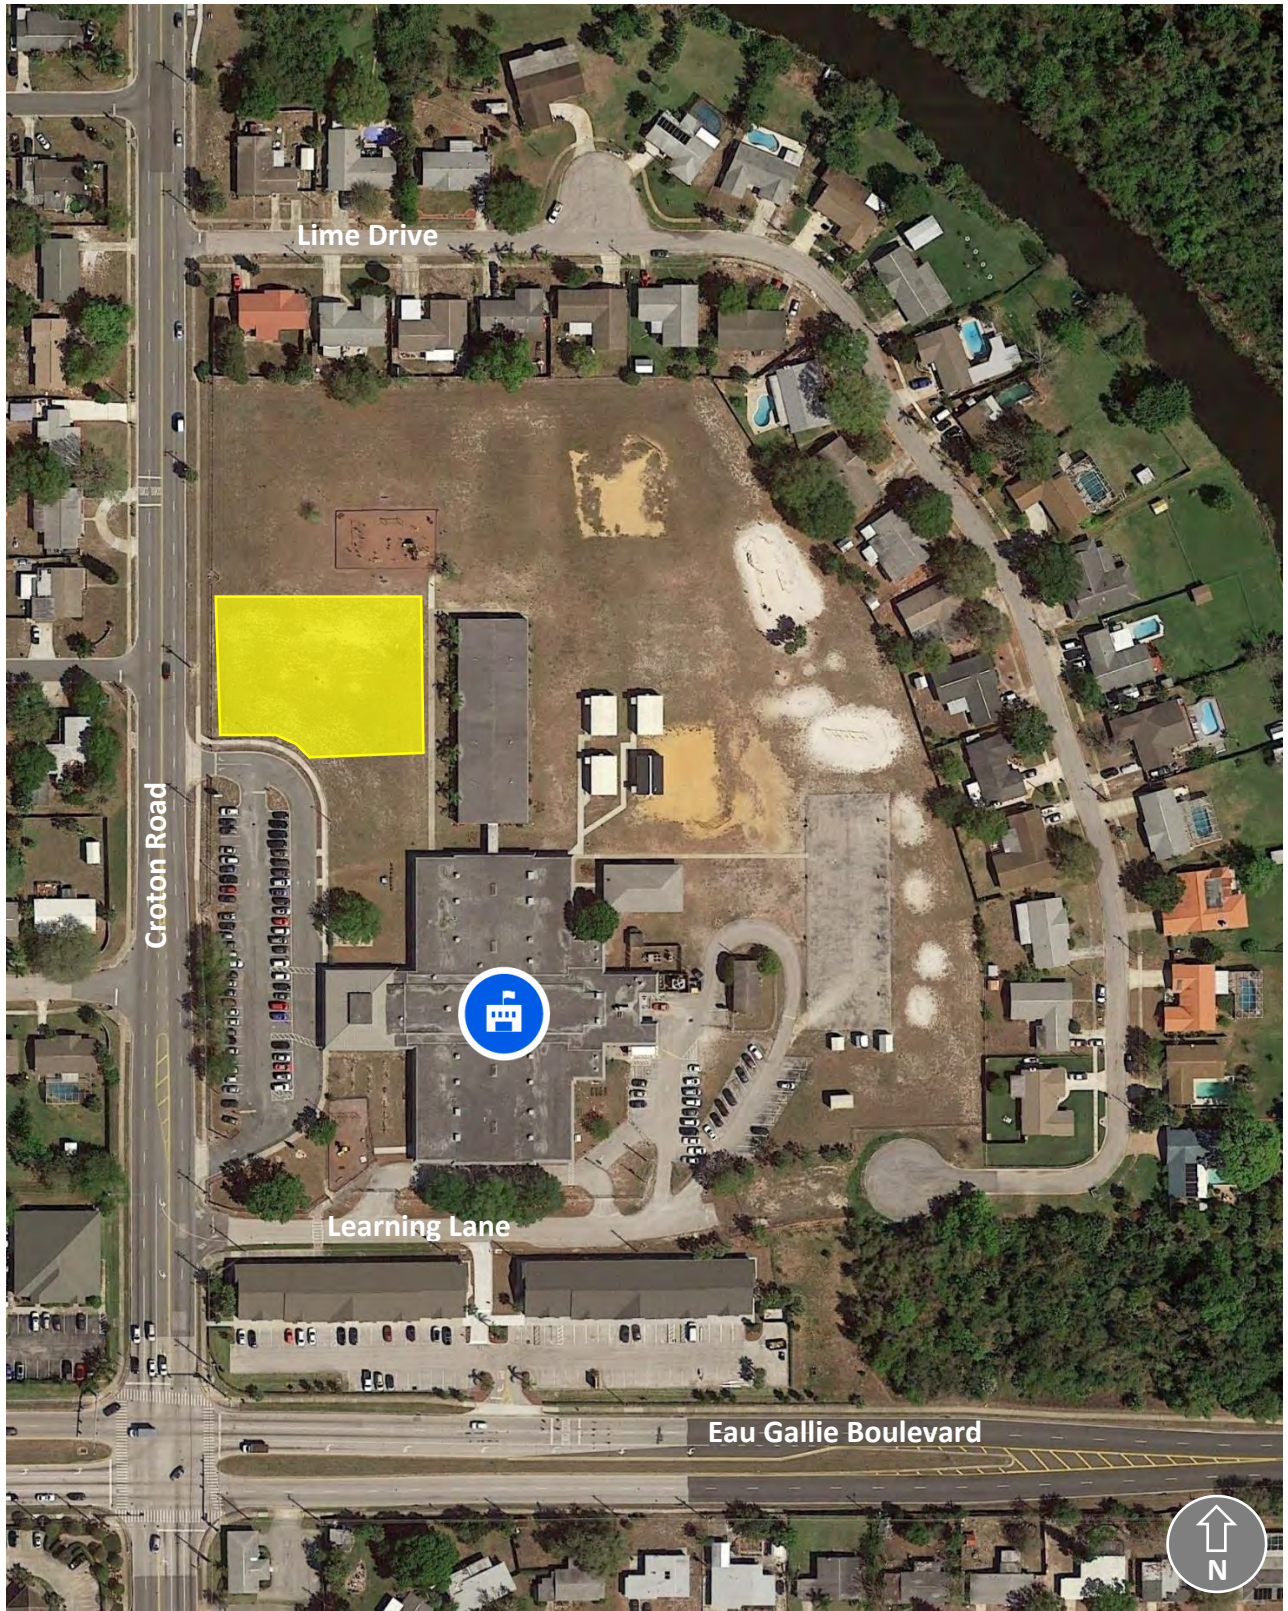
<b>Location</b>	Western Parking Lot
<b>Type</b>	School Circulation
<b>Issue</b>	There is not enough parking on the school campus for faculty and parents.
<b>Recommendation</b>	Expand the western parking lot north to the edge of the dry pond.

*Current Field North of Western Parking Lot*

<b>Implementation Time-Frame</b>	Long-Term
 	<b>Estimated Project Cost</b>	Further Study Is Required
 	<b>Right-of Way Needed?</b>	No
 	<b>Drainage or Utility Impact?</b>	Unknown
 	<b>Responsible Agency</b>	Brevard County Public Schools

*Expand Western Parking Lot North*

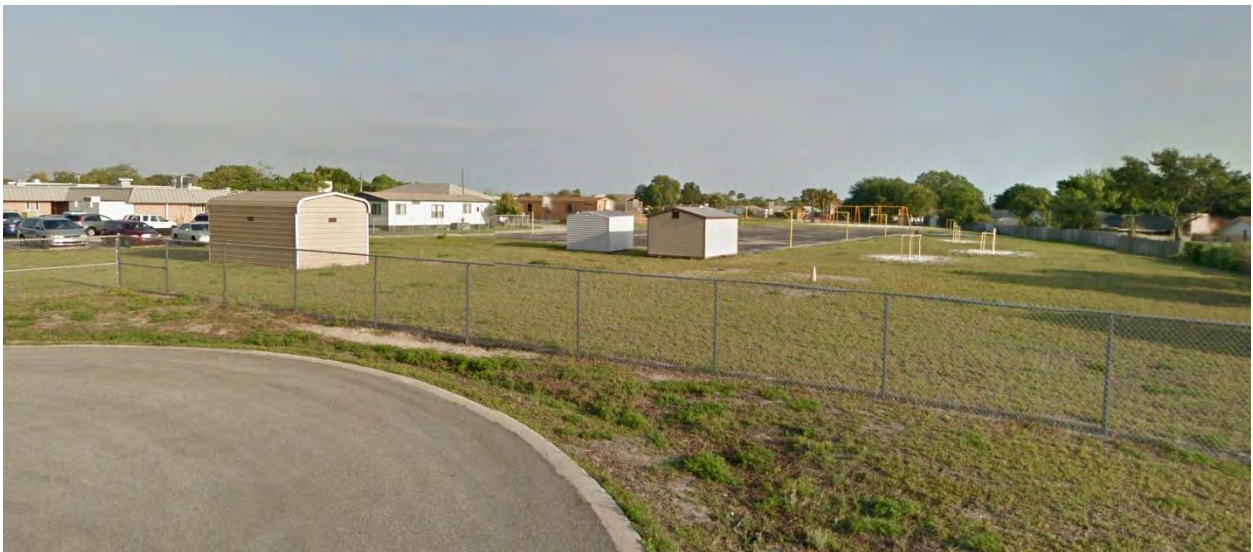
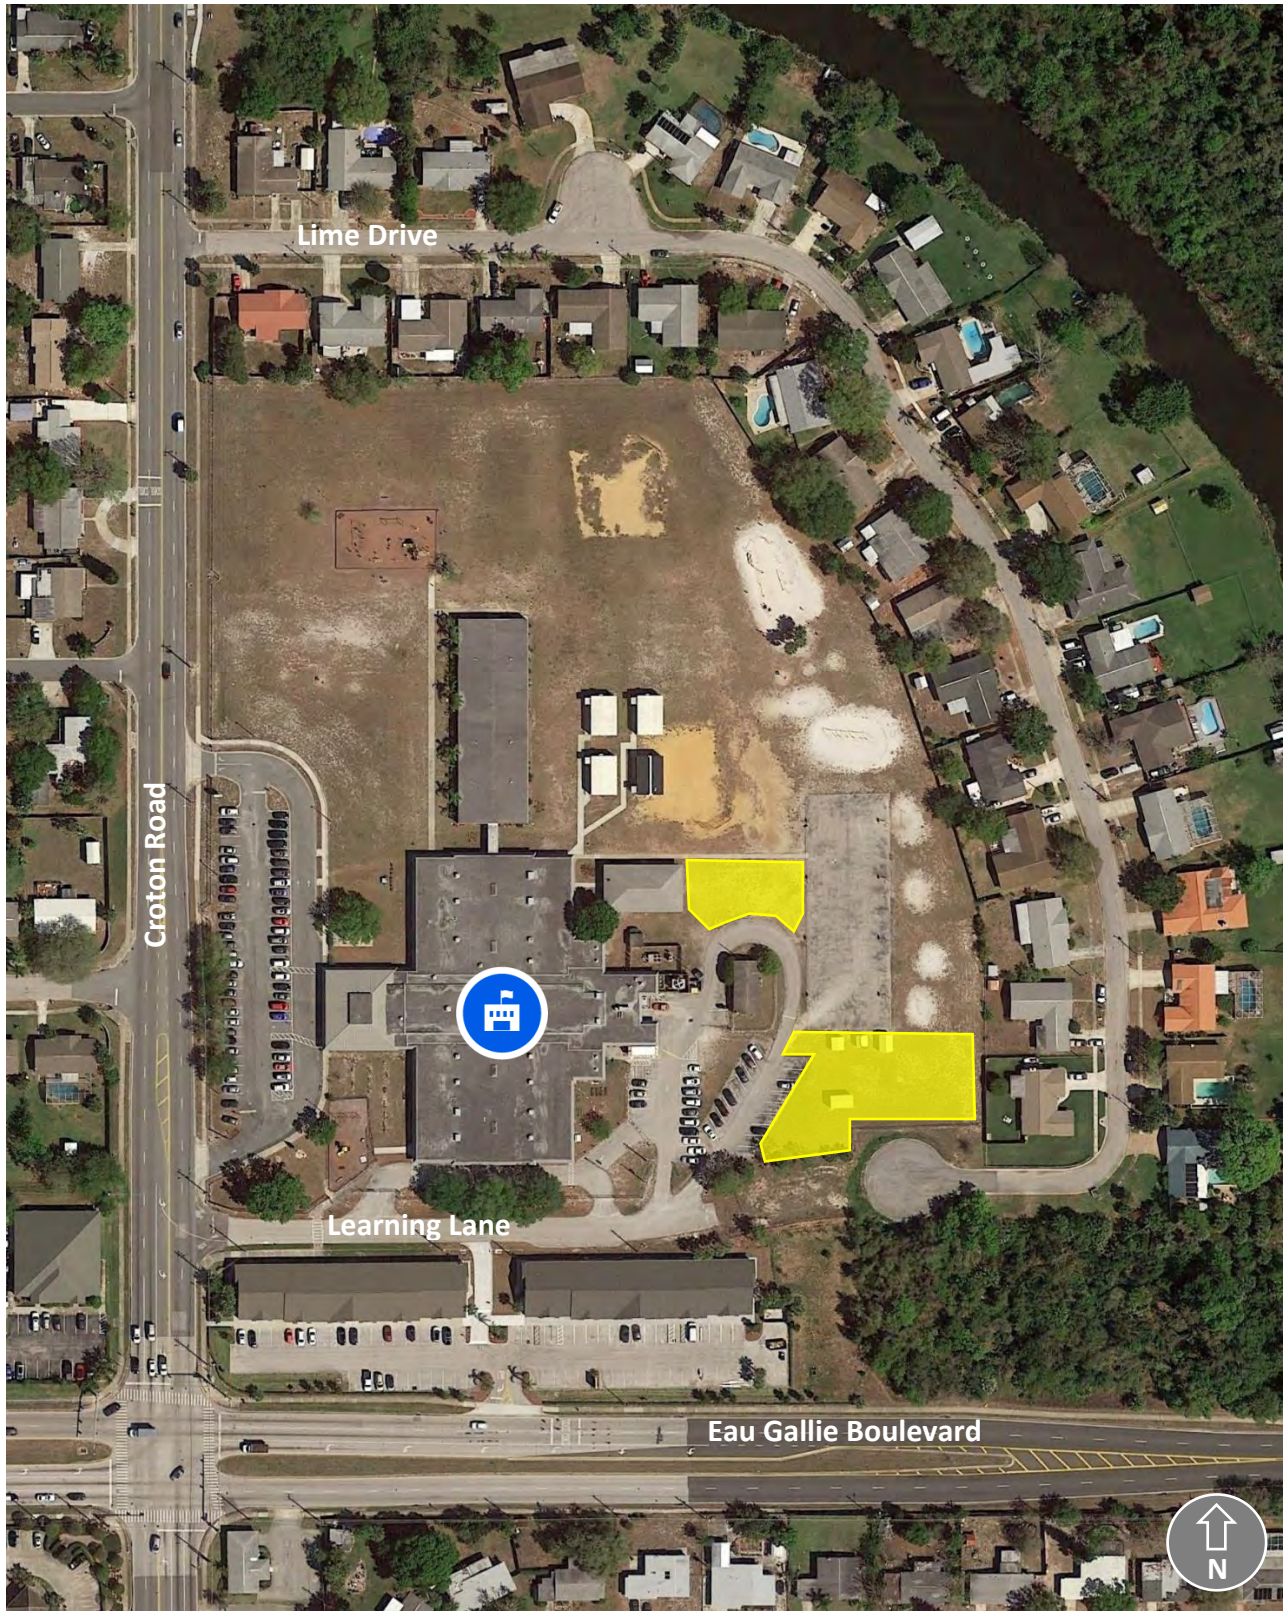
<b>Location</b>	Eastern Parking Lot
<b>Type</b>	School Circulation
<b>Issue</b>	There is not enough parking on the school campus for faculty and parents.
<b>Recommendation</b>	Expand the eastern parking lot to the north and east.

*Existing Field North and East of Eastern Parking Lot*

<b>Implementation Time-Frame</b>	Long-Term
 	<b>Estimated Project Cost</b>	Further Study Is Required
 	<b>Right-of Way Needed?</b>	No
 	<b>Drainage or Utility Impact?</b>	Unknown
 	<b>Responsible Agency</b>	Brevard County Public Schools

*Expand Eastern Parking Lot North and East*

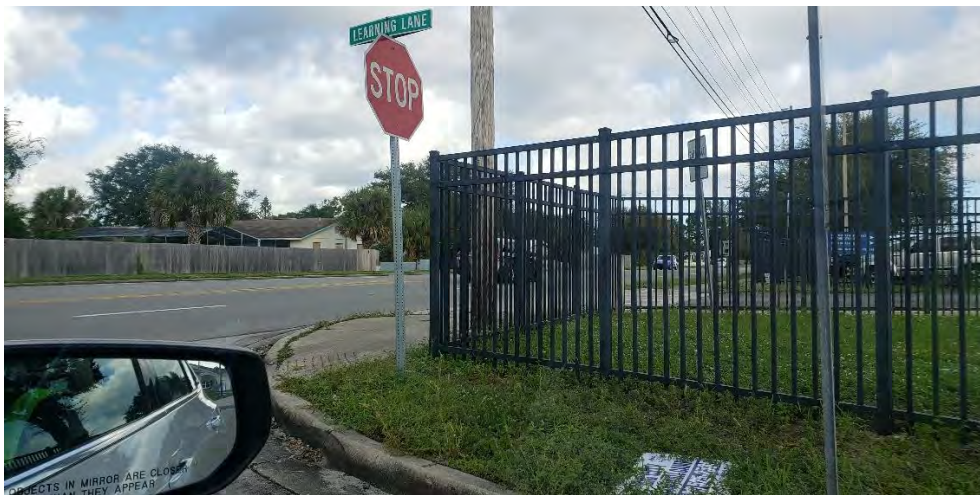
<b>Location</b>	Southwest Corner of the Campus along Learning Lane
<b>Type</b>	School Circulation
<b>Issue</b>	Drivers traveling along Learning Lane turning right onto Croton Road cannot see pedestrians and bicyclists traveling south along Croton Road due to black fencing along the southwest corner of campus along Learning Lane.
<b>Recommendation</b>	Remove black fencing from Learning Lane and Southern Croton Driveway intersection sight triangles.

*Black Fencing at Northeast Corner of Learning Lane and Croton Road*

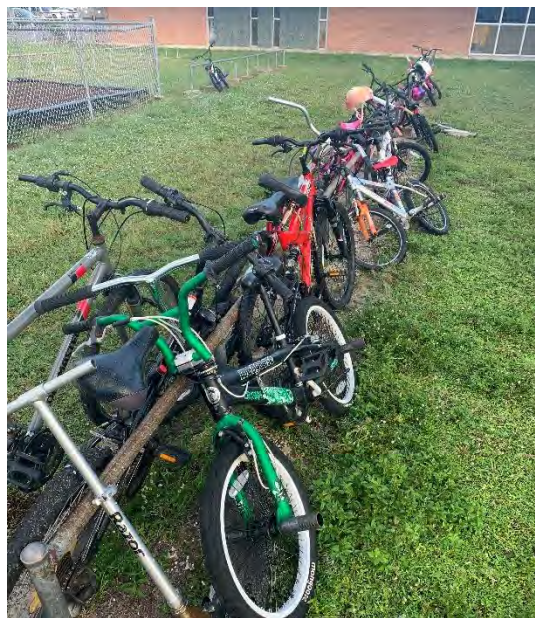
<b>Location</b>	South Side of the School Front Office
<b>Type</b>	School Circulation
<b>Issue</b>	The bicycle rack located on the south side of the school front office is old and needs to be replaced.
<b>Recommendation</b>	Replace bicycle parking rack.

*Bicycle Rack South of School Front Office*

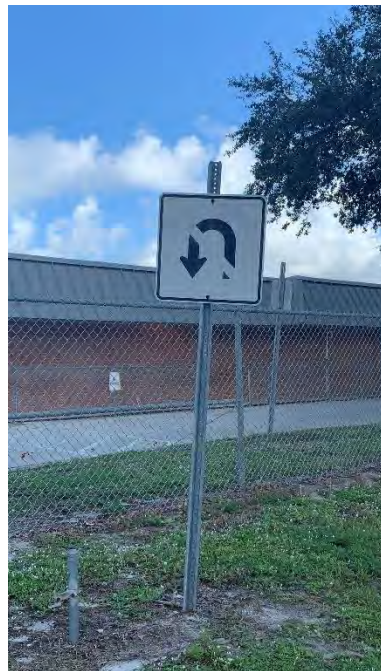
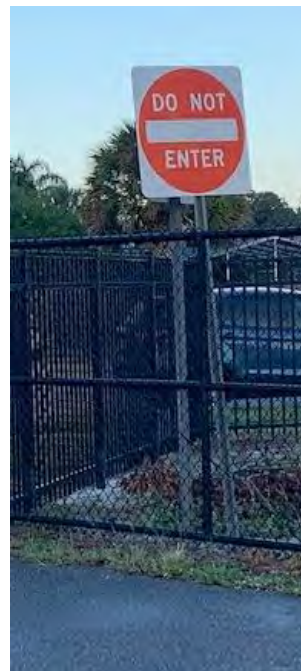
<b>Location</b>	School Property
<b>Type</b>	Sign/Signal
<b>Issue</b>	Signage on the school campus is old, faded, and hard to read.
<b>Recommendation</b>	Replace old signage.

*Signage on the School Campus*

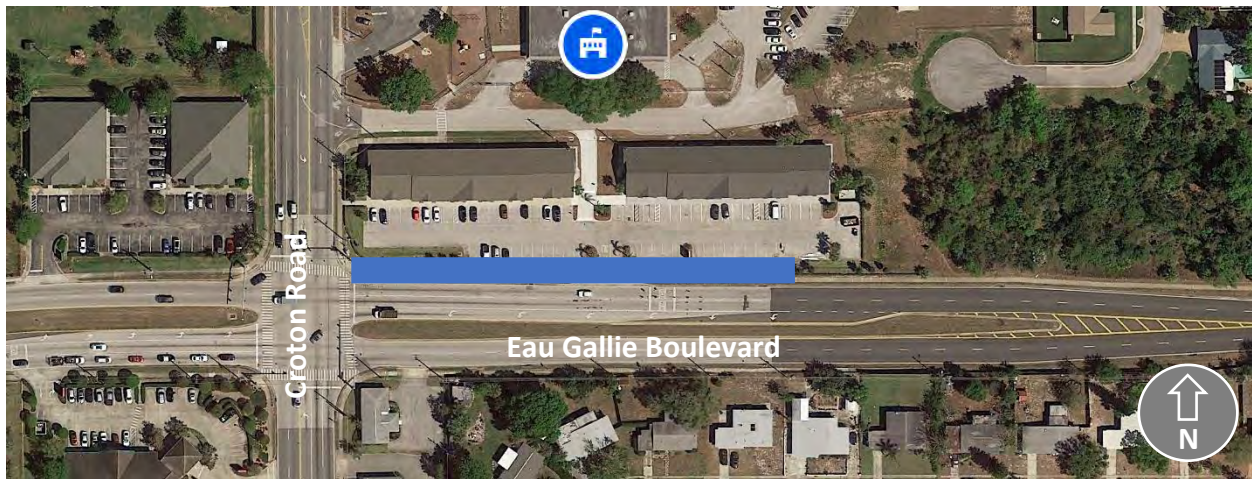
<b>Location</b>	Eau Gallie Boulevard and Croton Road Intersection
<b>Type</b>	Roadway
<b>Issue</b>	Vehicle stacking occurs along the east leg of the intersection of Eau Gallie Boulevard and Croton Road by vehicles turning right onto Croton Road.
<b>Recommendation</b>	Conduct a feasibility study to add a westbound right turn lane at the Eau Gallie Boulevard/Croton Road intersection.

***Add Westbound Right Turn Lane***

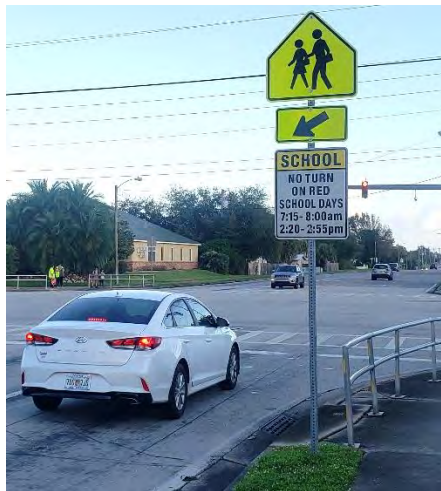
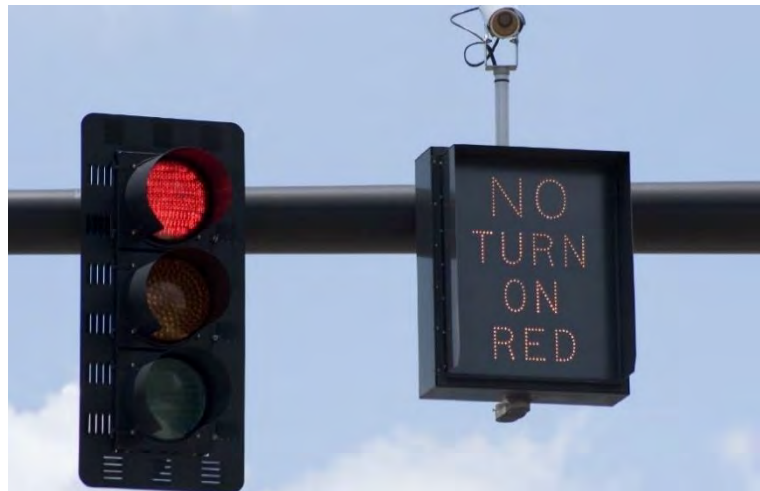
<b>Location</b>	Eau Gallie Boulevard and Croton Road Intersection
<b>Type</b>	Previous Study (Intersection)
<b>Issue</b>	Vehicles fail to yield to pedestrians crossing when making a right turn at the intersection of Eau Gallie Boulevard and Croton Road.
<b>Recommendation</b>	Implement FDOT Eau Gallie Boulevard and Croton Road Intersection Improvement Plan - Install "No Turn on Red" blank out signage active during school zone hours. Remove current "No Turn on Red" signage.

*Current 'No Turn On Red' Sign    Recommended Blank Out "No Turn On Red" Sign*

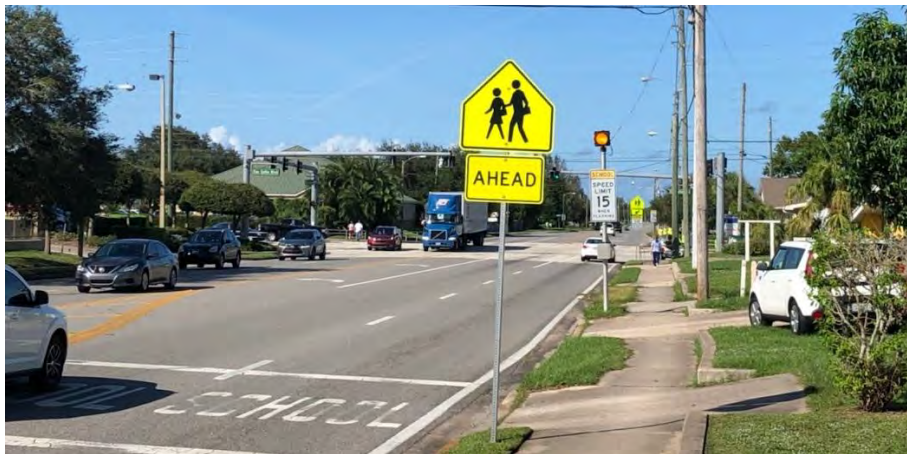
<b>Location</b>	Eau Gallie Boulevard
<b>Type</b>	Previous Study (Corridor)
<b>Issue</b>	School zone signage is not consistent with guidance in the FDOT Speed Zoning Manual. The intersection of Eau Gallie Boulevard and Croton Road only has a school zone along Croton Road.
<b>Recommendation</b>	Implement FDOT Eau Gallie Boulevard Multimodal Mobility and Safety Assessment recommendation - Adjust school zone to include the entire intersection. Update timing to include early release day on Friday. Update signage and pavement markings to be consistent with the FDOT Speed Zoning Manual.

*Existing School Zone Signage on Croton Road*

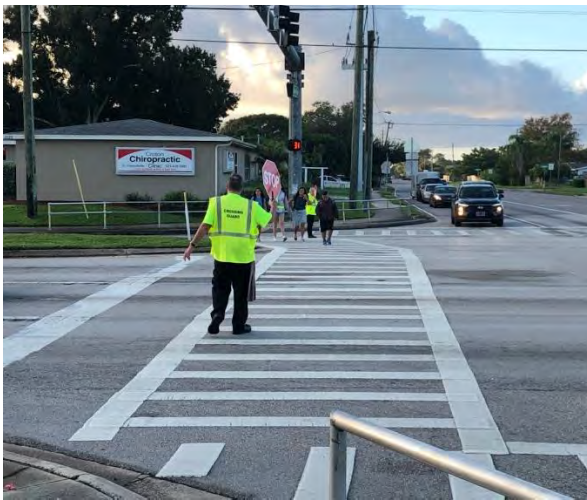
<b>Location</b>	Eau Gallie Boulevard and Croton Road Intersection
<b>Type</b>	Crossing
<b>Issue</b>	Students crossing the intersection of Eau Gallie Boulevard and Croton Road do not have a crossing guard in the southwest corner of the intersection.
<b>Recommendation</b>	Add a crossing guard at the southwest corner of intersection to maintain one crossing guard for each leg of the intersection.

*Existing Crossing Guard*

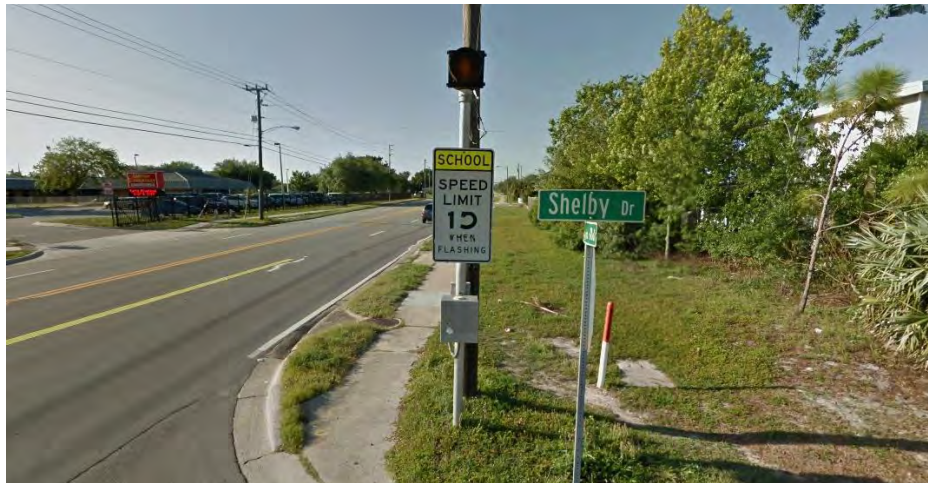
<b>Location</b>	Croton Road Just North of Eau Gallie Boulevard
<b>Type</b>	Sign/Signal
<b>Issue</b>	School zone signage is not consistent with guidance in the FDOT Speed Zoning Manual. School zone timing does not include early release schedule on Friday.
<b>Recommendation</b>	Adjust school zone signs and pavement markings to be consistent with the FDOT Speed Zoning Manual. Adjust timing to include early release schedule on Friday.

*Existing School Zone Sign along Croton Road*

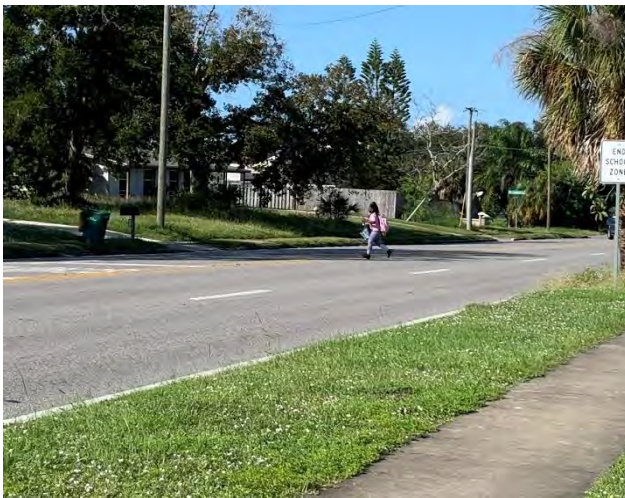
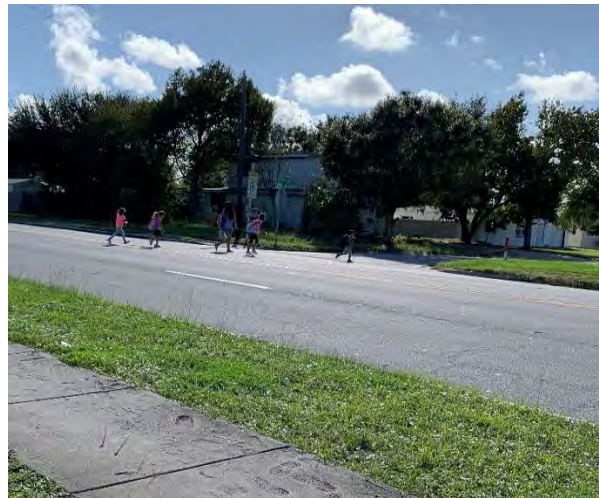
<b>Location</b>	Croton Road Just North of Shelby Drive
<b>Type</b>	Crossing
<b>Issue</b>	Pedestrians and bicyclists were observed walking across Croton Road not at marked crosswalks.
<b>Recommendation</b>	Construct a midblock crossing with a Rectangular Rapid Flashing Beacon (RRFB), a median refuge, and appropriate signage. Add a crossing guard at this intersection.

*Pedestrians Walking Across Croton Road*

<b>Implementation Time-Frame</b>	Near-Term
 	<b>Estimated Project Cost</b>	\$750,000 to \$870,000 for Midblock Crossing; Coordinate staffing for Crossing Guard
 	<b>Right-of Way Needed?</b>	Unknown
 	<b>Drainage or Utility Impact?</b>	Unknown
 	<b>Responsible Agency</b>	City of Melbourne and Brevard County

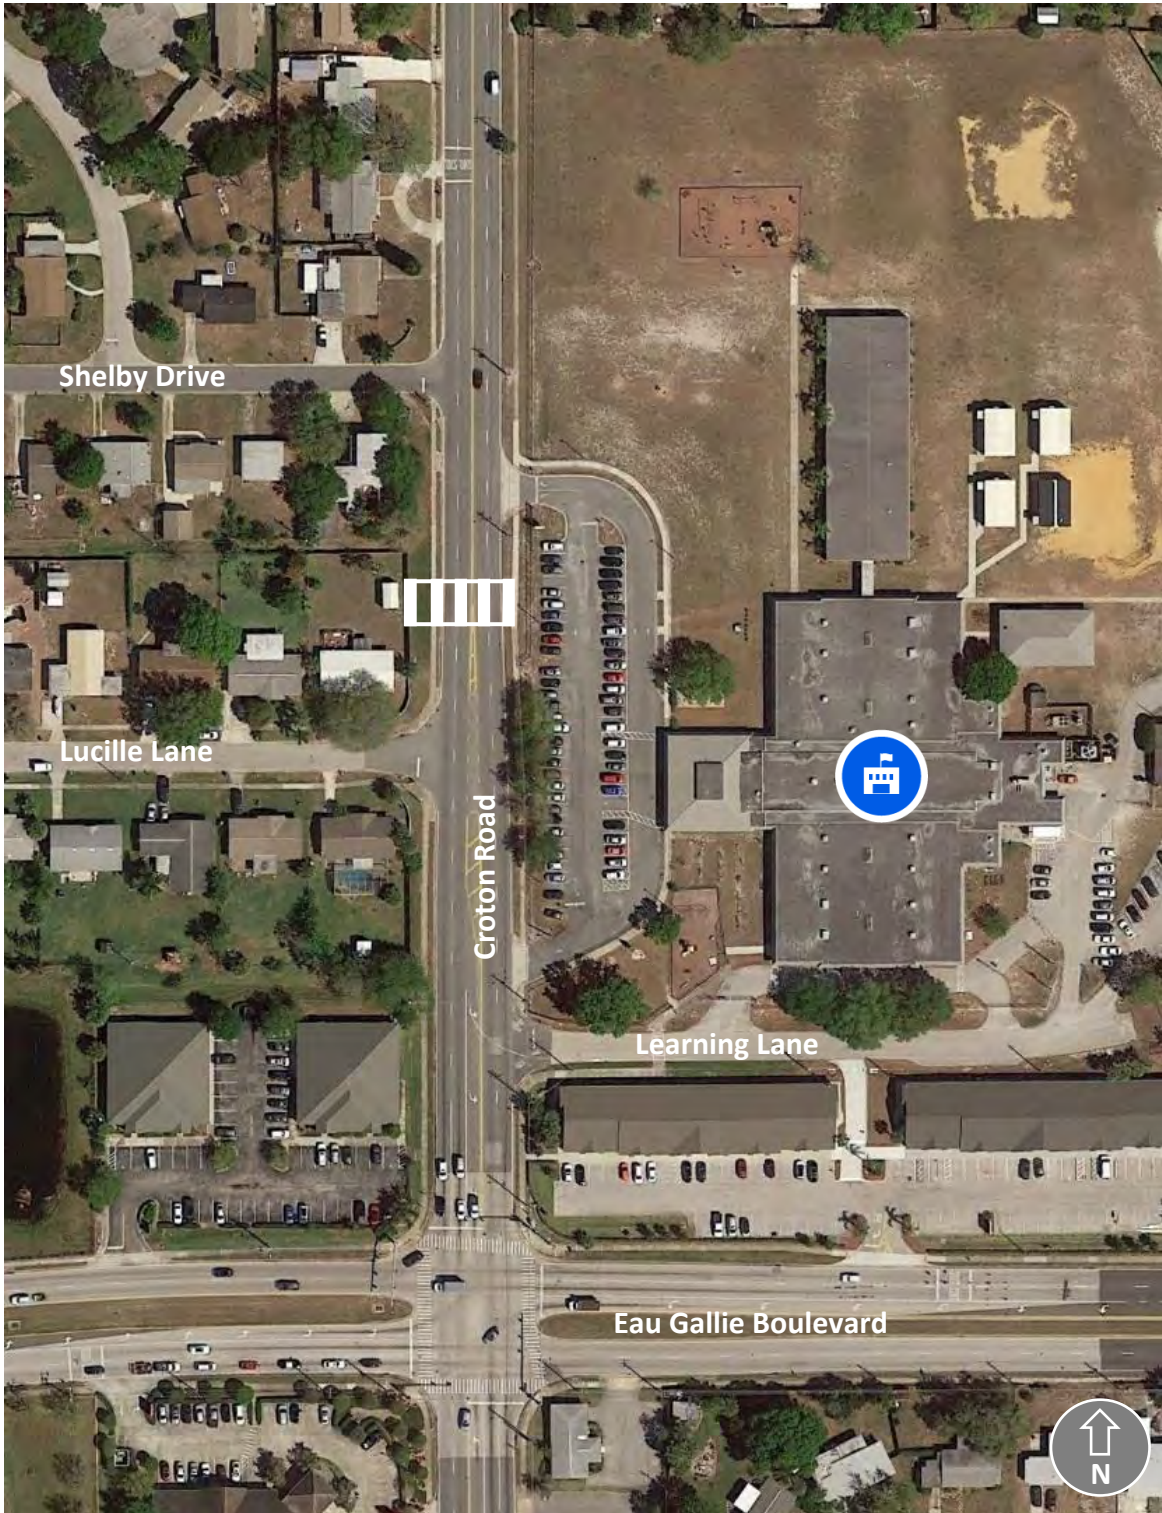
*Add Midblock Crossing Across Croton Road*

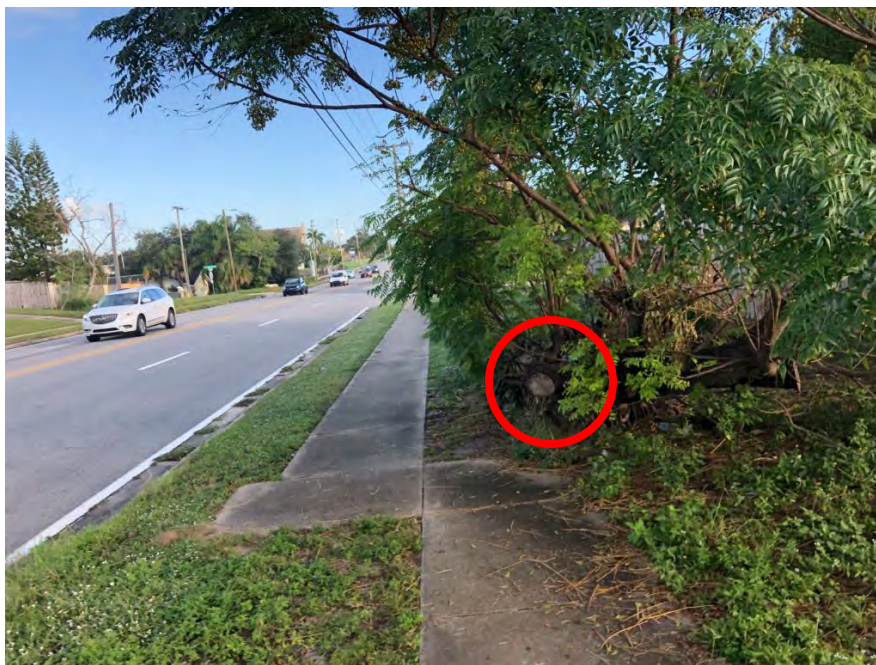
<b>Location</b>	Croton Road by Northwest Corner of School Property
<b>Type</b>	Maintenance
<b>Issue</b>	There is a dead tree on the eastern sidewalk along Croton Road by the northwest corner of the school property that blocks the sidewalk.
<b>Recommendation</b>	Remove the dead tree.

*Tree Along Croton Road*

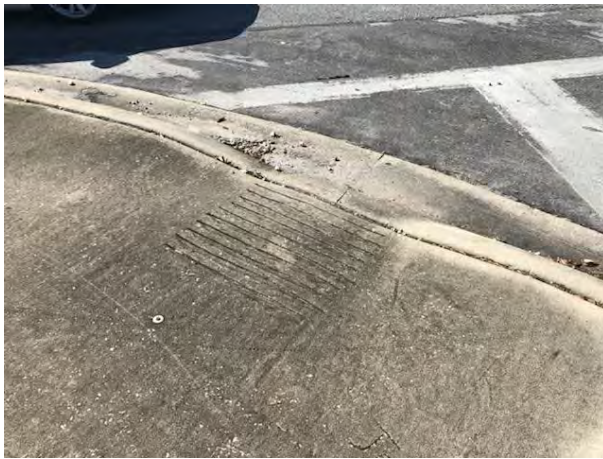
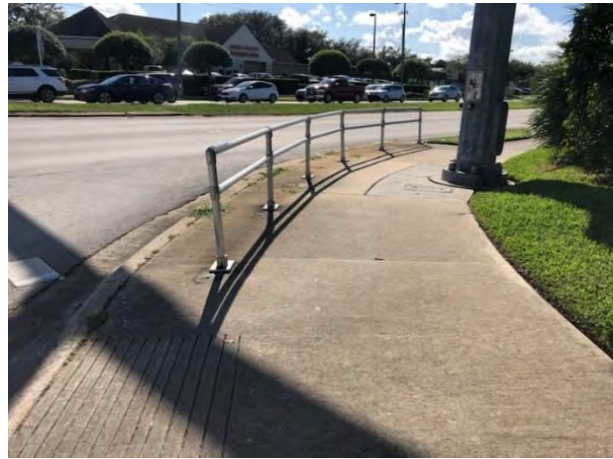
<b>Location</b>	Signalized Intersections within the Study Area
<b>Type</b>	Crossing
<b>Issue</b>	Pedestrian ramps at signalized intersections in the study area are not ADA compliant.
<b>Recommendation</b>	Upgrade/install ADA compliant pedestrian ramps.

*Pedestrian Ramps Within the Study Area*

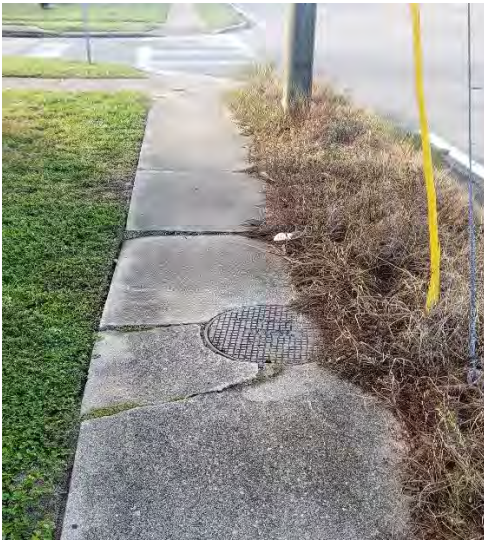
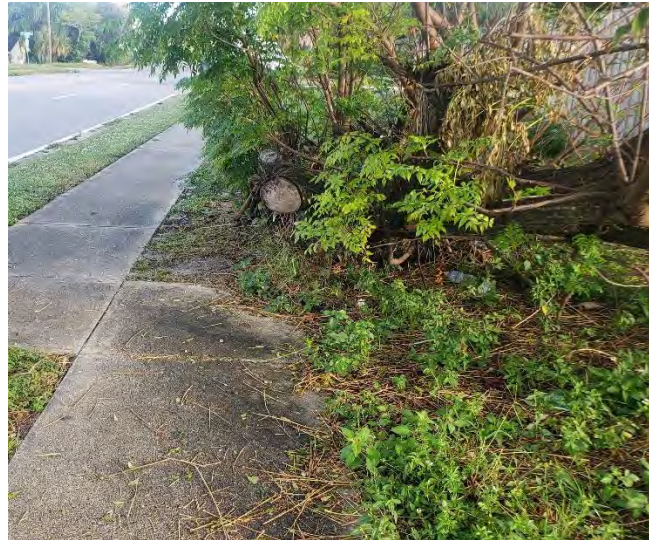
<b>Location</b>	Croton Road
<b>Type</b>	Maintenance
<b>Issue</b>	Landscaping along sidewalks along Croton Road is overgrown and blocks the sidewalk.
<b>Recommendation</b>	Maintain existing landscape to avoid sidewalks being blocked by completely overgrown weeds.

*Sidewalk Along Croton Road*

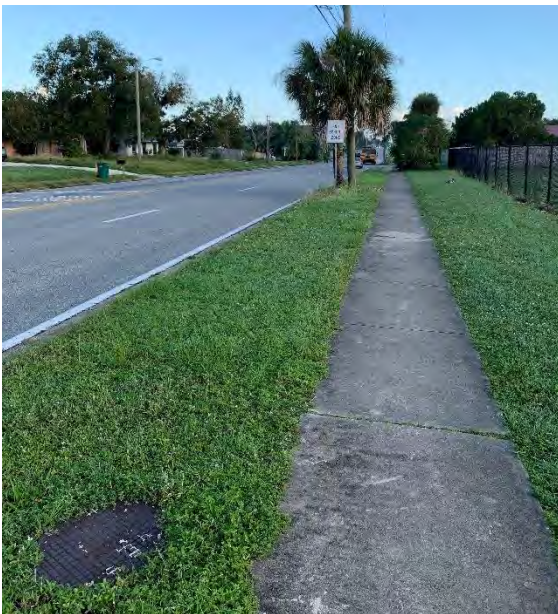
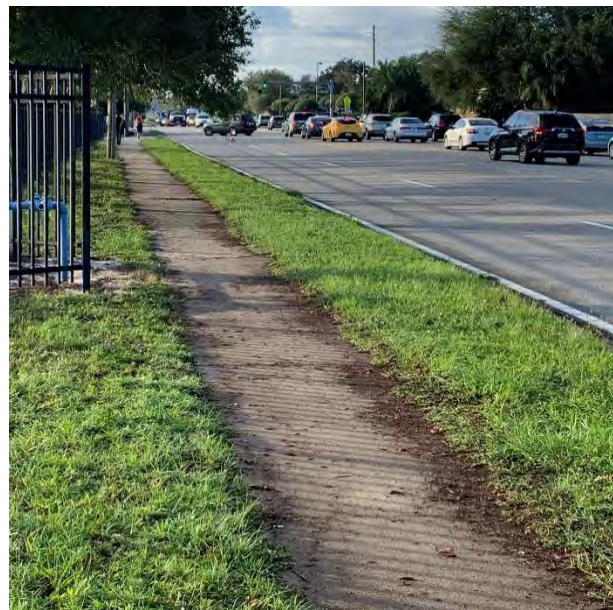
<b>Location</b>	Croton Road
<b>Type</b>	Sidewalk
<b>Issue</b>	There are no bicycle facilities along Croton Road.
<b>Recommendation</b>	Widen sidewalk on one side to make it a 10 to 12 foot-wide shared use path to accommodate bi-directional bicycle traffic.

*Existing Sidewalk Along Croton Road*

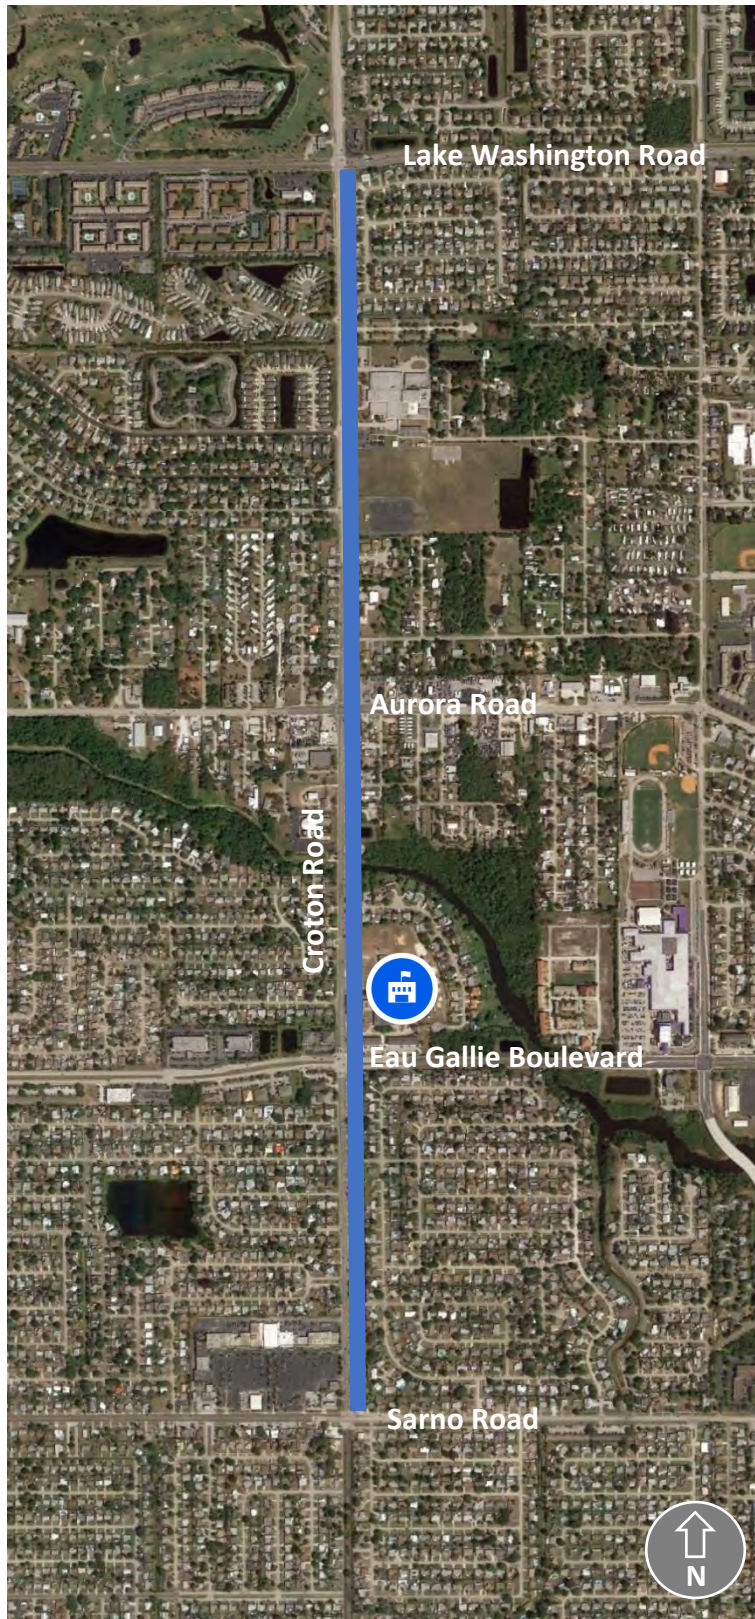
*Add Ten to 12 Foot Shared Use Path on Eastern Side of Croton Road*

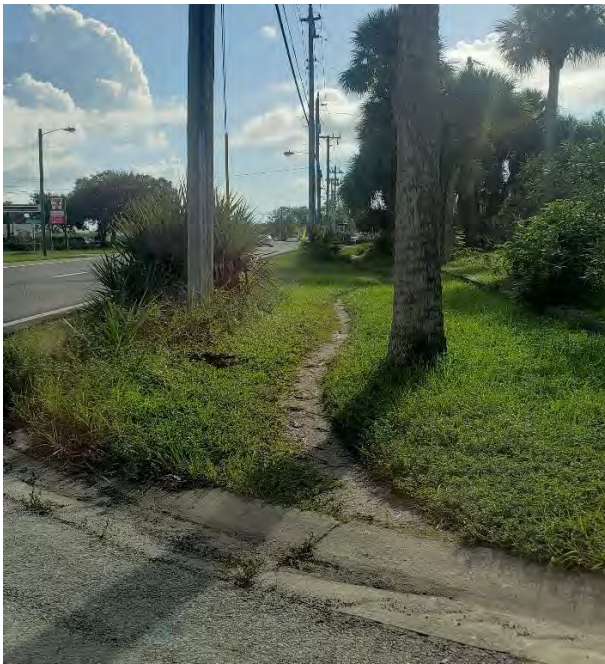
<b>Location</b>	Aurora Road
<b>Type</b>	Previous Study (Corridor)
<b>Issue</b>	A previous study along Aurora Road was conducted in 2018.
<b>Recommendation</b>	Implement recommendations from Aurora Road Corridor Study - 6 foot wide sidewalk on southern side; high visibility crosswalks and ADA improvements at intersections.

*Existing Sidewalk Gap*
