SCHOOL ROUTES ANALYSIS

SATURN ELEMENTARY SCHOOL

ASSESSMENT & IMPLEMENTATION REPORT

JANUARY 2024

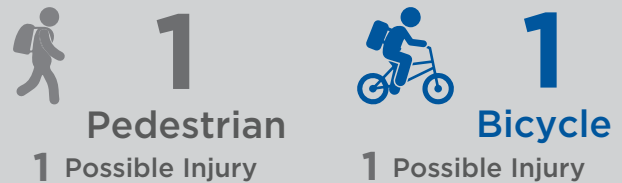
School Aged Bicycle & Pedestrian Crashes within Study Area

August 2017 to July 2023 Crashes from University of Florida's Signal Four Analytics Database

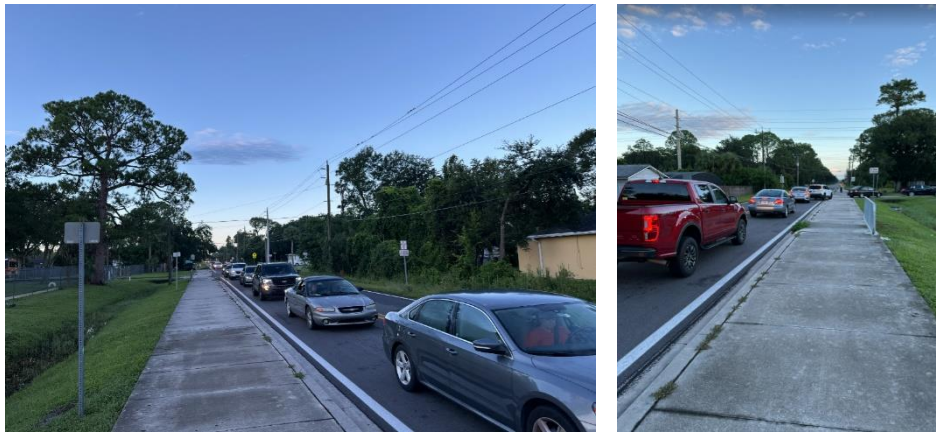
| Issues | During peak parent drop-off/pick-up times, the parent drop-off/pick-up loop have congestion that queues onto Range Road. |

Future Parent Drop-Off/Pick-Up & Future Bus Loop (Top) and Existing Congestion on Range Road (Bottom)

| Recommendations | <p>Flip the parent drop-off/pick-up loop to be on the south side of the school and the bus loop to be on the north side of the school:</p> <ul style="list-style-type: none"> • Southern proposed parent drop-off/pick-up loop: Widen the entrance/exit driveway and roadway width to comfortably accommodate 2 vehicles side-by-side. Extend the loop further to the east to provide more queue storage for vehicles. Open the proposed parent drop-off/pick-up loop gate at 7:00 AM and 1:30 PM to reduce queueing along Range Road prior to school start and dismissal times. Evaluate the drainage impacts of the swale located on the south side of the school property just east of the loop. • Northern proposed bus loop: Widen the entrance/exit driveway width to comfortably accommodate 2 buses side-by-side. Potentially remove parking spaces near the turnaround point at the east end of the parking lot and near the entrance/exit driveway to accommodate bus turning movements. Due to the northern bus loop area still having staff/visitor/parent parking, there will need to be signage restricting vehicle access from 7:15 AM to 8:00 AM and from 2:00 PM to 2:35 PM. |

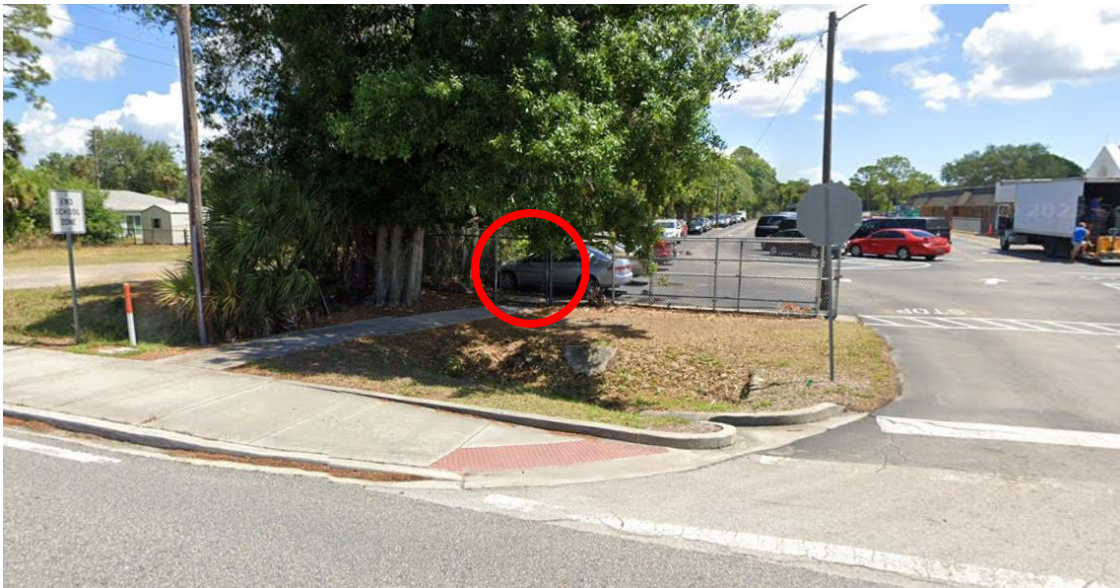
| Issue | There is a lack of safe pedestrian infrastructure on the north side of the school campus to allow students/parents to safely cross to access the school. |

Gate on the North Side of the School

| Recommendation | Open the gate on the north side of the school to allow students/parents to walk on the continuous sidewalk connected from the roadway onto the school property and encourage them to use the marked crosswalk across the northern school driveway. |

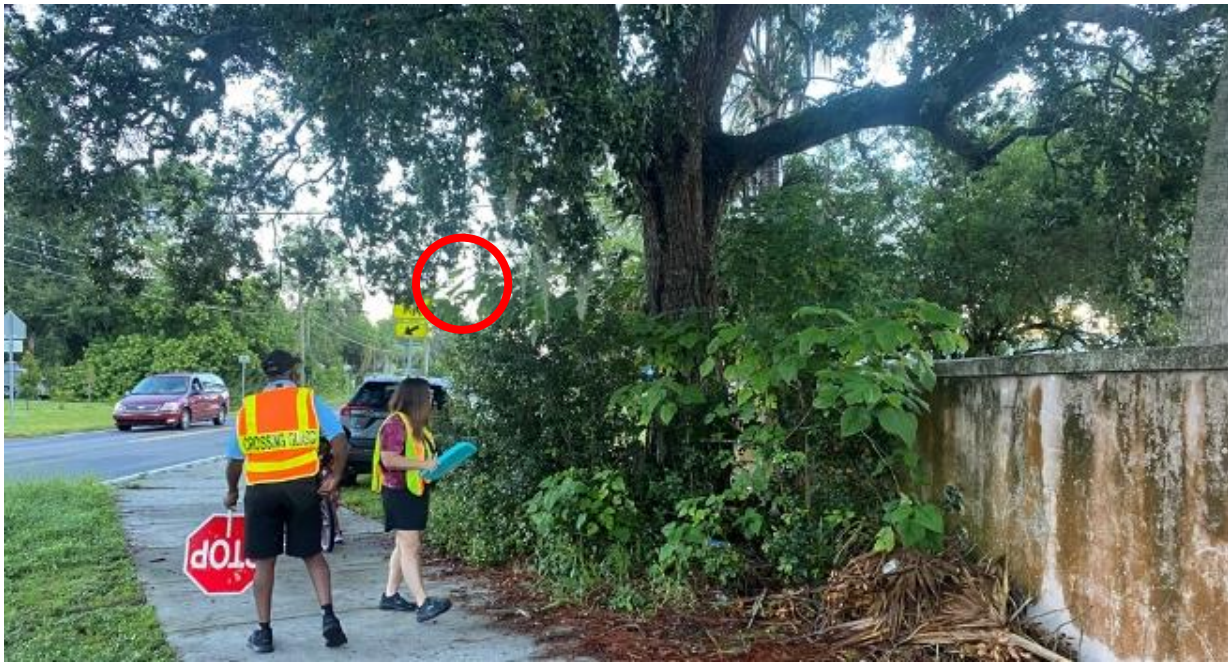
| Issue | Vegetation is overgrown on Range Road in front of the school property and obstructs signage and visibility. |

Tree Obstructing Pedestrian Crossing Sign

| Recommendation | Increase the frequency of landscaping and maintenance in front of school property to cut the vegetation . |

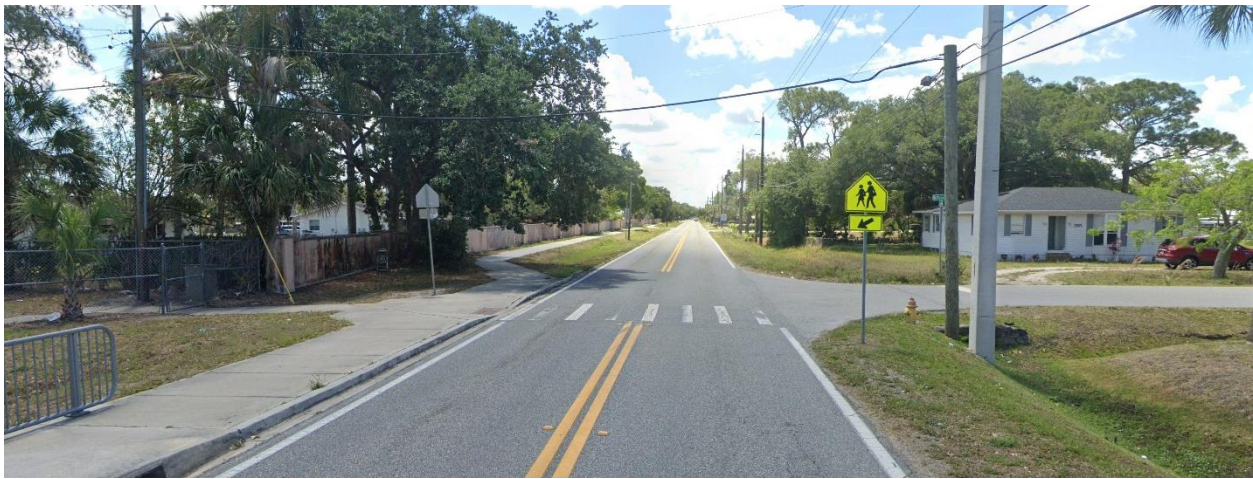
| Issue | The existing unsignalized crosswalks within the school study area need safety enhancements. |

Existing Crosswalk at Range Road & Palm Drive

| Recommendation | Add RRFBs, in-street pedestrian crossing signage, and pedestrian lighting at the existing crosswalks. |

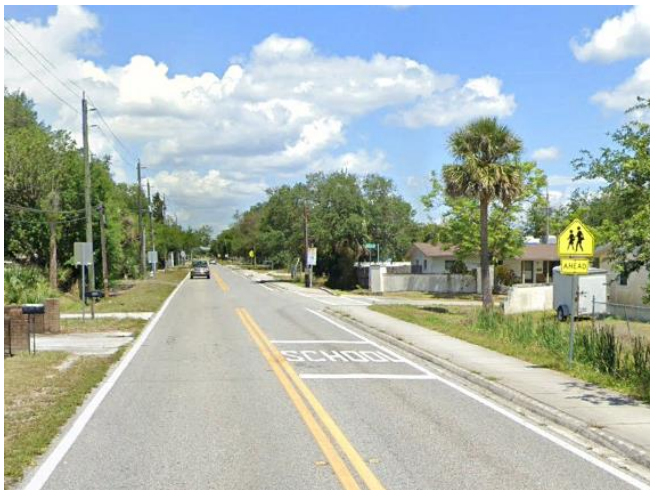
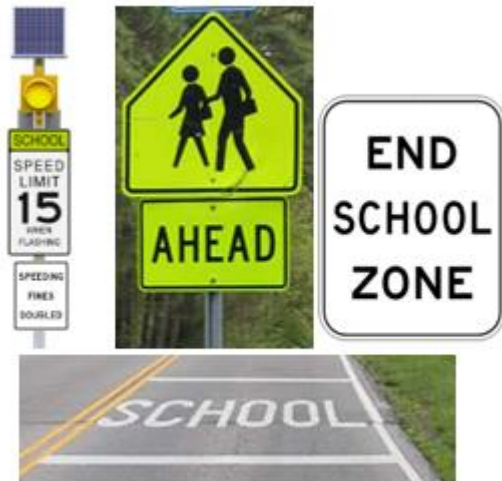
| Issue | There are currently two school zones approximately 600 feet apart on Range Road, which makes it confusing for drivers approaching and departing the school zone. |

Existing School Zone on Range Road (Left) and Proposed School Zone Signage/Pavement Markings (Right)

| Recommendation | Create one continuous school zone from Dianne Drive to Delys Street by including the roadway segment from Palmetto Drive to Palm Drive in the Range Road school zone. Add school zone pavement markings, "Speeding Fines Doubled", and "End School Zone" signage. |

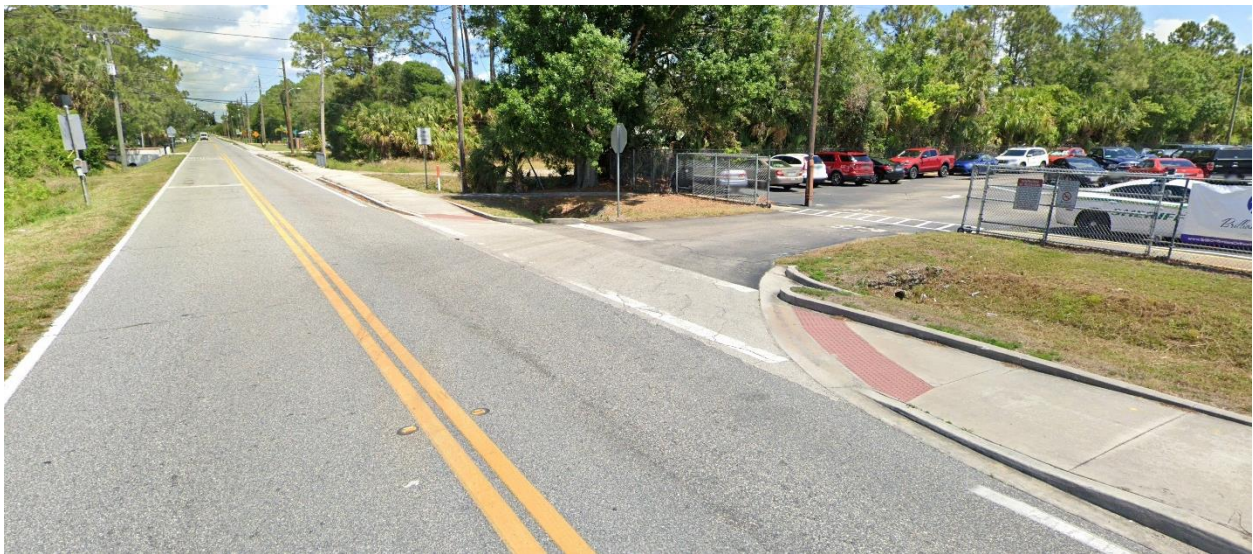
| Issue | Several crosswalks near the school campus driveways are faded and need to be restriped for better visibility. |

Existing Faded Crosswalk on Range Road at Southern School Driveway

| Recommendation | Restripe faded crosswalks to high-visibility crosswalks where sidewalks are present. |

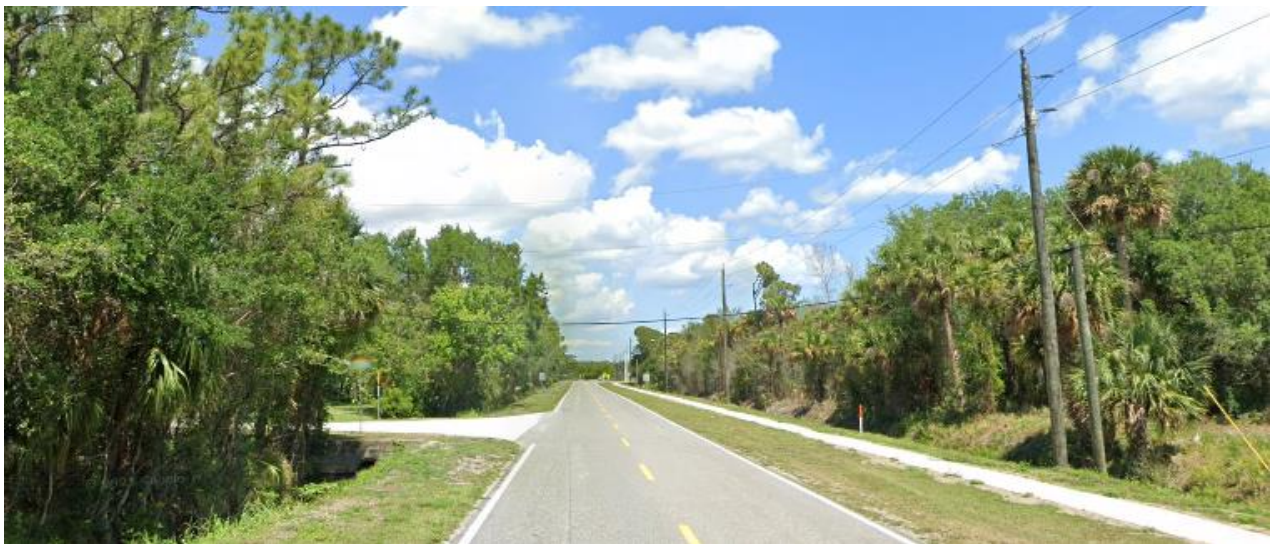
| Issue | There is a sidewalk gap on the west side of Range Road between SR 520 (King Street) and Tiger Trail. |

Existing Sidewalk Gap on Range Road

| Recommendation | Fill sidewalk gap on the west side of the roadway. |

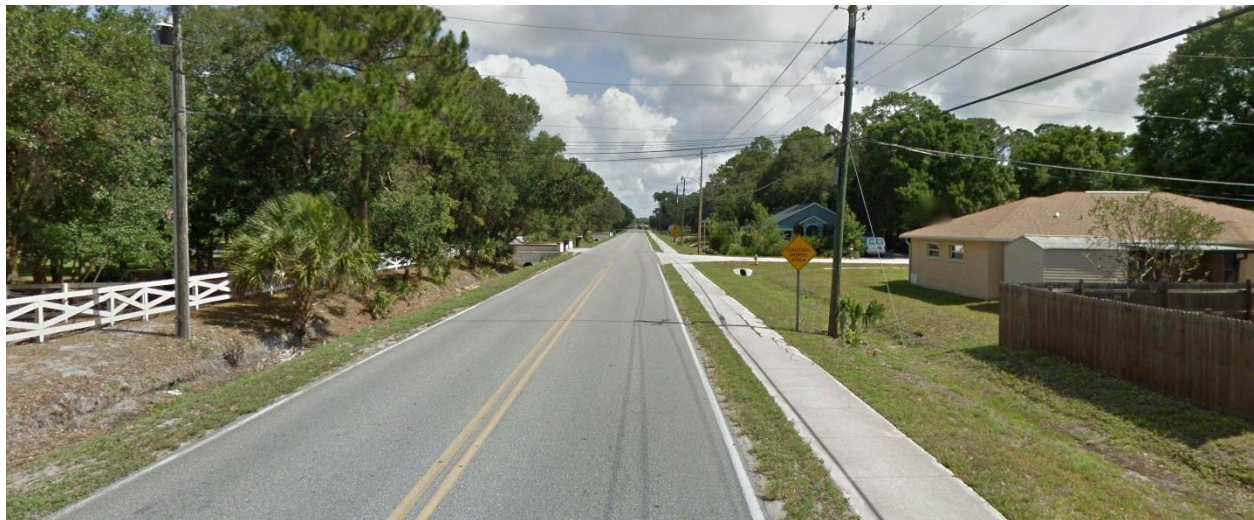
| Issue | There are several bicycle facility gaps in the study area that have been prioritized in the 2019 SCTPO Bicycle & Pedestrian Master Plan. |

Lack of Bicycle Facilities on Range Road

| Recommendation | <p>Fill bicycle facility gaps prioritized in the 2019 SCTPO Bicycle & Pedestrian Master Plan on:</p> <ul style="list-style-type: none"> • Range Road from SR 520 (King Street) to Tiger Trail; and • Lake Drive from Cox Road to SR 501 (Clearlake Road). |

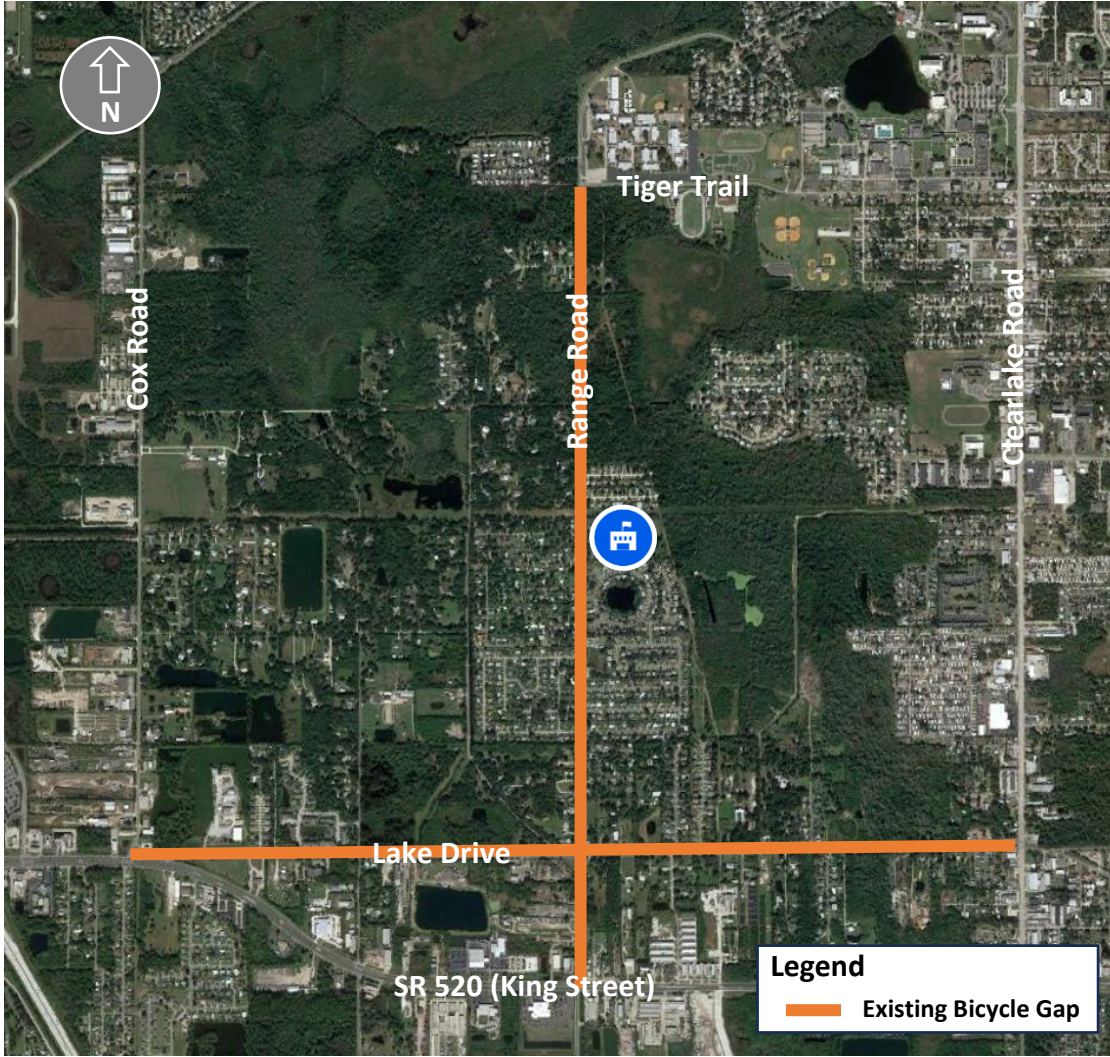
Prioritized Bicycle Facility Gaps

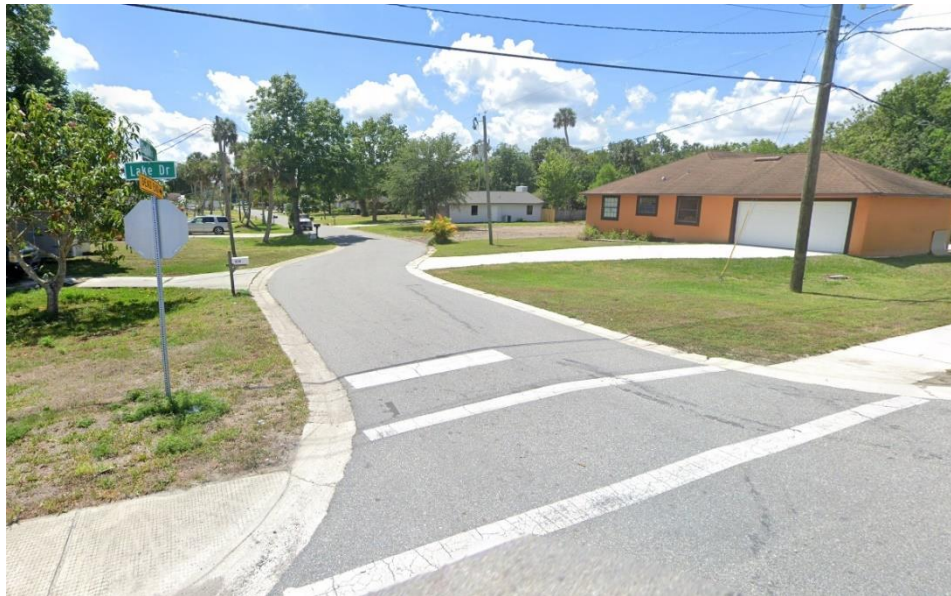
| Issue | Pedestrian ramps along Range Road and Lake Drive do not meet current standards. |

Pedestrian Ramps on Lake Drive

| Recommendation | Install/upgrade pedestrian ramps that meet current standards along: <ul style="list-style-type: none"> • Range Road from SR 520 (King Street) to Tiger Trail; and • Lake Drive from Cox Road to SR 501 (Clearlake Road). |
