SPACE COAST AREA TRANSIT BUS STOP ACCESSIBILITY STUDY

Final Report

November 28, 2018

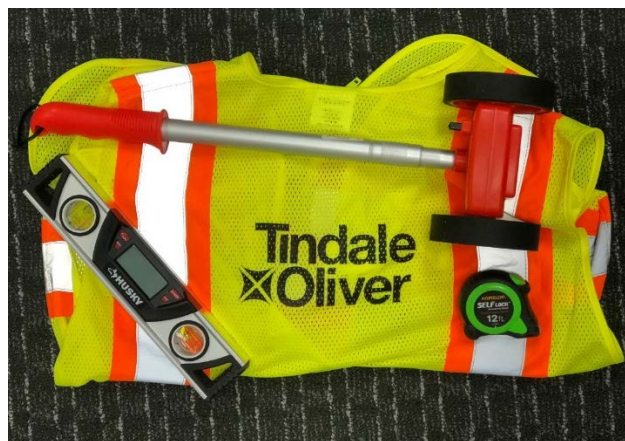
Figure 2-1: Field Data Collection Equipment

The primary equipment used by each surveyor to conduct the inventory is illustrated in **Figure 2-1** and includes:

- Mobile tablet or smartphone
- Smart level
- Measuring wheel
- Safety vest

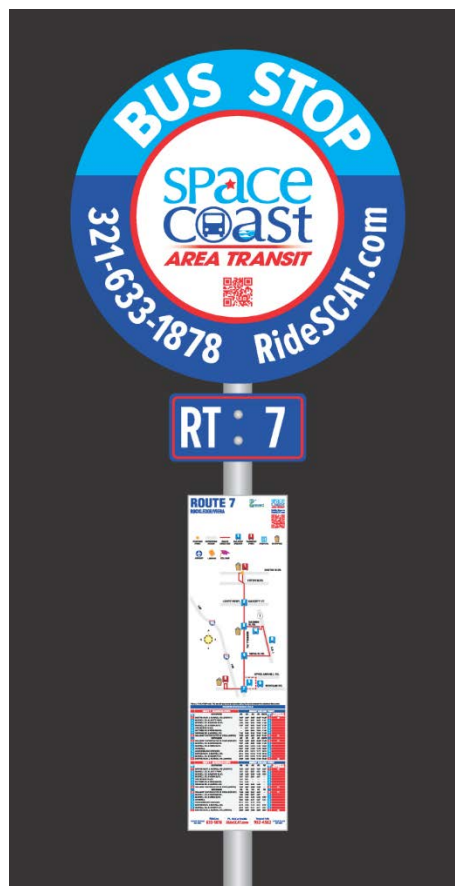
Figure 3-5: ADA-Compliant SCAT Bus Stop Sign, Schedule, and Route Number

The SCAT bus stop sign shown in **Figure 3-5** meets these requirements. All bus stops that require updated or relocated signage as a result of this study must meet applicable ADA requirements. It should be noted that, through the ride check process, flag stops were observed along two routes (3 and 5). **It is recommended that SCAT discontinue this practice system-wide to avoid accessibility, safety, and operational/scheduling issues that can result from using flag stops.**

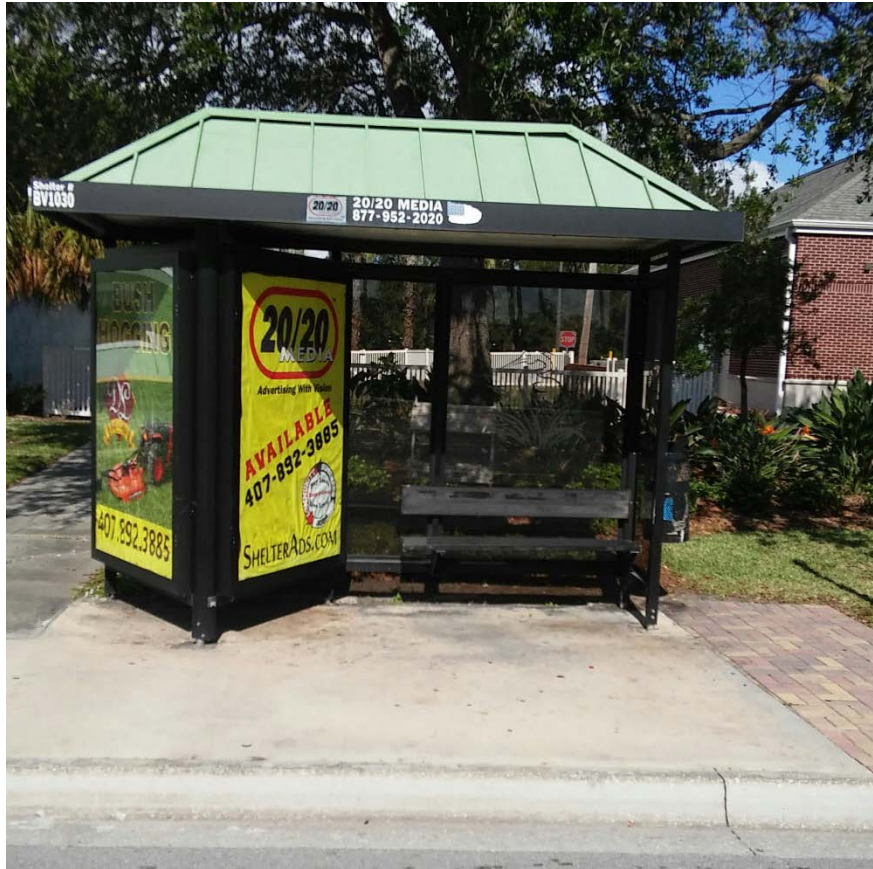
Figure 3-8: Example SCAT Bus Stop Obstruction

Figure 3-8 illustrates an example obstruction observed during the field data collection effort where an advertisement board is obstructing the required wheelchair clear area within the shelter. This obstruction also has the potential to create a blind spot for passengers waiting in the shelter that could decrease the safety of the area.
