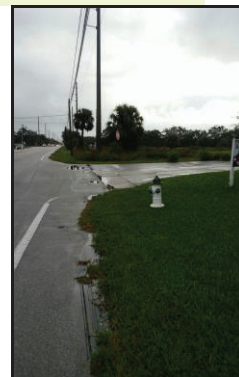
Southbound

B&A Condition: Surface not firm, stable, or slip resistant

Slope Parallel to Road(%): 0.6 **Slope Perpendicular to Road(%):** 4.2

Create a "rural bus stop" by paving a level 5'x8' slab with a raised 6" curb for the B&A area. Pave a ramp from the B&A area to the shoulder of the road, which will act as the accessible path. Consider adding a mid-block crosswalk to access the hospital across the street.
