# PEDESTRIAN / BICYCLE SAFETY REVIEW

SR 501 / Clearlake Road from Dixon Boulevard to Michigan Avenue

February 2016

## **Pedestrian/Bicycle Safety Review Report for SR 501/Clearlake Road from Dixon Boulevard to Michigan Avenue**

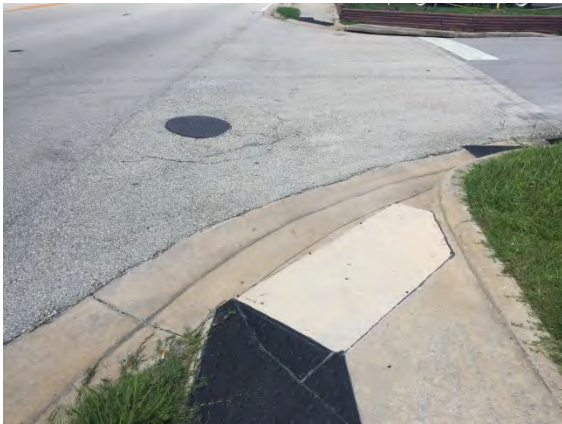
Figure 14

The detectable warning surfaces appear to be nailed down into the concrete. As a result, many of the surfaces have been displaced from the curb ramps at both signalized and unsignalized intersection locations. These displacements and absences of the detectable warning surfaces are shown in **Figure 14** through **Figure 17**.

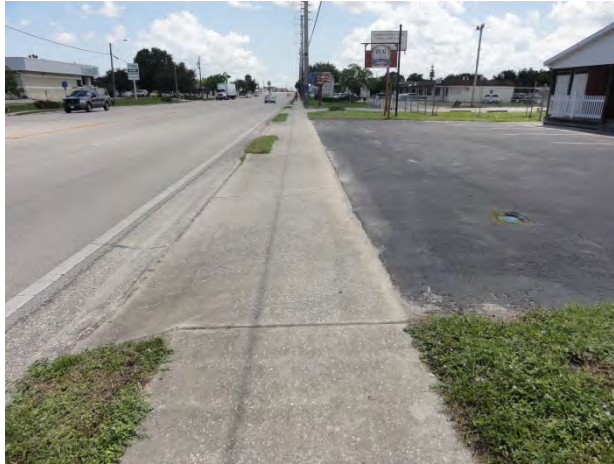
**Figure 20**

In some cases, businesses have multiple driveways facilitated by the TWLTL (**Figure 20**). The high driveway density increases exposure of sidewalk users to conflicts with turning vehicles.

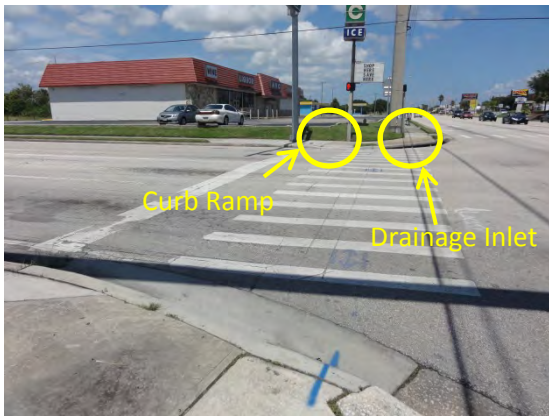
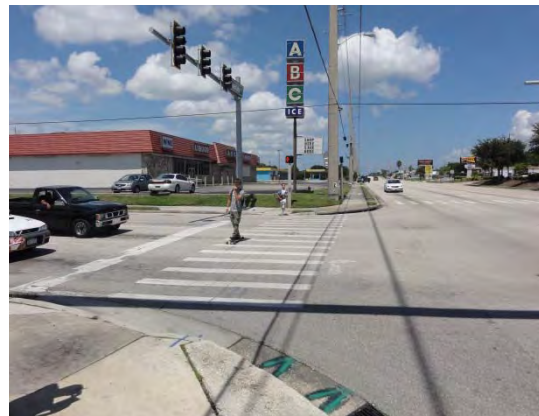
The crosswalk on the west leg does not connect to the pedestrian ramp on the northwest corner. Instead, the crosswalk connects to the drainage inlet on the northwest corner. This issue is shown in **Figure 31** and **Figure 32**.

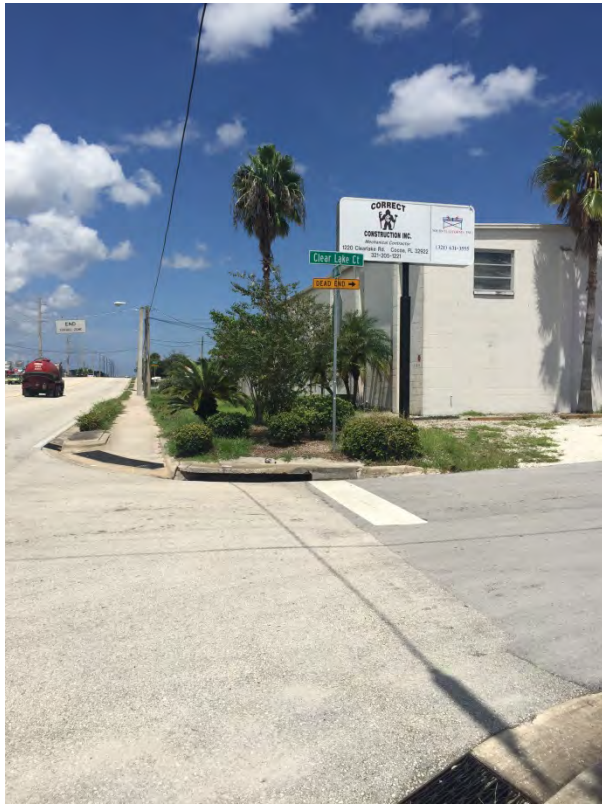
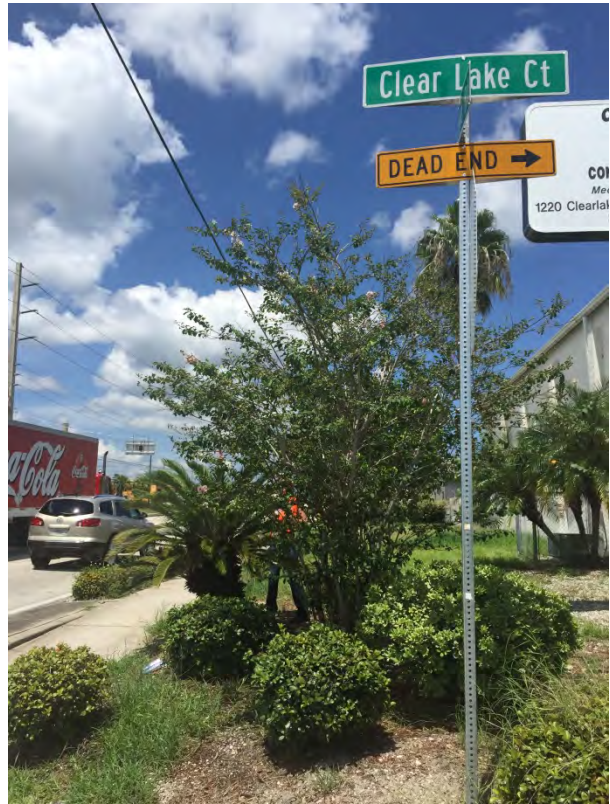
The existing landscaping (trees and bushes) on the northeast corner of the intersection blocks the available sight distance for vehicles attempting a westbound left-turn (Figure 39 and Figure 40). Vehicles

have to pull past the stop bar to look north to see past the landscaping. One related bicycle crash occurred at this location involving a westbound vehicle and a bicycle riding southbound along the east sidewalk (against the direction of traffic). Vehicles parked perpendicular to SR 501 in the parking area associated with the business on the southeast corner of the intersection block the available sight distance for westbound vehicles attempting a left-turn or right-turn onto SR 501. This is illustrated in **Figure 41**. Vehicles parking at the business were parked in the northernmost parking spaces and obstructed the view of drivers at the stop bar.

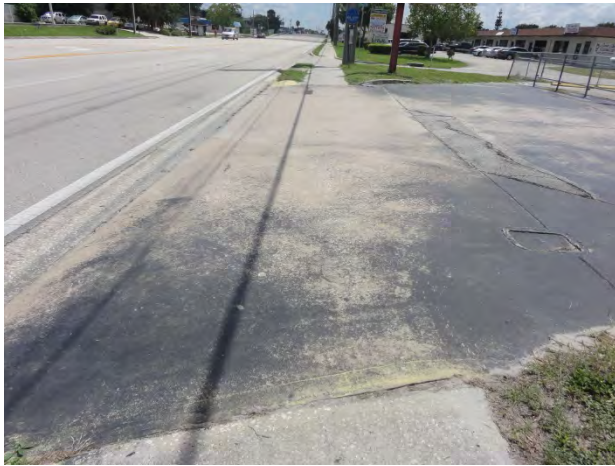
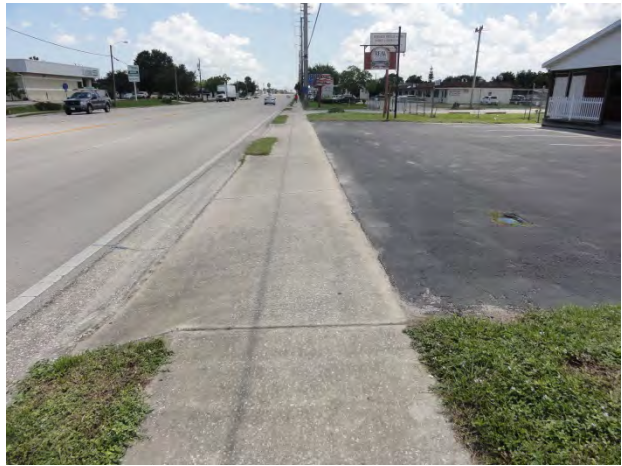
Level paths (i.e. cross slopes less than two percent) are not provided across the driveways along the west side of SR 501. The field review team measured driveways along this segment and most exceeded the maximum two percent cross slope per ADA requirements. Examples of driveways measured in the field are shown in **Figure 48** and **Figure 49**.

| Location | Issue Number | Issue | Suggestion |
|---|---|---|--|
| Mid-Block between Furnari Street and Fay Street | 17 | Driveway Cross Slopes | Consider rebuilding the driveways to provide a level path during the roadway's next 3R project. It appears these improvements can be done without negatively impacting parking or site circulation on the subject parcels. |

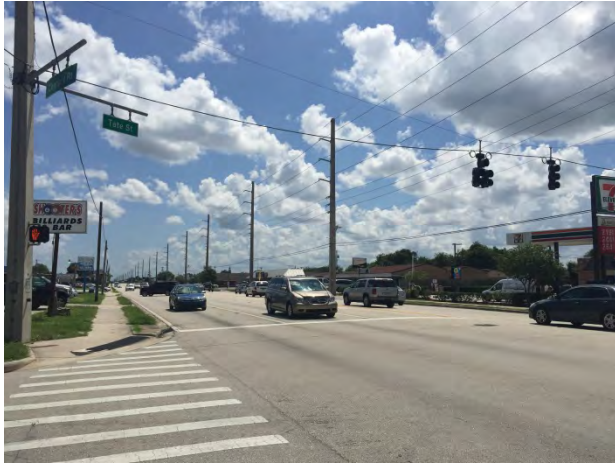
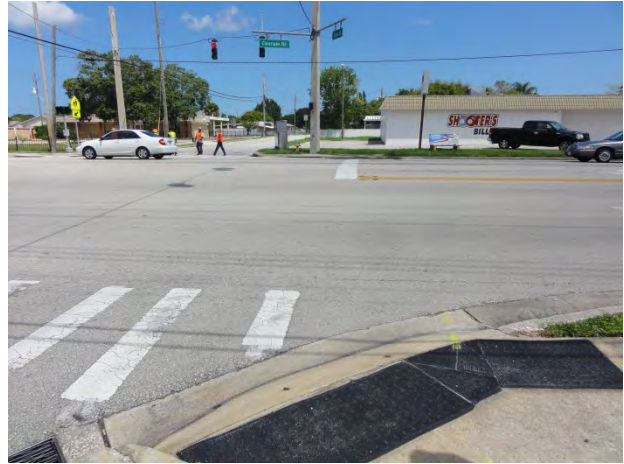
No crosswalk is provided along the south leg of the intersection as shown in **Figure 50** and **Figure 51**. A fatal crash occurred on the intersection's south side when a pedestrian crossing the street at night was struck by a northbound vehicle. There is a drainage inlet on the southeast and southwest corners of the intersection. No sidewalks are provided along the south sides of the Rosetine Street/Tate Street.

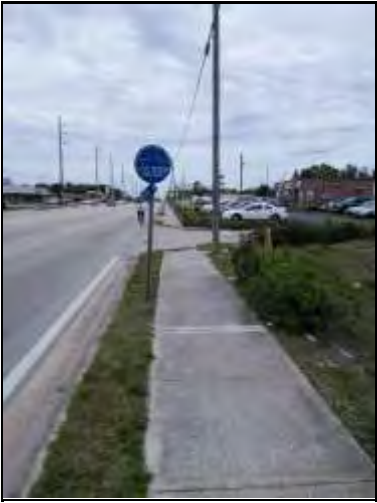
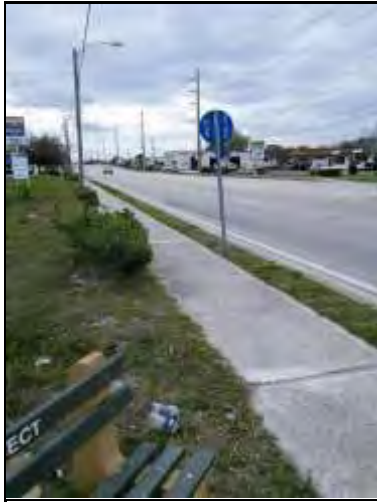
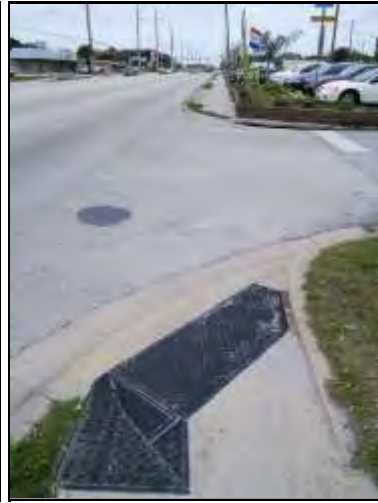
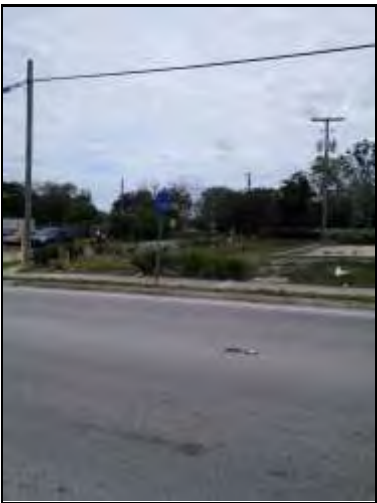
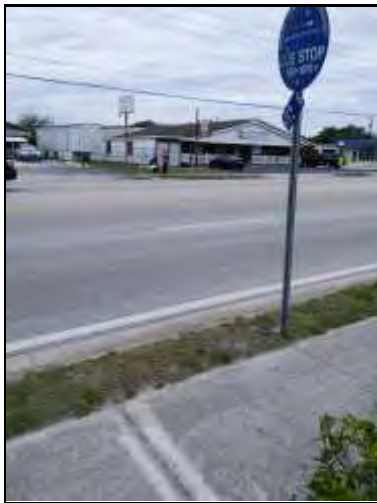
**Location:** CLEARLAKE RD & MELROSE ST **ID:** 549

**Is the B&A Safe:** Yes      **B&A Condition:** Surface not firm, stable, or slip r

**Recommendations:** Pave a level 5'x3' slab between the curb and sidewalk to complete a 5'x8' B&A area. Move the bench so that it is flush with the edge of the sidewalk and outside of the B&A area. Stripe a crosswalk at the nearby intersection.

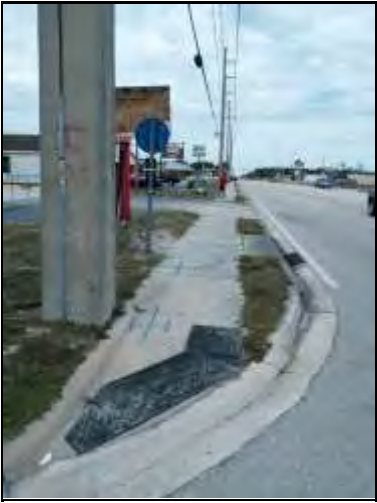
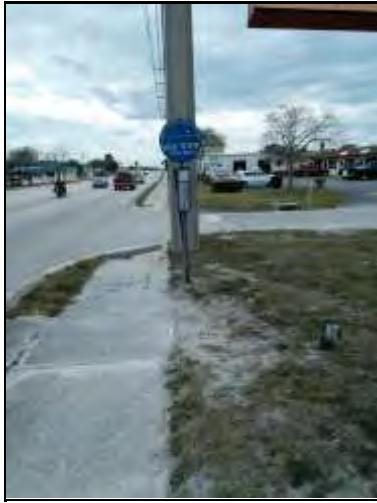
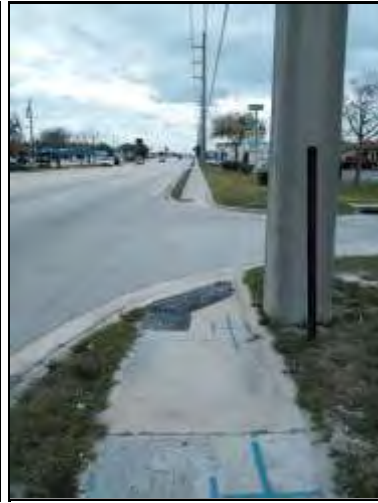
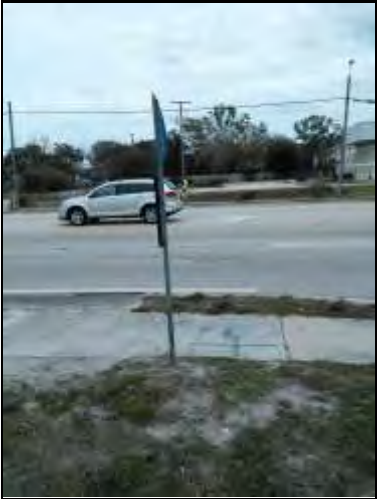
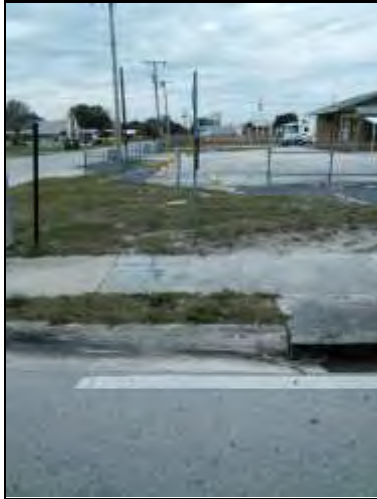
**Location:** CLEARLAKE RD & MINNIE ST **ID:** 570

**Is the B&A Safe:** Yes **B&A Condition:** Surface not firm, stable, or slip r

**Detectable Warning:** Yes **Detectable Warning Condition:** **Fair**

**Recommendations:** Pave a level 5'x3' slab between the curb and sidewalk to complete a 5'x8' B&A area. Make sure the pole with the bus schedule is located adjacent to the pavement so it is accessible. Add new detectable warnings to the nearby curb ramps. Stripe a crosswalk at the nearby intersection.

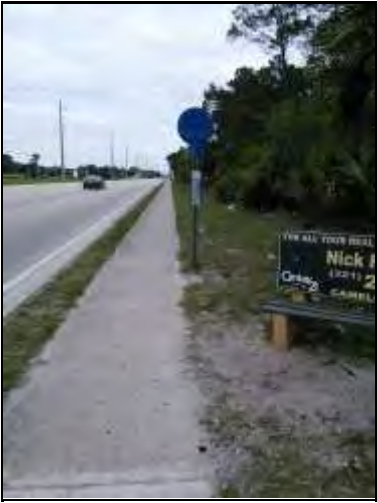
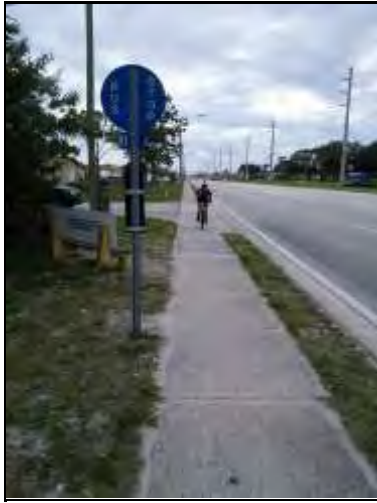
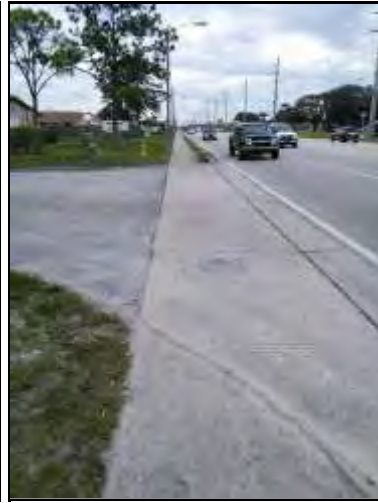
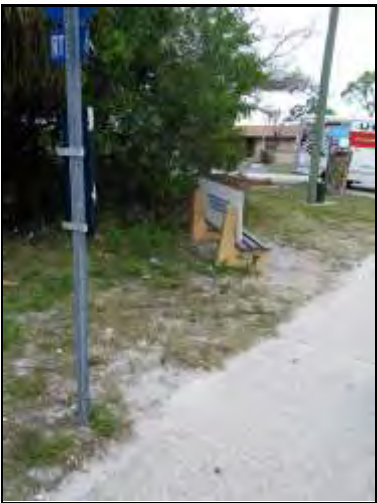
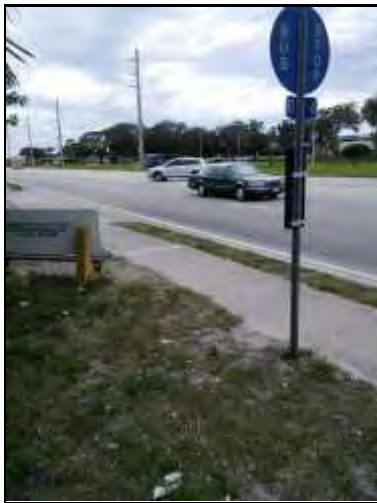
**Location:** CLEARLAKE RD & BCC **ID:** 25

**Is the B&A Safe:** Yes **B&A Condition:** Surface not firm, stable, or slip r

**Detectable Warning:** No **Detectable Warning Condition:**

**Recommendations:** Move the bus stop ~900' south. Pave a level 5'x2' slab between the curb and sidewalk and a level 5'x1' slab behind the sidewalk to complete a 5'x8' B&A area. Move the bench so that it is flush with the edge of the sidewalk and outside of the B&A area. Add detectable warnings to the nearby curb ramps.

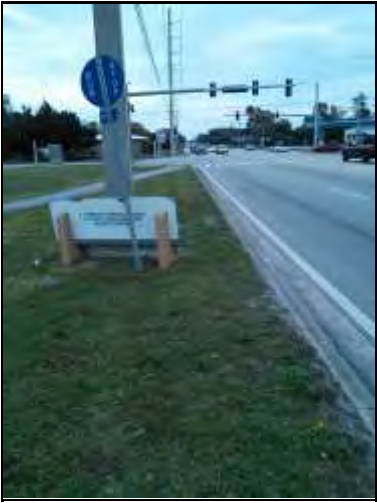
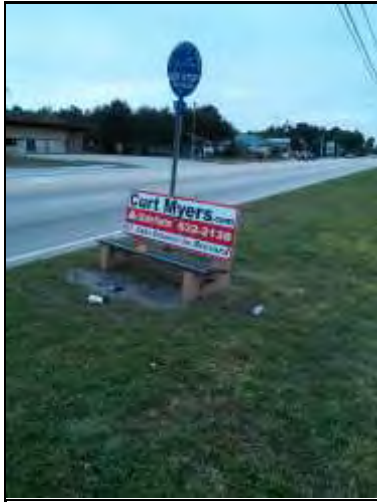
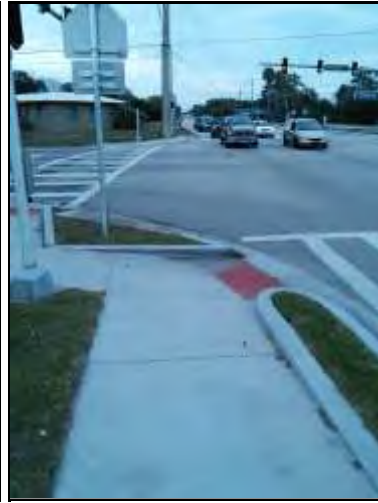
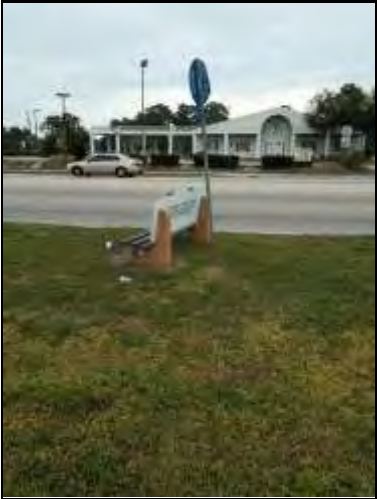
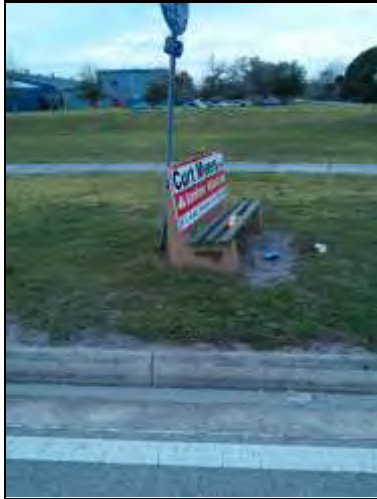
**Location:** CLEARLAKE RD & MICHIGAN AVE **ID:** 576

**Is the B&A Safe:** Yes **B&A Condition:** Surface not firm, stable, or slip r

**Recommendations:** Move the stop 50' north. Pave a level 5'x8' slab for the B&A area and connect to the existing sidewalk. Move the bench and schedule so they are flush with the edge of the sidewalk and outside of the B&A area.

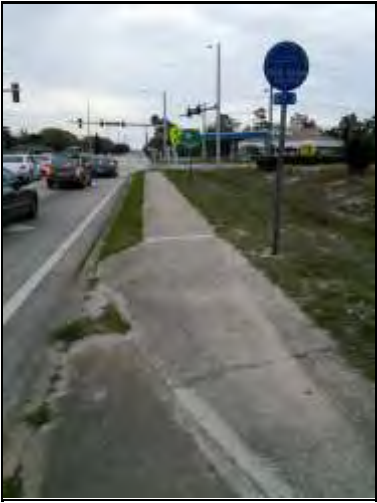
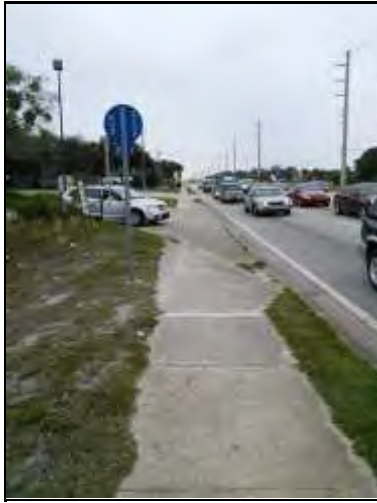
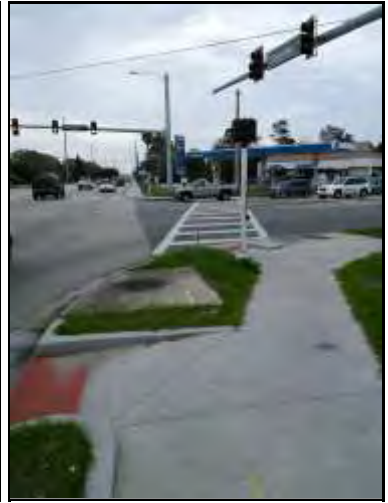
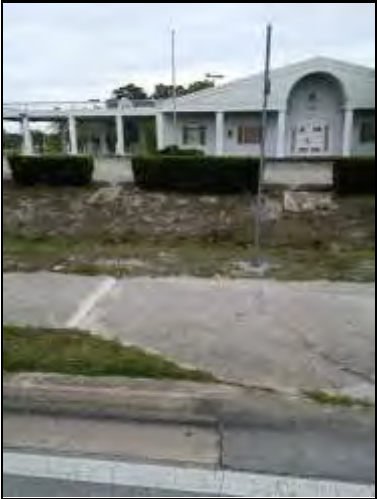
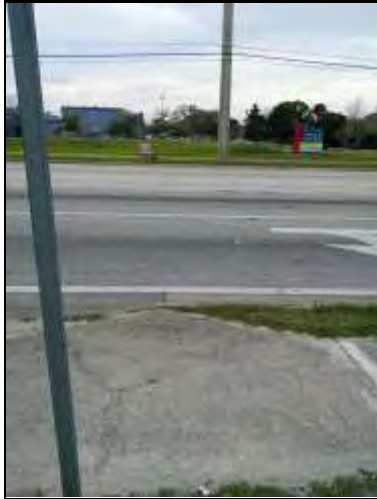
**Location:** CLEARLAKE RD & MICHIGAN AVE **ID:** 580

**Is the B&A Safe:** Yes **B&A Condition:** Surface not firm, stable, or slip r

**Recommendations:** Move the stop 30' north. Pave a level 5'x2' slab between the curb and sidewalk and a level 5'x1' slab behind the sidewalk to complete a 5'x8' B&A area.
