ROAD SAFETY AUDIT

Emerson Drive/Minton Road/Palm Bay Road from Jupiter Boulevard to Culver Drive

July 2016

Project Title: Emerson Drive Road Safety Audit

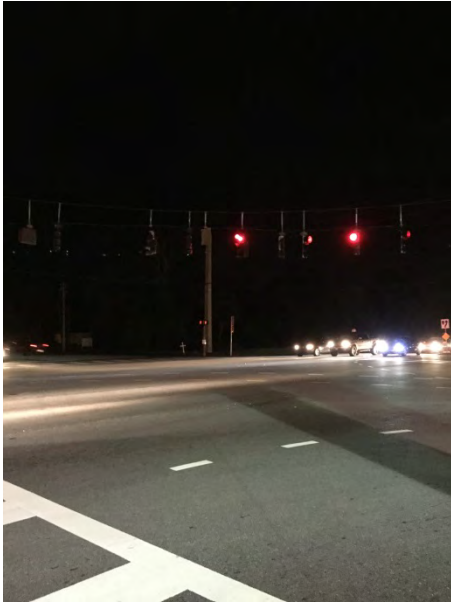
Figure 17

- Emerson Drive/Jupiter Boulevard: Southwest corner
- Emerson Drive/Park and Ride Lot: Southeast corner
- Emerson Drive/Minton Road: Northwest and southwest corners, northwest corner has ambient lighting from CVS (**Figure 17** looking at the southeast corner)
- Minton Road/Palm Bay Road: No intersection lighting (**Figure 18** looking at southwest corner)
- Palm Bay Road/Athens Drive: No intersection lighting
- Palm Bay Road/Culver Drive: No intersection lighting

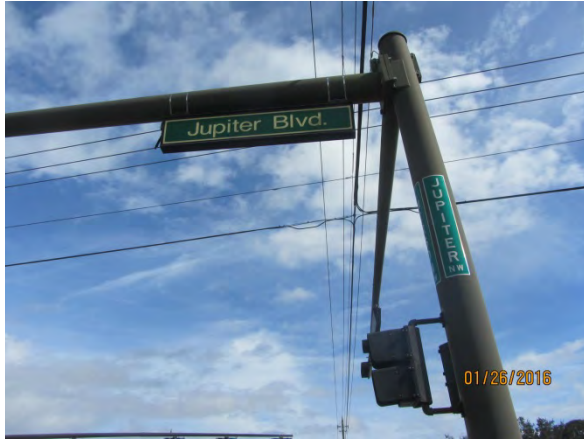
Figure 21

Street name signage types and sizes at signalized intersections are inconsistent along the study corridor. At some intersections such as Emerson Drive/Jupiter Boulevard, overhead street name signage is present on one side (**Figure 21**) but not the other (**Figure 22**). The Emerson Drive/Minton Road intersection does not have any hanging street name signs, only signs mounted on posts at the corners of the intersection as displayed in **Figure 23**. Minton Road/Palm Bay Road has street name signage mounted on the mast arm as displayed in **Figure 24**.

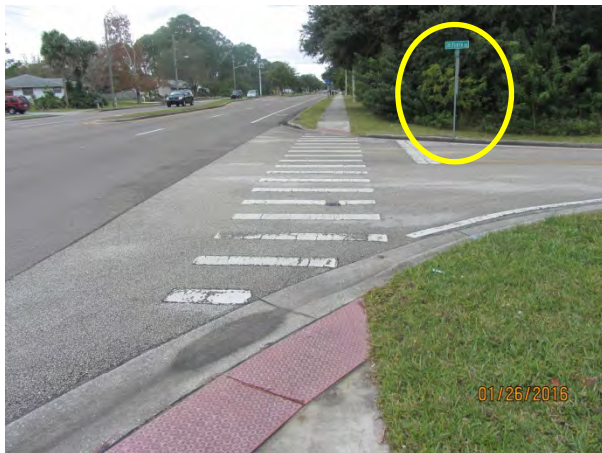
Figure 25

- Street name signage is mounted on stop signs but the stop signs are set back from intersection, making it difficult to see the street signage from Emerson Drive (**Figure 25**)
- At some three leg intersections, street name signage is located on the side of the roadway with no leg in addition to on the stop sign for the minor street leg. Some of the opposite side street name signs are located at three-leg intersections where no median opening is present, rendering the signage ineffective (**Figure 26**).
- The street name signage retro-reflectivity was poor.

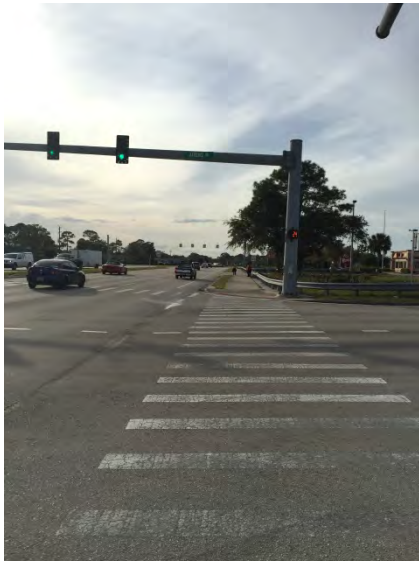
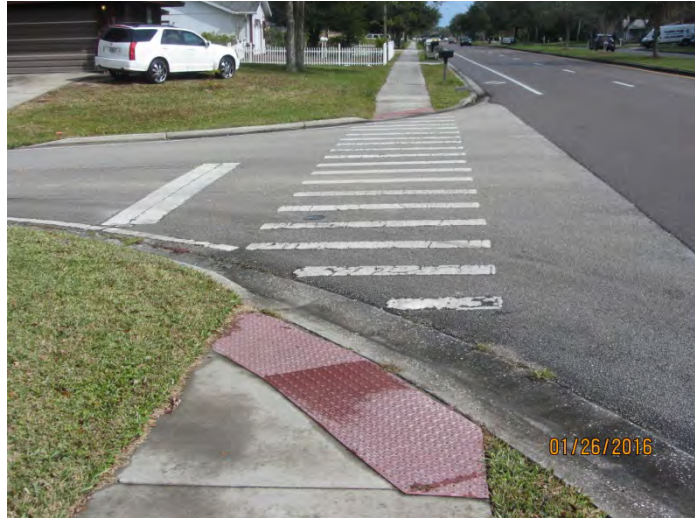
Crosswalk markings at signalized intersections, minor street intersections, and driveways along the study corridor are wearing and fading. In most cases, crosswalk markings at these locations are striped with old special emphasis markings, as illustrated in **Figure 27** and **Figure 28**. Five of the nine pedestrian/bicycle crashes along the study corridor occurred within marked crosswalk areas either at signalized intersections or at minor streets/driveways with a marked crosswalk.

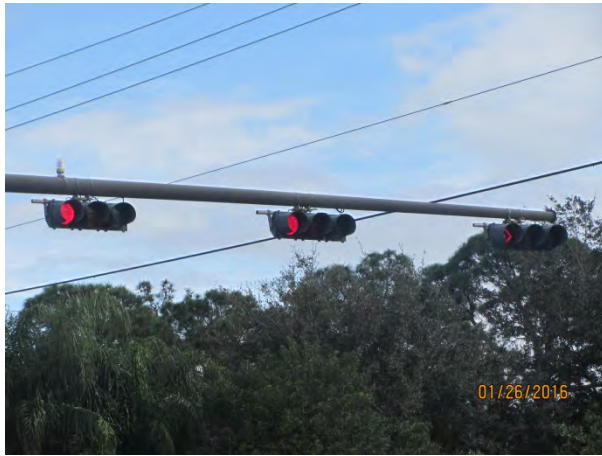
Figure 29

The study team observed signals missing signal head backplates at Emerson Drive/Jupiter Boulevard (**Figure 29**), Emerson Drive/Park and Ride Lot, Emerson Drive/Minton Road, and Minton Road/Palm Bay Road (**Figure 30**). Rear-end crashes at the signalized intersections accounted for 399 of the 440 crashes (91 percent) along the entire study corridor.

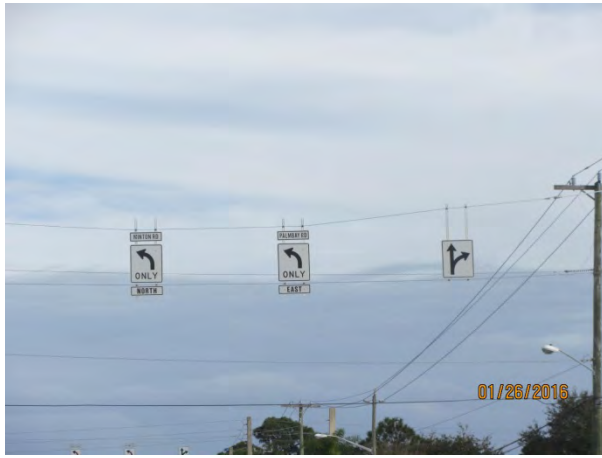
Figure 32

drivers what lane they need to be in depending on where they need to travel. For example, the rightmost eastbound left-turn lane sign says “Palm Bay Road East” informing drivers they need to pre-position themselves in that lane if they want to go east on Palm Bay Road. The wording on these signs is small and the driver cannot read the roadway names until they are practically under the sign (Figure 32).

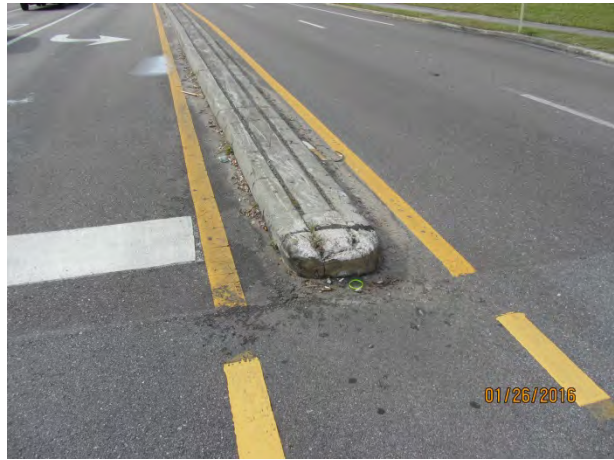
Figure 33

- The median nose on the west leg between the eastbound left-turn and westbound through lanes has been damaged (Figure 33). There is no “Keep Right” signage for the median nose to alert drivers of the raised separation.

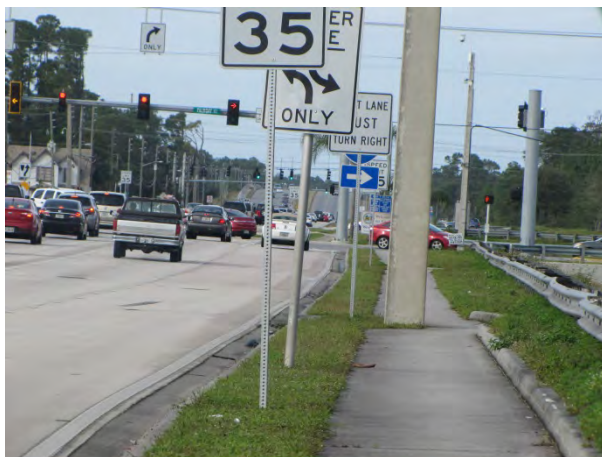
Figure 34

- Along Minton Road between Emerson Drive and Palm Bay Road, sign pollution is present on the east side of roadway making it difficult to discern which signs are important (Figure 34). There are numerous ground mounted signs and three sets of overhead signs within the 1,200 feet between signals.

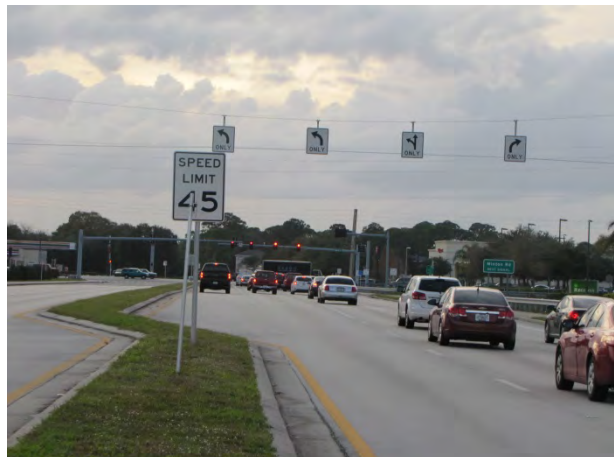
Figure 35

- The overhead lane designation signage westbound along Palm Bay Road does not have street name signage similar to what is being provided along Emerson Drive. Also, only one set of overhead signs are present approximately 800 feet east of the Minton Road/Palm Bay Road intersection (Figure 35).

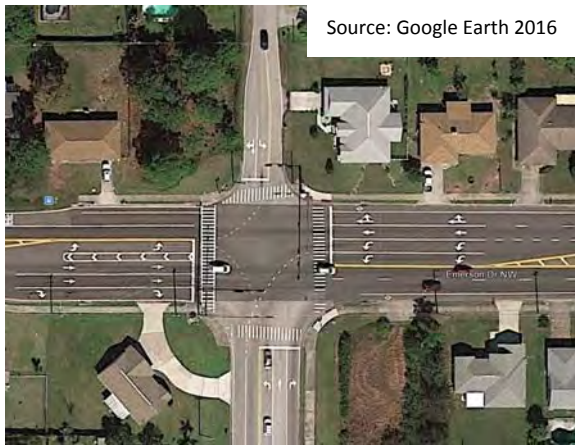
Figure 36

Emerson Drive has been recently resurfaced, as displayed in **Figure 36**, but the Jupiter Boulevard legs of the intersection were not resurfaced during this project. A rain storm passed through the study area before the afternoon field review. During the field review, the study team observed vehicles losing traction and sometimes skidding on the wet pavement along Jupiter Boulevard. The study team also observed a vehicle making a westbound left-turn to go south on Jupiter Boulevard lose control and crash into the speed limit sign (**Figure 37**). On the south leg, three (3) of the seven (7) crashes occurred under wet pavement conditions. Worn pavement can be a contributing factor in crashes during wet conditions.

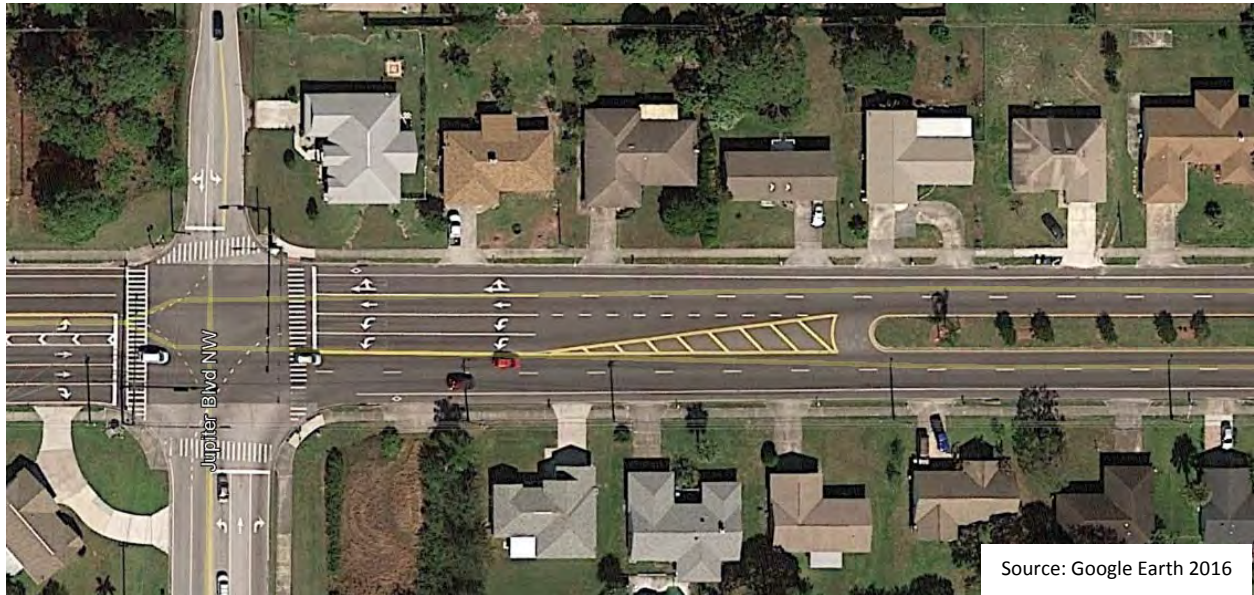
Figure 40

The current westbound left-turn lanes (displayed in **Figure 40**) are approximately 125 feet long, not including the taper. A westbound U-turn is located just east of the start of the westbound left-turn lanes. During the PM peak hour field review, the study team observed queuing from the left-turn movement extending into the westbound through lanes along Emerson Drive.

Function	Classification	Reasoning
Exposure	Category III	High westbound left-turn volume observed during PM peak hour
Probability	Category I	No crashes reported due to this issue
Consequence	Category II	Potential for PDO to minor injury rear-end and sideswipe crash types
<i>Overall</i>	<i>Category II</i>	-

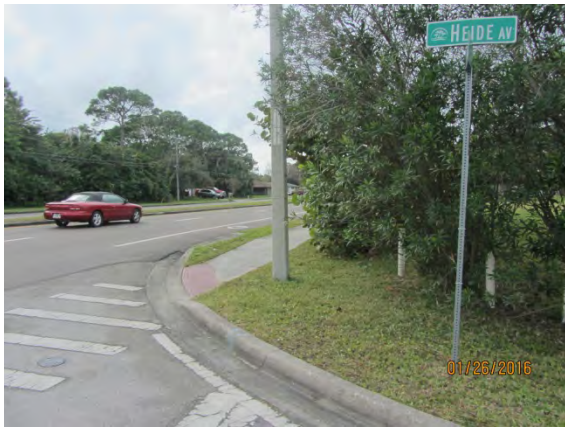
Figure 47

- Hoff Place northbound looking westbound.
- Coberg Avenue southbound looking westbound.
- Stadt Road northbound looking westbound.
- Heide Avenue southbound looking westbound (**Figure 47**).
- Ulm Road northbound looking westbound.
- Olden Avenue southbound looking westbound (**Figure 48**).

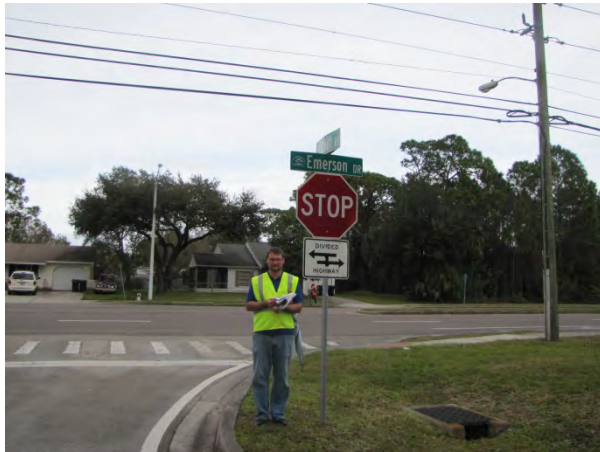
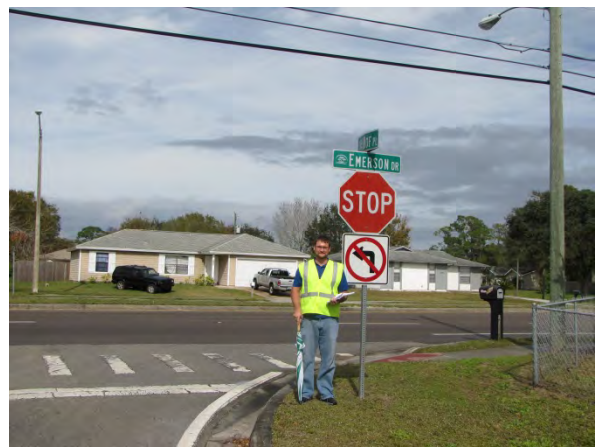
The intent of the RSA is to consider safety for all user groups based on both crash data and risk factors. There may not be crash data supporting the noted design deficiencies, but the RSA team conducted a risk-based assessment and identified locations to address potential safety issues based on risk. At minor streets along Emerson Drive, the study team observed stop signs mounted less than 7 feet and secondary signs underneath the stop sign mounted less than 6 feet above the edge of the travel way (**Figure 49** and **Figure 50**). Section 2A.18 of the MUTCD states that the minimum height of the primary sign should be 7 feet above the travel way and the secondary sign should be mounted one foot less than the 7 feet height.

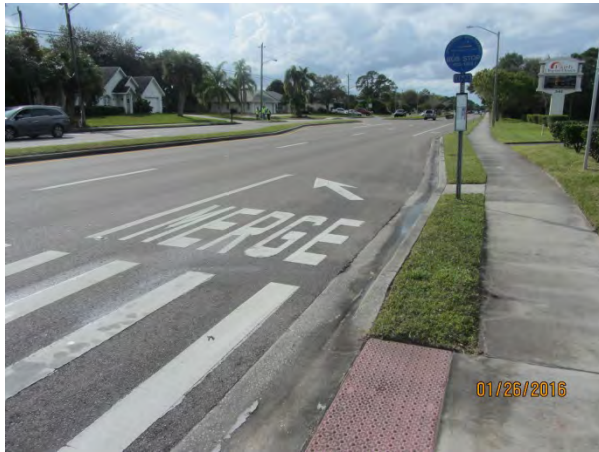
Figure 51

- The intersection was designed for far side bus pullouts (**Figure 51** displays the westbound stop) but only the westbound bus pullout is being utilized. This leaves extra pavement on the far side of the intersection in the eastbound direction.
 - The bus pullout for the westbound bus is not long enough, causing the bus to stop on the west leg crosswalk.
- The guide signs along the corridor point to the south side parking lot as the official park and ride lot but the bus stop is located on the north side of the roadway in the westbound direction (**Figure 52**).

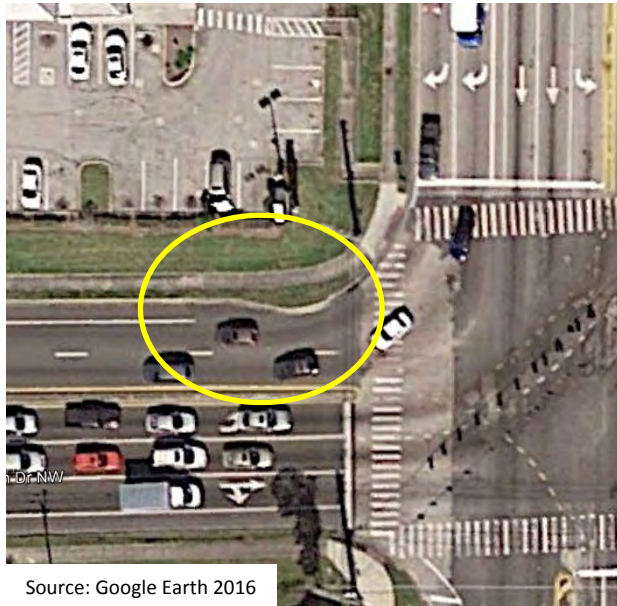
Figure 53

The northwest corner of the intersection has a small radius due to a small tangent section leading to a bulb out for the bicycle lane addition (**Figure 53**). The study team observed multiple vehicles in the inside right-turn lane crossing over the guide striping into the area designated for the outside right-turn lane as displayed in **Figure 54**. Twenty-five (25) sideswipe crashes occurred between southbound right-turning vehicles around this curve.

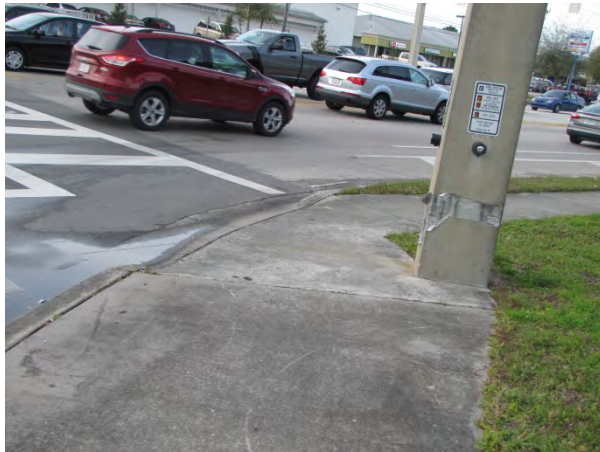
Figure 55

The intent of the RSA is to consider safety for all user groups based on both crash data and risk factors. There may not be crash data supporting the noted design deficiencies, but the RSA team conducted a risk-based assessment and identified locations to address potential safety issues based on risk. The study team observed missing detectable warning surfaces on the northeast (**Figure 55**) and southeast (**Figure 56**) corners of the intersection.

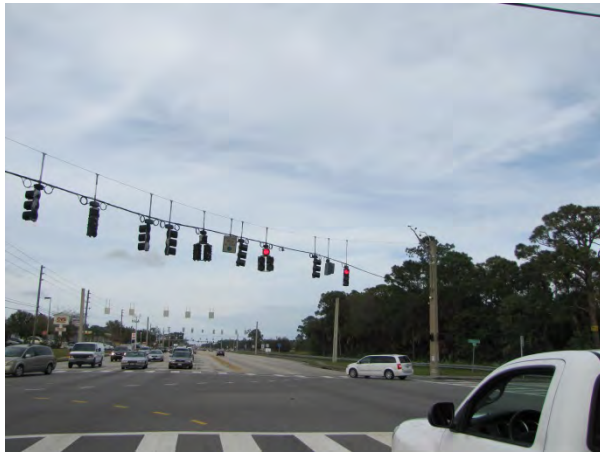
Figure 57

The northbound left-turn movement has protected/permmissive signal phasing (i.e., 5-section doghouse signal head) as displayed in **Figure 57**. The permmissive phase of the movement is allowed during the protected southbound right-turn phase, leading to possible turning vehicle conflicts as observed in **Figure 58**. During the permmissive phase, the northbound left-turn driver is having to process information regarding the southbound through vehicles and their speed along with if there are one or more right-turning vehicles. There have been seven crashes involving northbound left-turning vehicles and southbound through/right-turning vehicles.

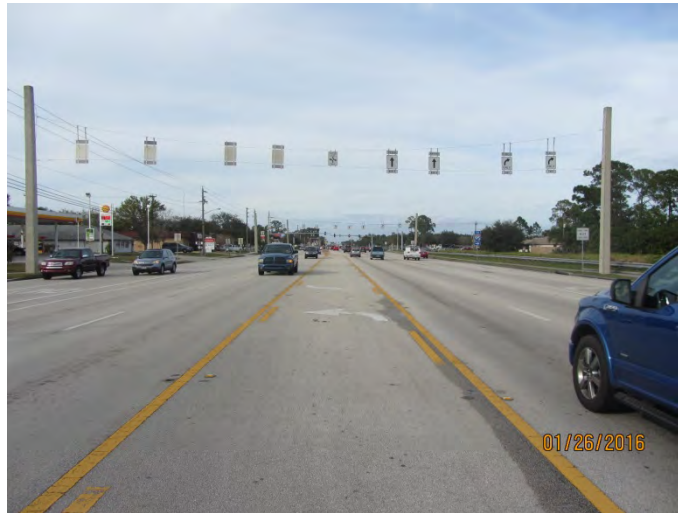
Figure 64

The roadway segment along Minton Road between Emerson Drive and Palm Bay Road is nine lanes wide with two 5-foot wide bicycle lanes between the through lanes and the right turn lanes (**Figure 64**). Two northbound/southbound through lanes, two northbound/southbound right-turn lanes, along with a TWLTL make up the cross section of this segment. With the open access, vehicles are allowed to turn left to/from the properties along the west side of the corridor across four or more lanes of travel. Nine crashes occurred between left turning vehicles to/from the properties and southbound traveling vehicles.

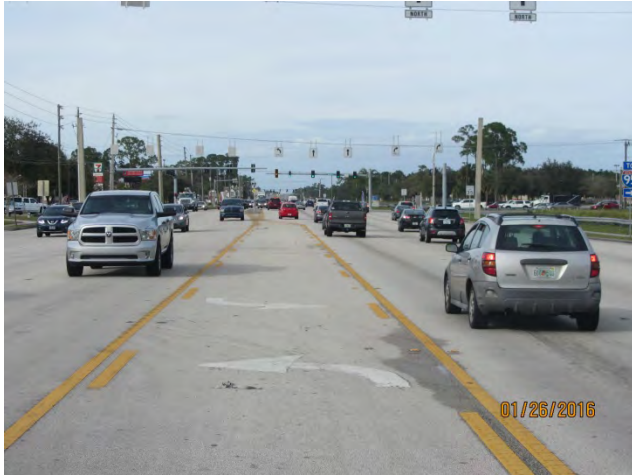
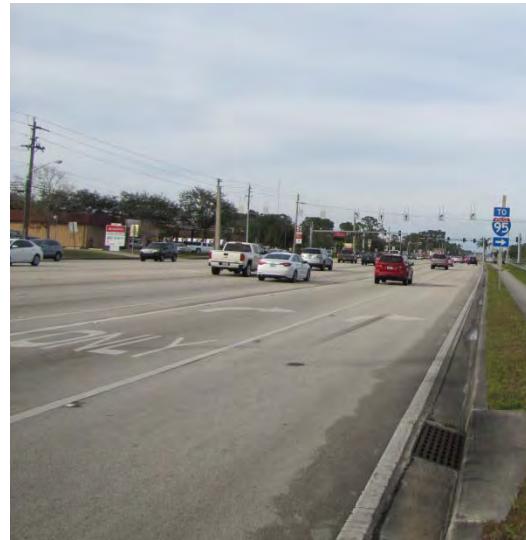
Pavement markings along the Minton Road section from Emerson Drive to Palm Bay Road are wearing and fading (**Figure 65** and **Figure 66**). This may possibly contribute to rear-end and sideswipe crashes both along this segment and at the signalized intersections of Emerson Drive/Minton Road and Minton Road/Palm Bay Road. Crosswalk markings at the Minton Road/Palm Bay Road signalized intersection are striped with old special emphasis markings and are beginning to wear (**Figure 67**). In the case of the west leg of the Minton Road/Palm Bay Road intersection, the lane markings are faded to a point the driver cannot tell which lane corresponds to which movement (**Figure 68**).

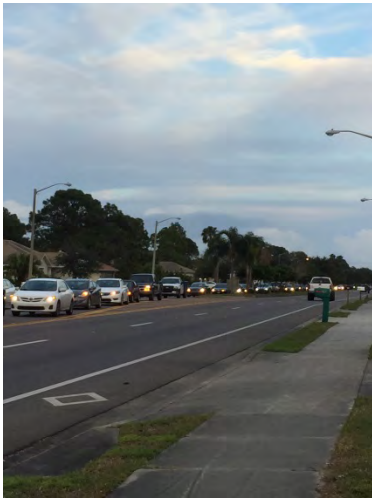
Figure 69

- AM Peak Hour –
 - Northbound and eastbound (**Figure 69**) at the Emerson Drive/Minton Road intersection.
- PM Peak Hour –
 - Southbound at Minton Road/Palm Bay Road intersection (**Figure 70**).
 - Westbound along Palm Bay Road.

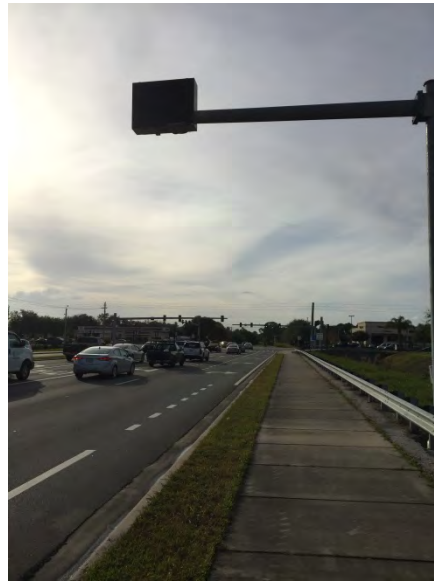
Figure 71

The intent of the RSA is to consider safety for all user groups based on both crash data and risk factors. There may not be crash data supporting the noted design deficiencies, but the RSA team conducted a risk-based assessment and identified locations to address potential safety issues based on risk. While out on the RSA, the study team noted a dynamic message sign (DMS) facing the westbound direction of travel along Palm Bay Road approximately 350 feet east of the Minton Road/Palm Bay Road intersection that was not working (**Figure 71**). This DMS is in a great position to display some type of warning/public service announcement about crash statistics before turning onto Minton Road, where a combined 430 of the 735 crashes occurred during the study period.

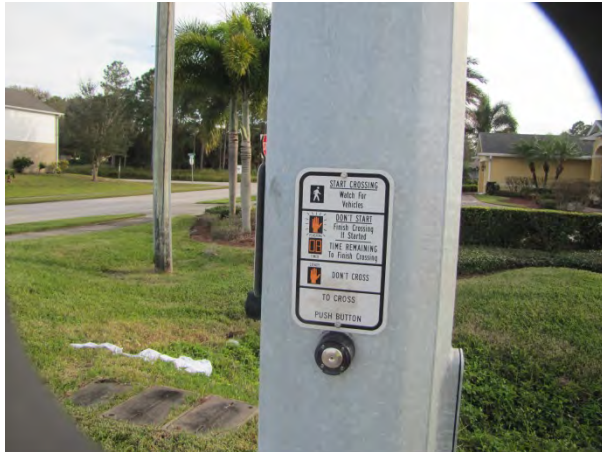
Figure 72

The intent of the RSA is to consider safety for all user groups based on both crash data and risk factors. There may not be crash data supporting the noted design deficiencies, but the RSA team conducted a risk-based assessment and identified locations to address potential safety issues based on risk. The pedestrian push button signage at the intersection does not have street names to identify which pedestrian detectors pertain to which crossing (**Figure 72**). The pedestrian detectors on the south side of the roadway are mounted to the traffic signal poles which are placed greater than 10 feet from the curb ramp for the crosswalk, the maximum distance as defined in Section 4E.08 of the MUTCD. Also, no sidewalk is present on the north leg into the development on the north side of Palm Bay Road (**Figure 73**).

Consider installing R10-3i pedestrian plaques at all push button locations indicating which pedestrian detectors pertain to which crossing. Also consider installing separate push button poles that are less than ten feet from the pedestrian curb ramp on the southwest and southeast corners of the

intersection. Consider working with the County and the property owner to review the feasibility of a sidewalk along one side of Athens Drive north of the intersection. Providing an accessible pedestrian route to/from the property is important in keeping pedestrians/bicyclists safe when they leave the Palm Bay Road right-of-way.

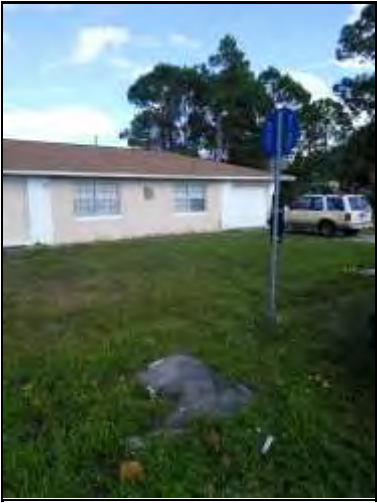
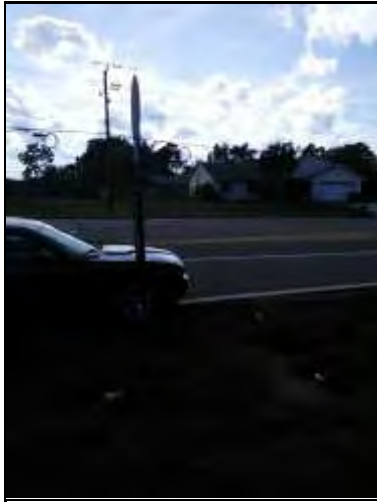
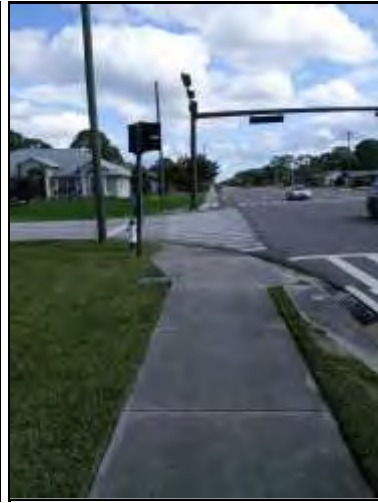
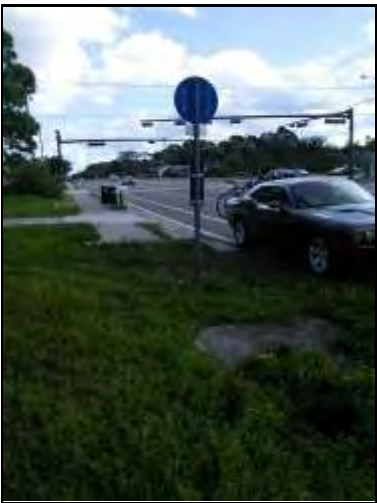
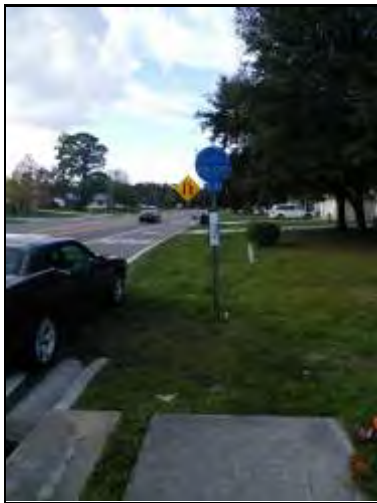
Is the B&A Safe: Yes **B&A Condition:** Surface not firm, stable, or slip r

Detectable Warning: **No** **Detectable Warning Condition:**

Recommendations: Move the stop 60' east. Pave a level 5'x3' slab between the curb and sidewalk to create a 5'x8' B&A area. Add detectable warnings to the nearby curb ramps. Make sure the pole with the bus schedule is located adjacent to the pavement so it is accessible.

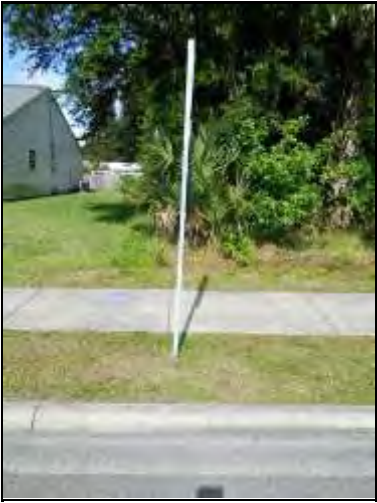
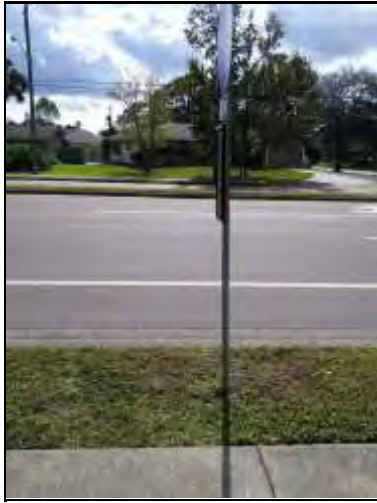
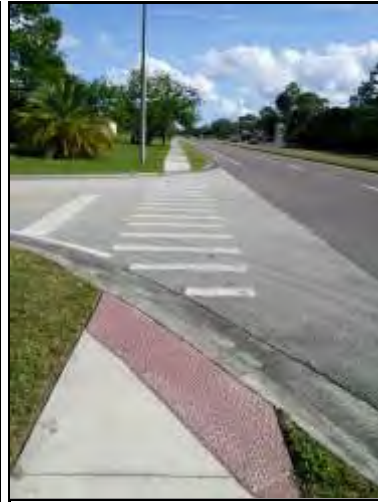
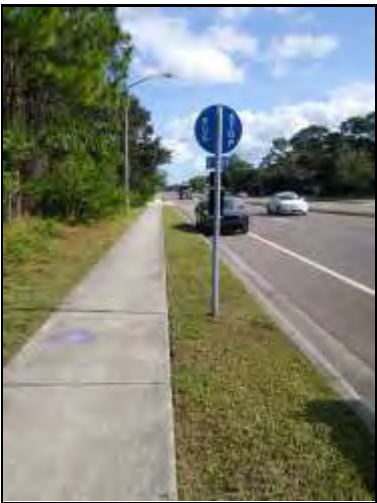
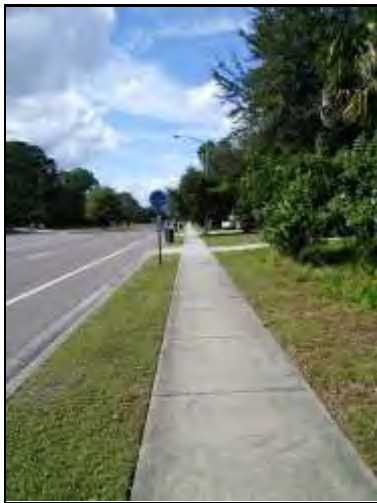
Is the B&A Safe: Yes **B&A Condition:** Surface not firm, stable, or slip r

Recommendations: Pave a level 5'x4' slab between the curb and sidewalk to complete a 5'x8' B&A area. Make sure the pole with the bus schedule is located adjacent to the pavement so it is accessible.

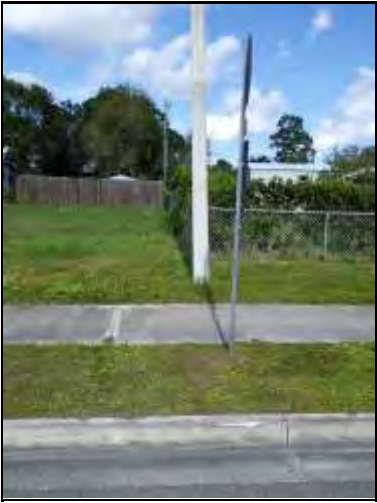
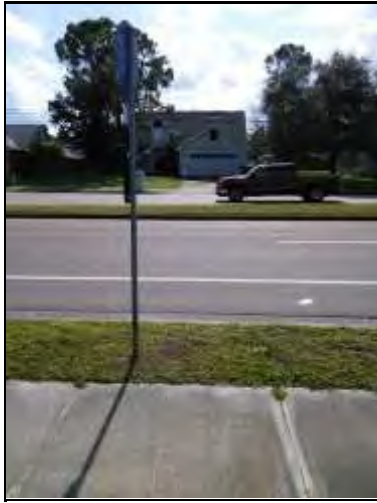
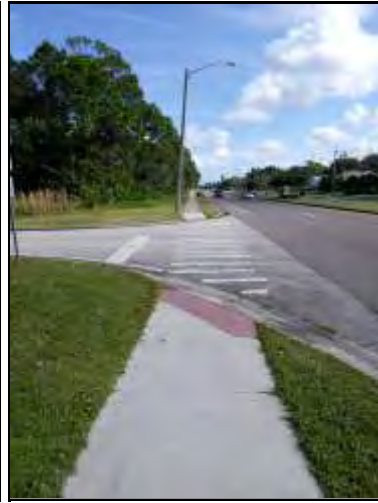
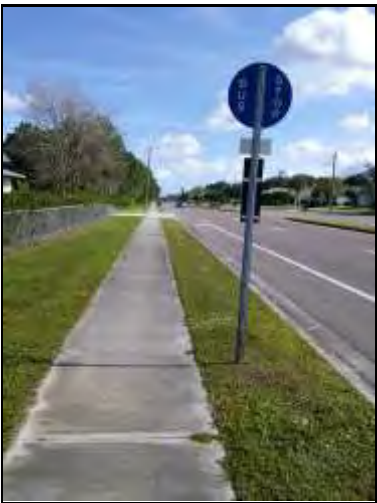
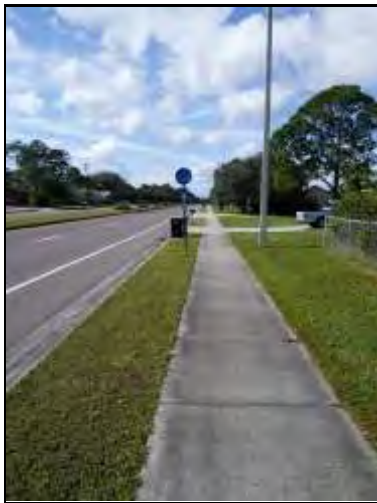
Is the B&A Safe: Yes **B&A Condition:** Surface not firm, stable, or slip r

Recommendations: Pave a level 5'x4' slab between the curb and sidewalk to complete a 5'x8' B&A area. Make sure the pole with the bus schedule is located adjacent to the pavement so it is accessible.

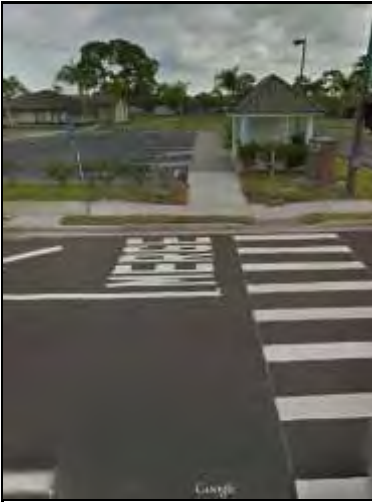
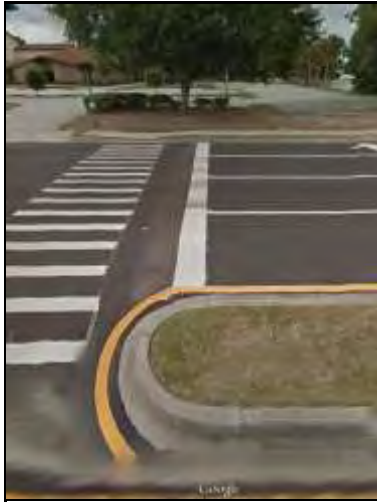
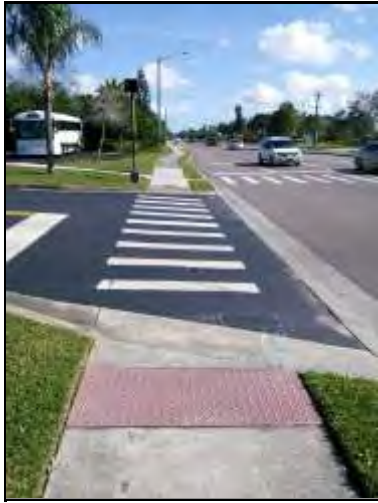
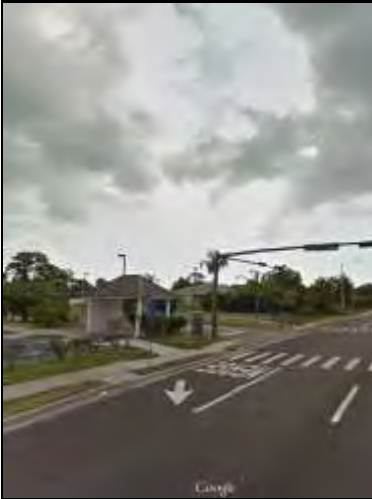
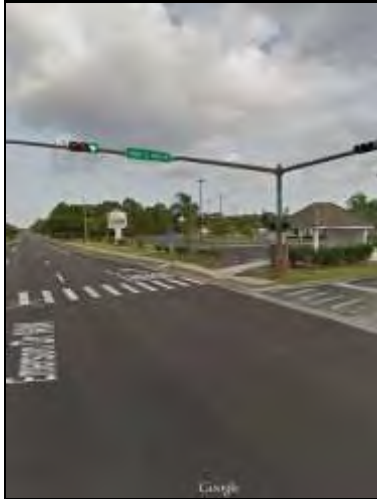
Is the B&A Safe: Yes **B&A Condition:** No defects

Recommendations: Resurface the B&A area to have a cross slope of <=2%. Move the pole with the bus schedule adjacent to the pavement on the far side of the B&A area.

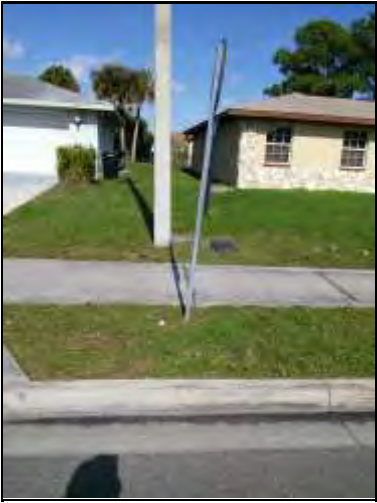
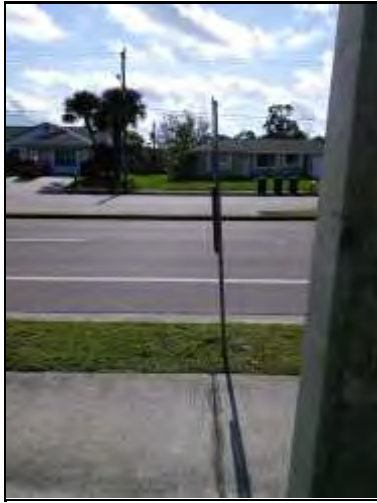
Location: NE EMERSON DR & TILBERG AVE **ID:** 364

Is the B&A Safe: Yes **B&A Condition:** Surface not firm, stable, or slip r

Recommendations: Pave a level 5'x4' slab between the curb and sidewalk to complete a 5'x8' B&A area. Make sure the pole with the bus schedule is located adjacent to the pavement so it is accessible.

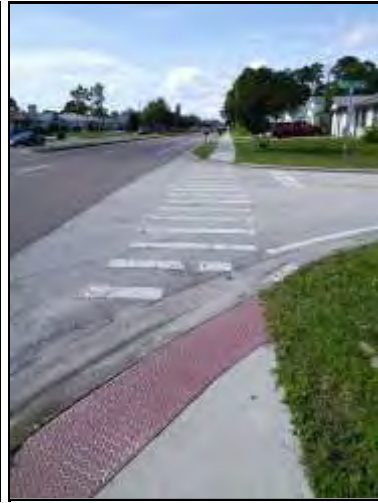
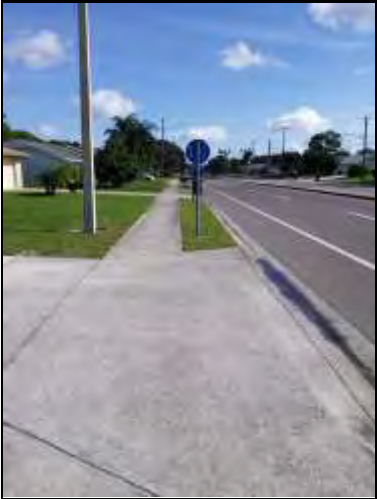
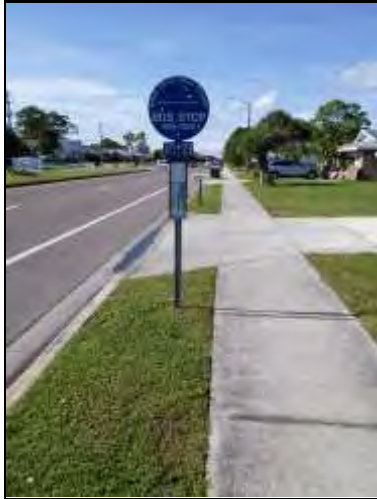
Location: NW MINTON RD & EMERSON DR **ID:** 403

Is the B&A Safe: Yes **B&A Condition:** Surface not firm, stable, or slip r

Recommendations: Pave a level 5'x4' slab between the curb and sidewalk to complete a 5'x8' B&A area. Make sure the pole with the bus schedule is located adjacent to the pavement so it is accessible.
