ROAD SAFETY AUDIT

Malabar Road from Jupiter Boulevard to Minton Road and Emerson Drive to San Filippo Drive

June 2016

Project Title: Malabar Road Safety Audit

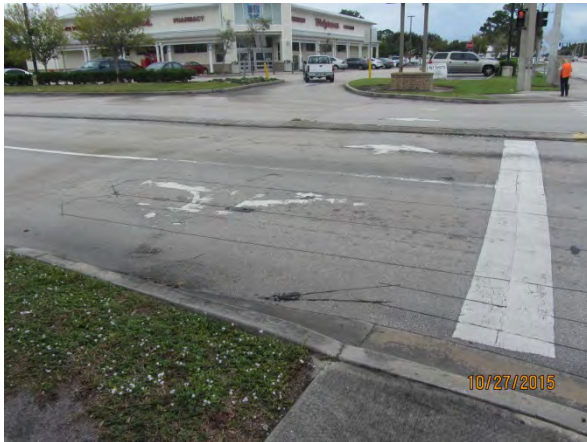
Figure 29

Pavement markings along the corridor are wearing and fading. In some cases, the lane markings are faded to a point the driver cannot tell which lane corresponds to which movement (**Figure 29**). Crosswalk markings at the signalized intersections along the corridor are striped with old special emphasis markings and are beginning to wear, as illustrated in **Figure 30**. Ten of the 16 bicycle crashes along the corridor occurred at signalized intersections with the bicycle located in the marked crosswalk. Crosswalk markings across minor streets and driveways (**Figure 31**) are faded as well as lane markings in the roadway (**Figure 32**).

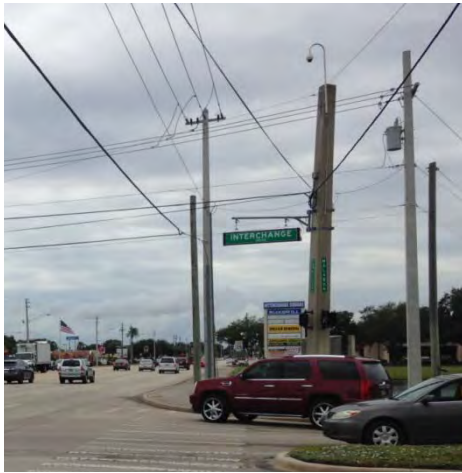
Figure 35

Street name signage types and sizes at signalized intersections are inconsistent along the study corridor. At some intersections such as San Filippo Drive/Interchange Drive (**Figure 35**), interior illuminated street signage is present while at other intersections such as the Palm Bay West Plaza Entrance (**Figure 36**), the street name signage is not interior illuminated.

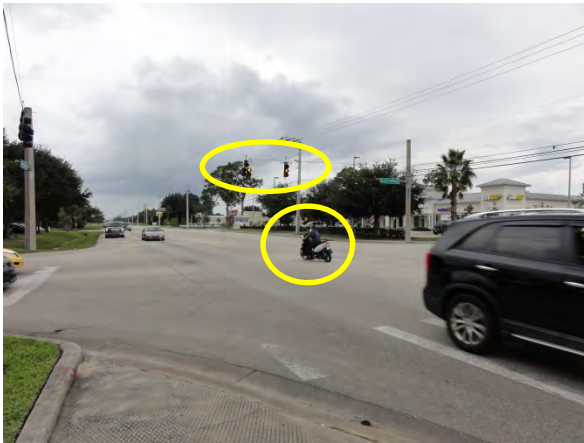
Figure 37

- 1 crash each between eastbound left/westbound through and westbound left/eastbound through movements
- All left-turn movements at Palm Bay West Plaza Entrance (**Figure 37**) – no left-turn crashes

In the near term, consider replacing “doghouse” five-section signal displays with 4-section flashing yellow arrow (FYA) protected/permissive left-turn display for the left-turn movements noted above. If the left-turn phasing is converted to a FYA display, consider providing protected only left-turn phasing during peak periods and allow the protected-permissive phasing during the off-peak periods. Even though some of the left-turn phases noted on the previous page do not have associated crashes, the FYA display should be applied corridor wide for corridor consistency and driver expectancy.

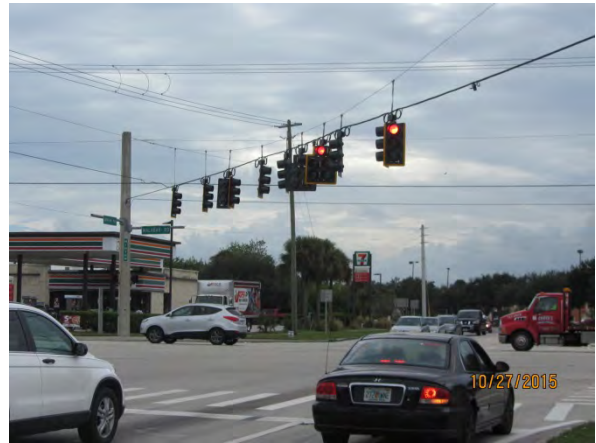
Figure 38

- Northbound and southbound (**Figure 38**) left-turn movements at Minton Road –
 - 10 crashes between southbound left/northbound through movements
- Northbound and southbound left-turn movements at Emerson Drive –

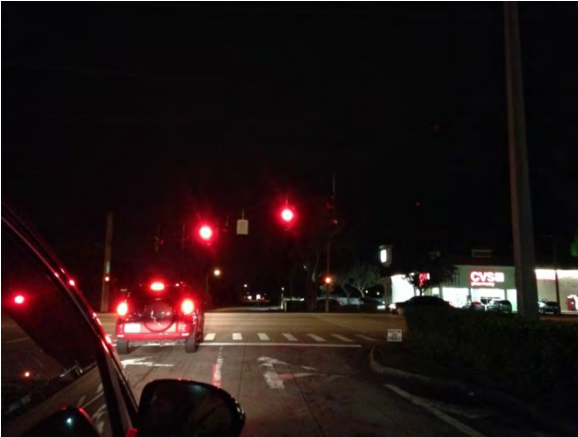
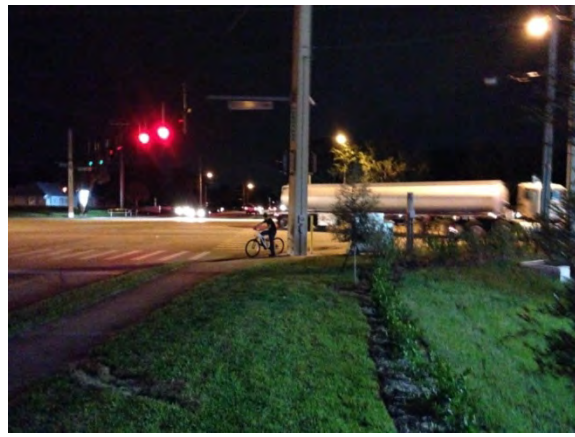
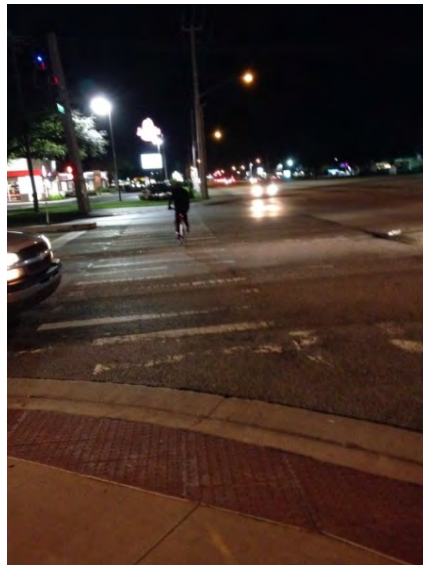
In total, 24 percent of crashes at these seven intersections occurred under non-daylight lighting conditions.

In the near term, consider upgrading the lighting at the signalized intersections to meet the requirements of section 7.3.2.2 in Volume 1 of the FDOT Plans Preparation Manual (PPM). This may require the existing lighting to be replaced. Lighting the intersection may reduce the number of night time crashes and will make pedestrians utilizing the crosswalk more visible.

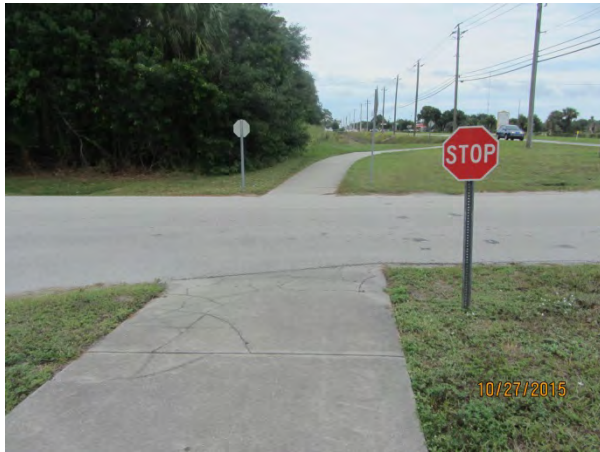
Figure 48

- Missing crosswalk markings at sidewalk/trail crossings on north side of roadway (**Figure 48**).
- Missing stop bars and double yellow striping along the minor street approaches (**Figure 49**).
- Brush/shrubbery causing intersection sight distance issues (**Figure 50**).
- Stop signs were placed far back from the roadway, leading to sight distance issues and drivers not stopping at the stop sign location (**Figure 51**).

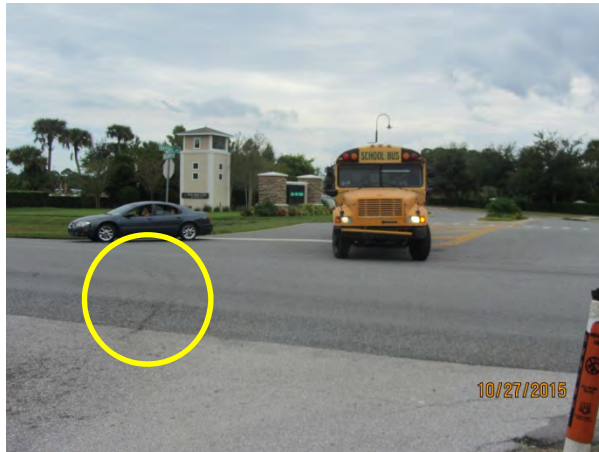
Figure 53

Over the course of multiple resurfacing projects along the Malabar Road West Segment, an asphalt lip has been created between Malabar Road and the minor streets as displayed in **Figure 53** and **Figure 54**. The study team observed where vehicles had scraped the bottom of their cars on the lip (**Figure 53**). In addition to the lip, a noticeable grade was also present along minor streets leading up to intersections with Malabar Road. This issue creates possible rear-end conflicts with slow turning vehicles from Malabar Road and vehicles approaching from behind.

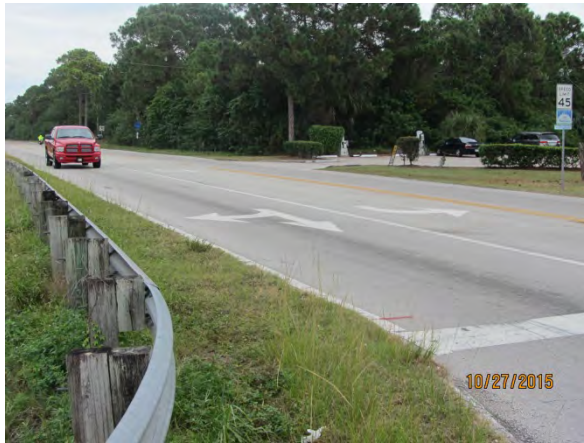
Figure 55

Westbound rear-end crashes accounted for 17 of the 32 (53 percent) rear-end crashes and 27 percent of the total crashes at the Jupiter Boulevard intersection. As displayed in **Figure 55**, the outside lane for the westbound approach is a shared through/right-turn lane. No signal head backplates are installed at the intersection (**Figure 56**).

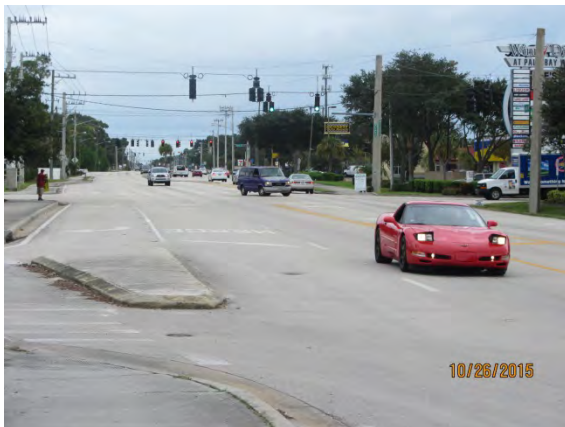
Figure 67

Just west of the Palm Bay Plaza Entrance signal, the westbound lanes reduce from two to one within a 500' long merge area, as displayed on **Figure 66** and **Figure 67**. Prior to the Palm Bay West Plaza Entrance, a RIGHT LANE ENDS sign (**W9-1**) is located just west of the Minton Road intersection, a LANE ENDS MERGE LEFT sign (**W9-2**) is located just west of the road that runs on the east side of Walgreens, and a lane merge sign (**W4-2**) is located just east of the Plaza Entrance intersection (**Figure 68**). With these signs in place, the study team observed the driver behavior during the AM and PM peak hour and noted the outside westbound through lane that merges with the inside through lane was being used by one to two vehicles per cycle. The study team observed most of the westbound vehicles utilizing the inside westbound through lane. The few vehicles utilizing the merge lane were observed accelerating at a faster rate of speed to cut in front of vehicles in the non-merging lane. This situation creates a conflict with vehicles attempting to exit the Dollar General driveway because they may not notice the merging vehicle is traveling at a faster speed than the non-merging vehicles. Two sideswipe crashes occurred in the westbound direction, one before and one after the Palm Bay West Plaza Entrance.

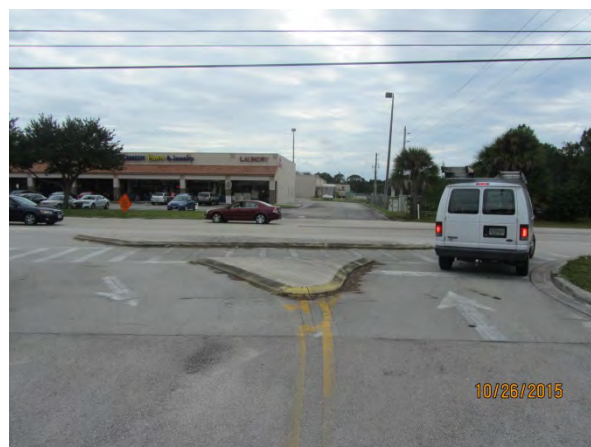
Figure 69

Vehicles were also observed making an eastbound left-turn into the Coral Bay Shopping Center where that entrance is limited to a right-in/right-out configuration with the porkchop island on the north leg (**Figure 69** looking south at island).

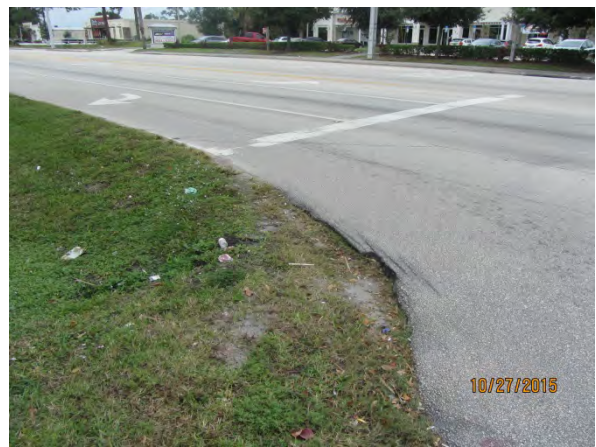
Figure 73

The intent of the RSA is to consider safety for all user groups based on both crash data and risk factors. There may not be crash data supporting the noted design deficiencies, but the RSA team conducted a risk-based assessment and identified the locations to address potential safety issues based on risk. If a sidewalk is constructed on the south side of Malabar Road (**Figure 72**) as noted in **Issue #17: Sidewalk Connection**, the southwest corner of the Palm Bay West Plaza Entrance intersection would need to be reconstructed to add pedestrian facilities (**Figure 73**).

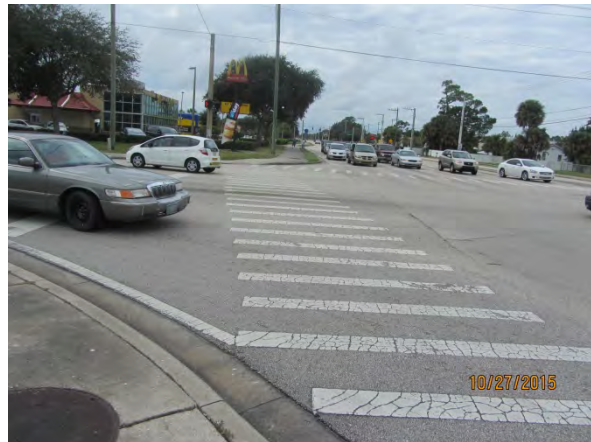
Figure 75

The intent of the RSA is to consider safety for all user groups based on both crash data and risk factors. There may not be crash data supporting the noted design deficiencies, but the RSA team conducted a risk-based assessment and identified the locations to address potential safety issues based on risk. At the Minton Road intersection (**Figure 74**), the south leg crosswalk is skewed and does not align with the curb ramp on the southeast corner of the intersection (**Figure 75**). The west leg crosswalk is also skewed slightly to align with the curb ramp in the northwest corner of the intersection. The pedestrian is walking longer distances across the west and south legs due to the skew of these crosswalks. One bicycle crash occurred within the south leg crosswalk.

Consider realigning the south and west leg crosswalks to be more perpendicular with Minton Road and Malabar Road. This would require constructing new curb ramps on the northwest, southwest, and southeast corners for those two crosswalks. As part of this project, consider installing new push button poles on the northwest, southwest, and southeast corners having pedestrian detectors that are parallel

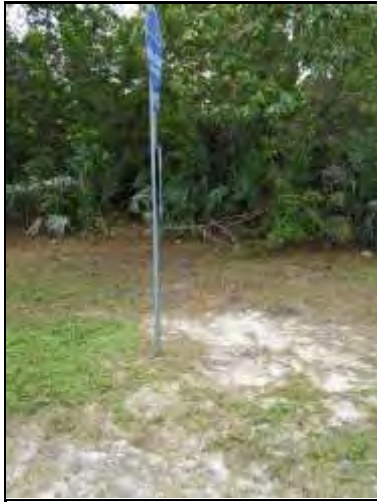
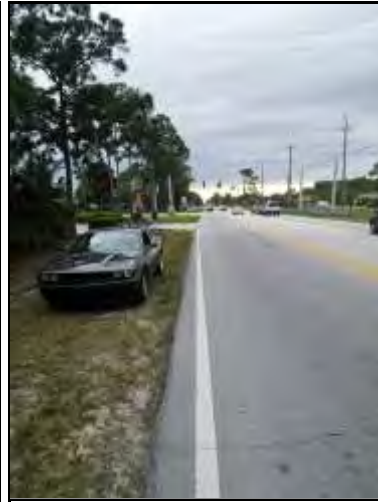
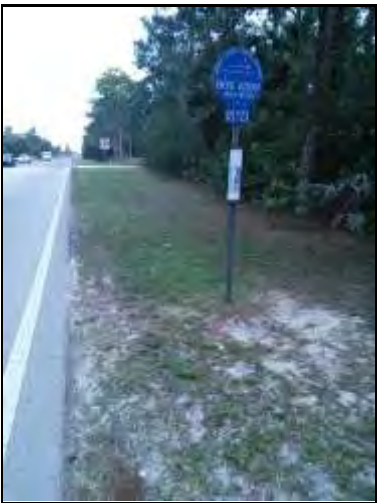
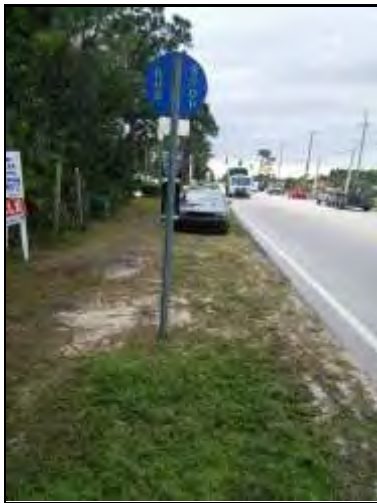
Is the B&A Safe: Yes **B&A Condition:** Surface not firm, stable, or slip r

Recommendations: Move the bus stop ~240' west. Have a level 5'x8' slab with a raised 6" curb for the B&A area. See note 1. Pave a 40' path to connect to the existing sidewalk to the west. Add detectable warnings to the nearby curb ramps. Make sure the pole with the bus schedule is located adjacent to the pavement so it is accessible.

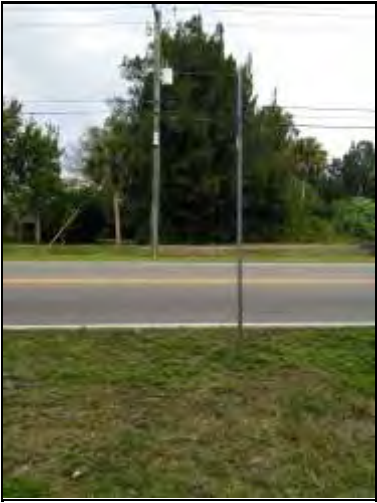
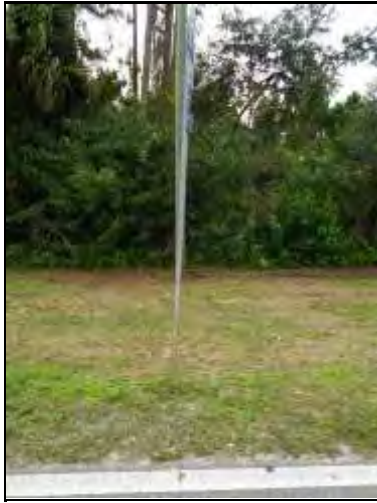
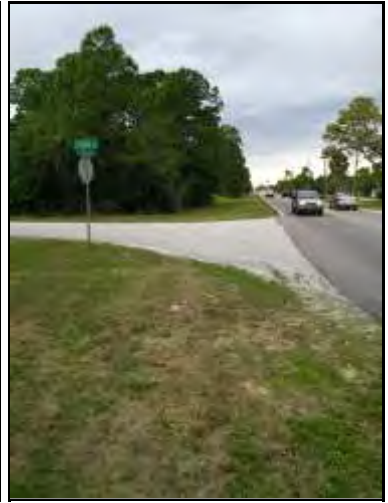
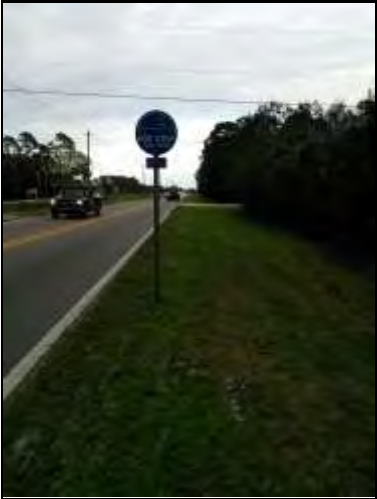
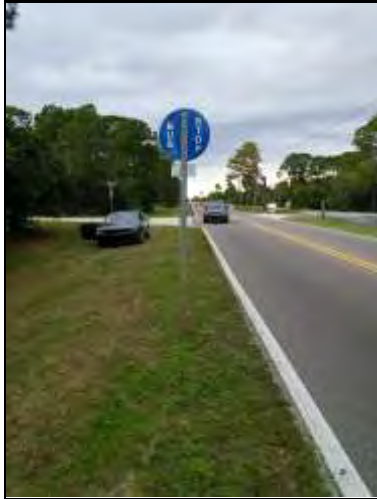
Location: NW MALABAR RD & WARE AVE **ID:** 343

Stop Location: On an unpaved shoulder of roadway

Is the B&A Safe: Yes **B&A Condition:** Surface not firm, stable, or slip r

Recommendations: Move the stop 80' west. Pave a level 5'x8' slab with a raised 6" curb for the B&A area and pave a ramp from the B&A area to the shoulder of the road, which will act as the accessible path. See note 1 and note 3. Add detectable warnings to the new curb ramp.

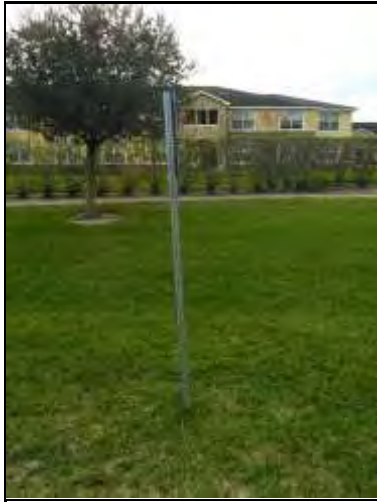
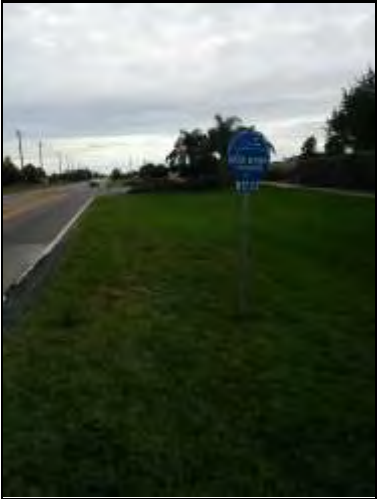
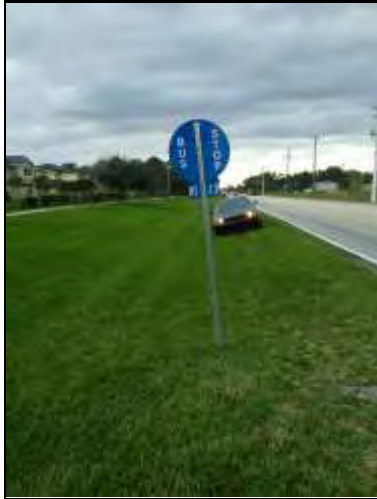
Is the B&A Safe: Yes **B&A Condition:** Surface not firm, stable, or slip r

Recommendations: Move the bus stop 100' east. Pave a level 5'x8' slab with a raised 6" curb for the B&A area. See note 1. Make sure the B&A area has a cross slope of <=2%. Add a 50' path to connect the B&A to the existing sidewalk.

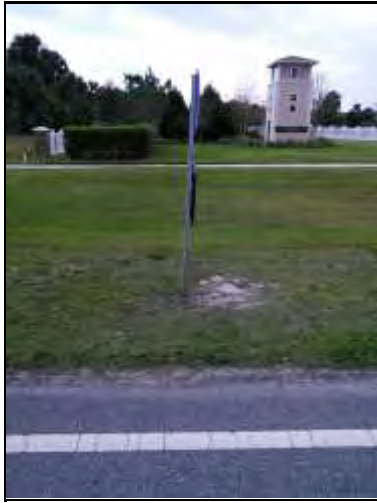
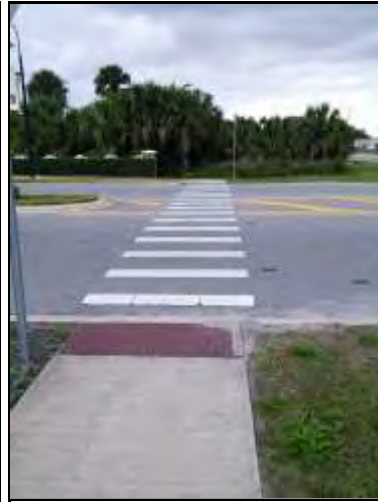
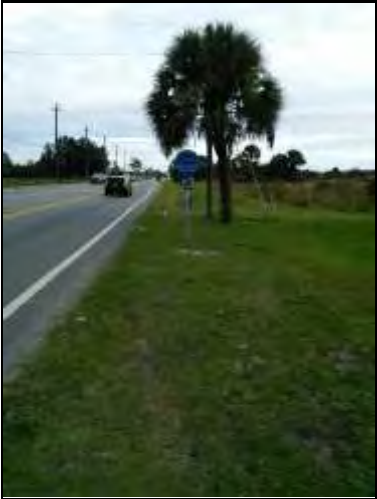
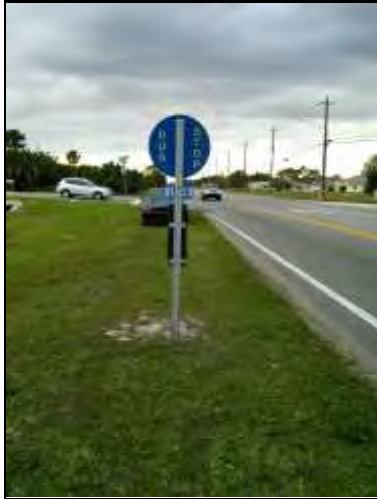
Location: NW MALABAR RD & MAYWOOD AVE **ID:** 331

Is the B&A Safe: Yes **B&A Condition:** Surface not firm, stable, or slip r

Recommendations: Move the bus stop 70' west. Pave a level 5'x8' slab with a raised 6" curb for the B&A area. See note 1. Add a 50' path to connect the B&A to the existing sidewalk. Resurface the B&A area to have a cross slope of <=2%.

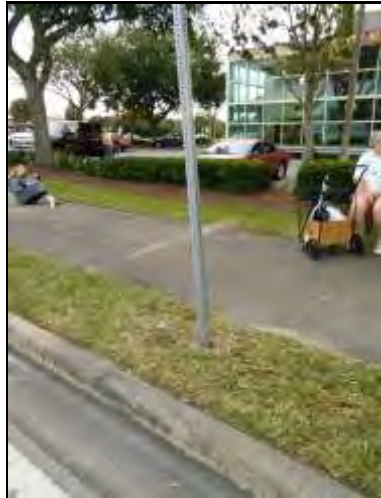
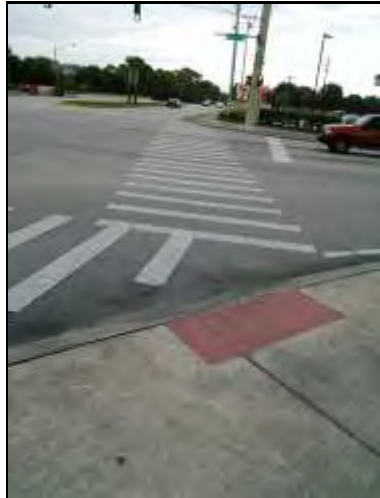
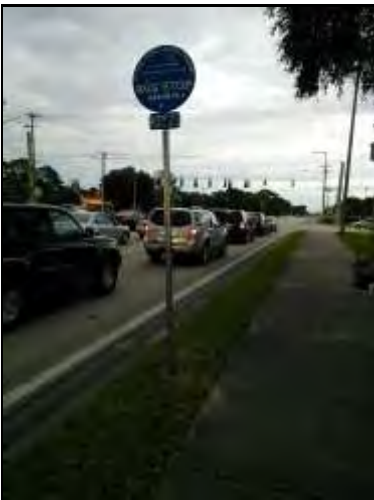
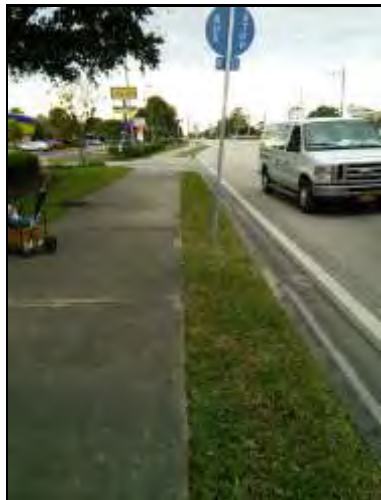
Location: PALM BAY WEST SHOPPING CENTER & MINTON **ID:** 322

Is the B&A Safe: Yes **B&A Condition:** Surface not firm, stable, or slip r

Recommendations: Pave a level 5'x3' slab between the curb and sidewalk to complete a 5'x8' B&A area.

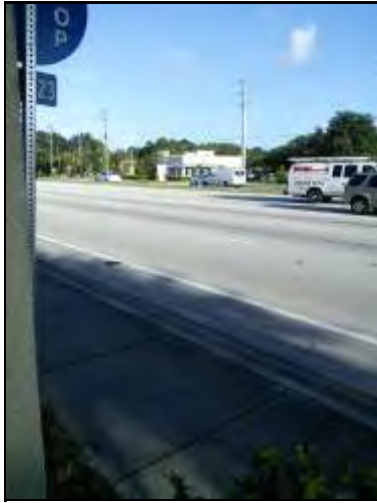
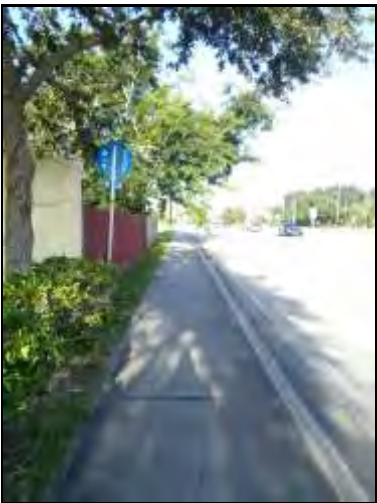
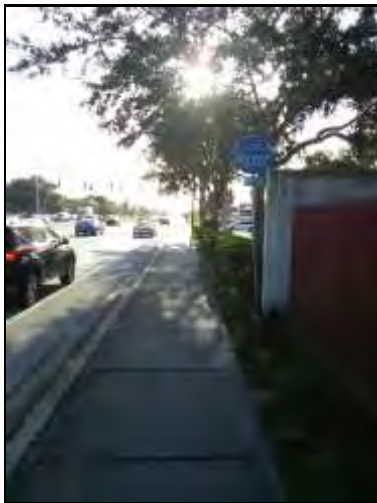
Is the B&A Safe: Yes **B&A Condition:** Surface not firm, stable, or slip r

Recommendations: Move the stop 270' west. Pave a level 5'x2' slab behind the sidewalk to complete a 5'x8' B&A area.

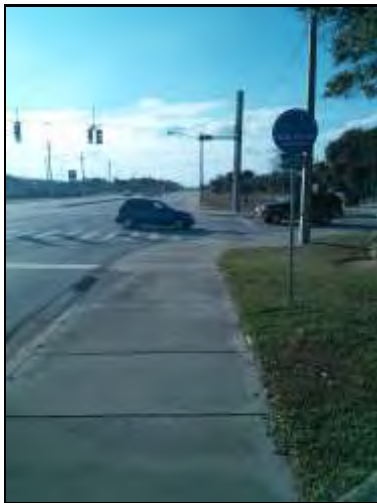
Westbound

Is the B&A Safe: Yes **B&A Condition:** Surface not firm, stable, or slip r

Detectable Warning: No **Detectable Warning Condition:**

Recommendations: Move the stop 280' east. Add detectable warnings to the nearby curb ramps.
