PEDESTRIAN / BICYCLE SAFETY REVIEW

Palm Bay Road from Babcock Street to Lipscomb Street

February 2016

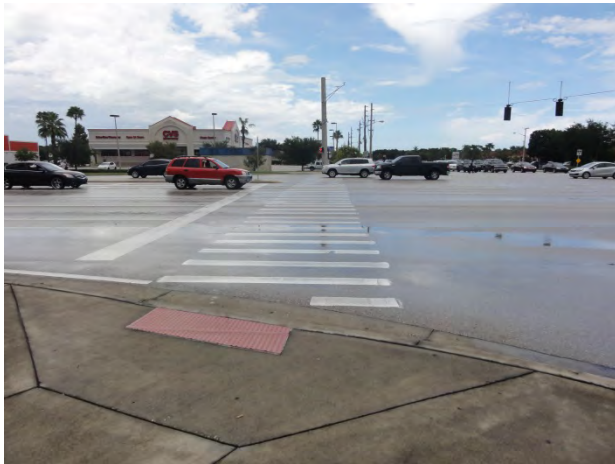
Figure 27

Due to the number of lanes along Babcock Street and Palm Bay Road on each intersection approach, the crossing distance is relatively long. The crossing distance for the west leg of the intersection is approximately 150 feet (illustrated in **Figure 27**) and the crossing distance for the east leg of the intersection is approximately 140 feet as shown in **Figure 28**.

Babcock Street Intersection	7	Pedestrian Crossing Distances	Consider altering the curb radii on the northwest and southeast corners of the intersection to create a bulb out (locations illustrated in Figure 29). The existing right-turn lanes could be developed approximately 35-40 feet downstream of the intersection. This would look something similar to the north and south legs as those right-turn lanes are developed downstream of the intersection.
Windwood Drive to Knecht Drive	9	Mid-Block Crosswalk	The team discussed consideration for a mid-block crossing to serve the existing crossing demand along this segment. The following safety enhancements should be considered as part of this consideration: <ul style="list-style-type: none"> • Provide an active warning device, such as Rapid Rectangular Flashing Beacons (RRFB), at the crosswalk. RRFBs may also be used on the advance crosswalk signs per FHWA's interim approval memorandum. • Provide a staggered z-crossing median refuge island for pedestrians in the existing landscaped center median. This would force the pedestrian to perform a two-stage crossing. The pedestrian would be required to separately activate the RRFB for crossing each direction of travel along Palm Bay Road. • Install lighting on the crosswalk's north and south sides. • Stripe the crosswalk with Special Emphasis Crosswalk markings consistent with sheet 10 of the FDOT Design Index 17346.

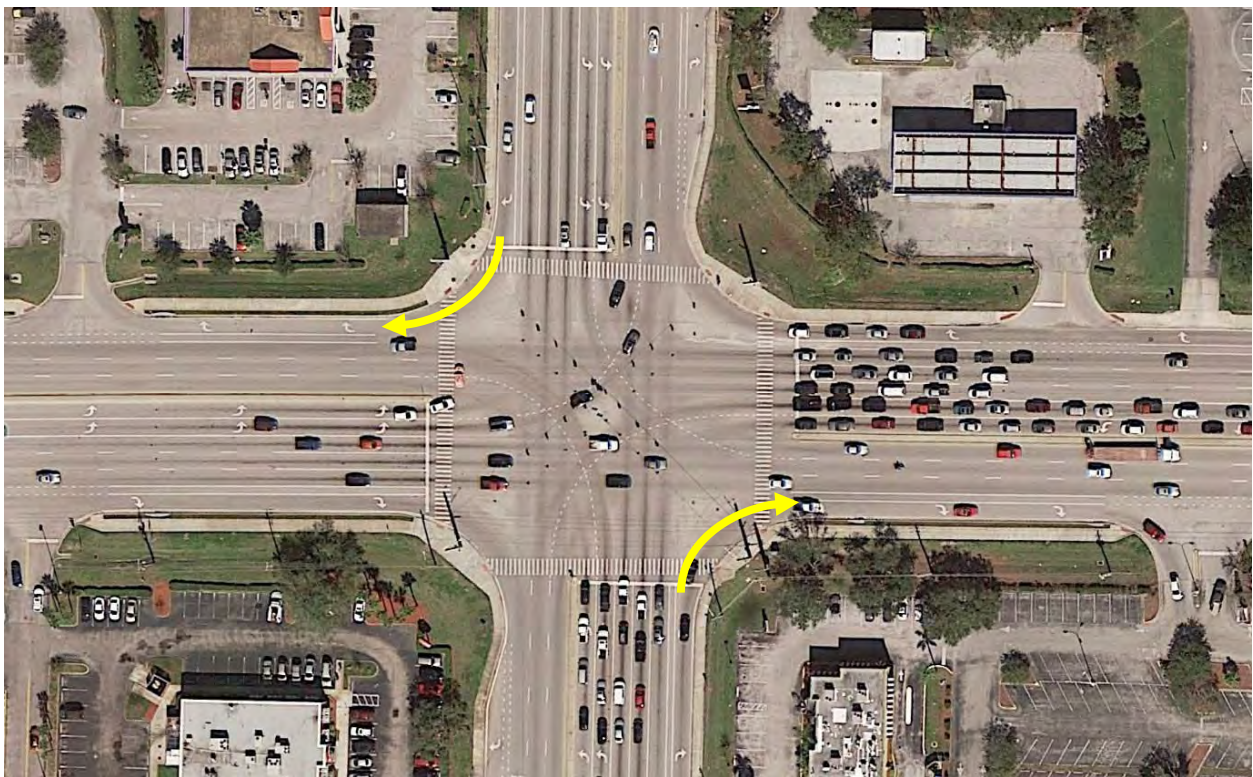
Figure 29

When making a northbound or southbound right-turn movement, the curb line guides drivers into either a continuous eastbound (for the northbound movement) or westbound (for the southbound movement) right-turn lane, as depicted in **Figure 29**. This forces drivers to have to merge with thru traffic. The larger curve radius encourages higher speeds for the northbound and southbound right-turn movements, posing potential higher speed interactions with pedestrians and bicyclists. The larger curve radius also extends the distance a pedestrian must cross northbound and southbound.

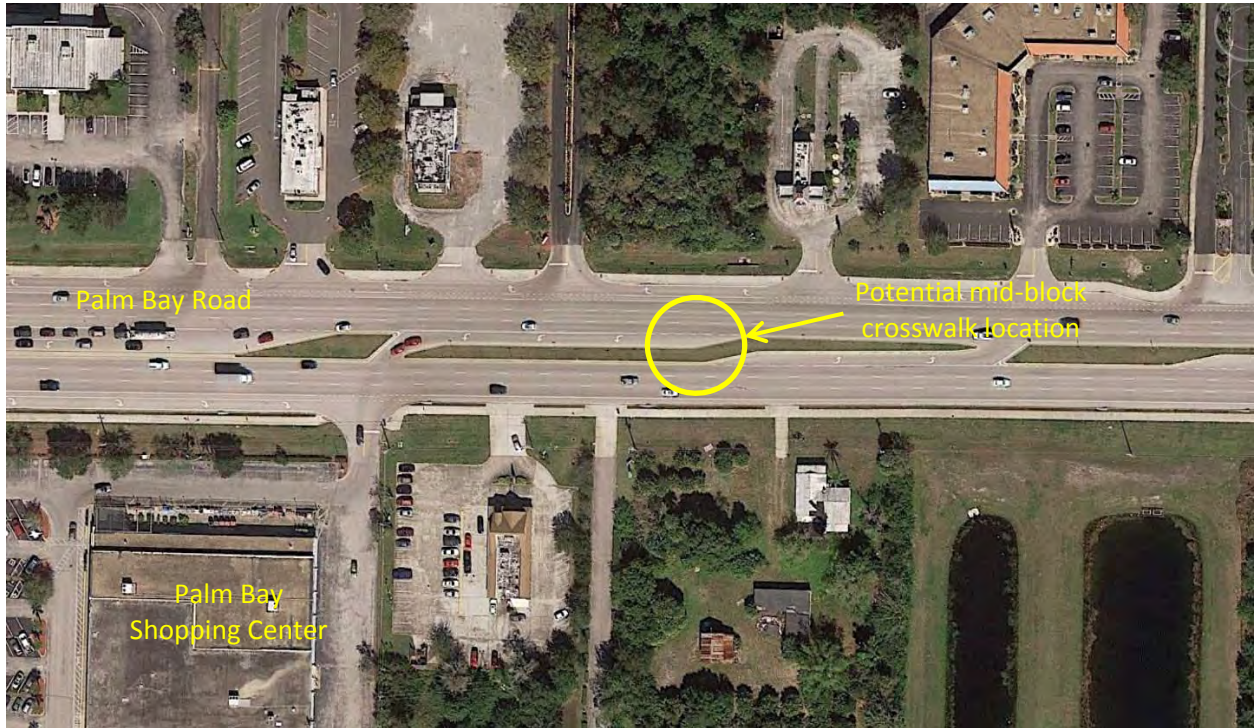
Figure 35

The team discussed consideration for a mid-block crossing to serve the existing crossing demand along this segment (location displayed in **Figure 35**). The westbound left-turn lane length into the Palm Bay Shopping Center could be reduced to allow for a mid-block crossing. According to the FDOT Standard Index 301, a left-turn lane needs a deceleration length of 185 feet. Assuming a distance of 100 feet (~4 vehicles) for queue storage, the combination of the deceleration length and queue storage length is 285 feet, leaving 40 feet for a mid-block crossing. In this case, the length of the existing eastbound left-turn lane at this location would not be impacted. The following safety enhancements should be considered as part of this consideration:

- Install lighting on the crosswalk's north and south sides.
- Stripe the crosswalk with Special Emphasis Crosswalk markings consistent with sheet 10 of the FDOT Design Index 17346.

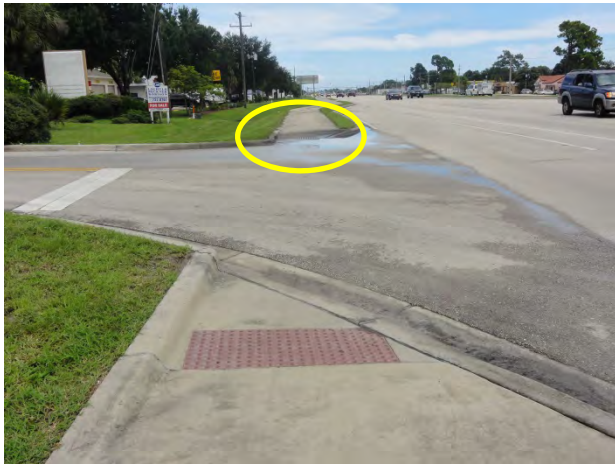
Figure 39

Water pools up onto the curb ramp and detectable warning surface on the east side of the driveway to the 7-11 gas station (northeast corner of the Pinewood Drive intersection). This issue is displayed in **Figure 39** and **Figure 40**. This poses an issue to pedestrians, bicyclists, and vehicles as they cross the approach or make a westbound right-turn maneuver. There is a curb inlet approximately 90 feet west of the issue and approximately 65 feet east of the drainage issue.

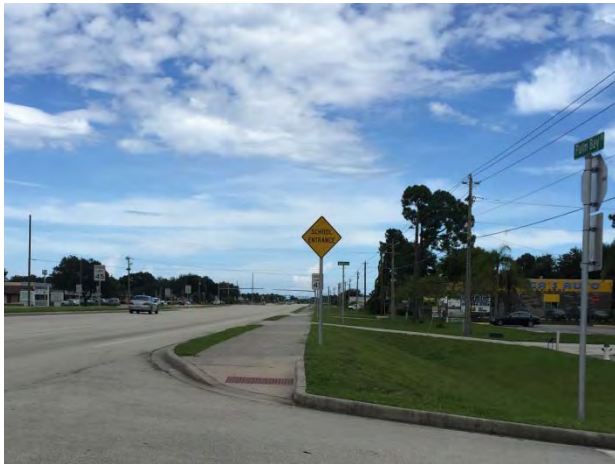
Figure 41

A School Entrance sign is located on the south side of Palm Bay Road just west of Bellaire Lane as illustrated in **Figure 41** and **Figure 42**. Bellaire Drive used to be the main entrance to the Palm Bay Academy Charter School, but the main entrance has been moved off of Tropicana Drive. Tropicana Drive is approximately 375 feet east of Bellaire Lane.

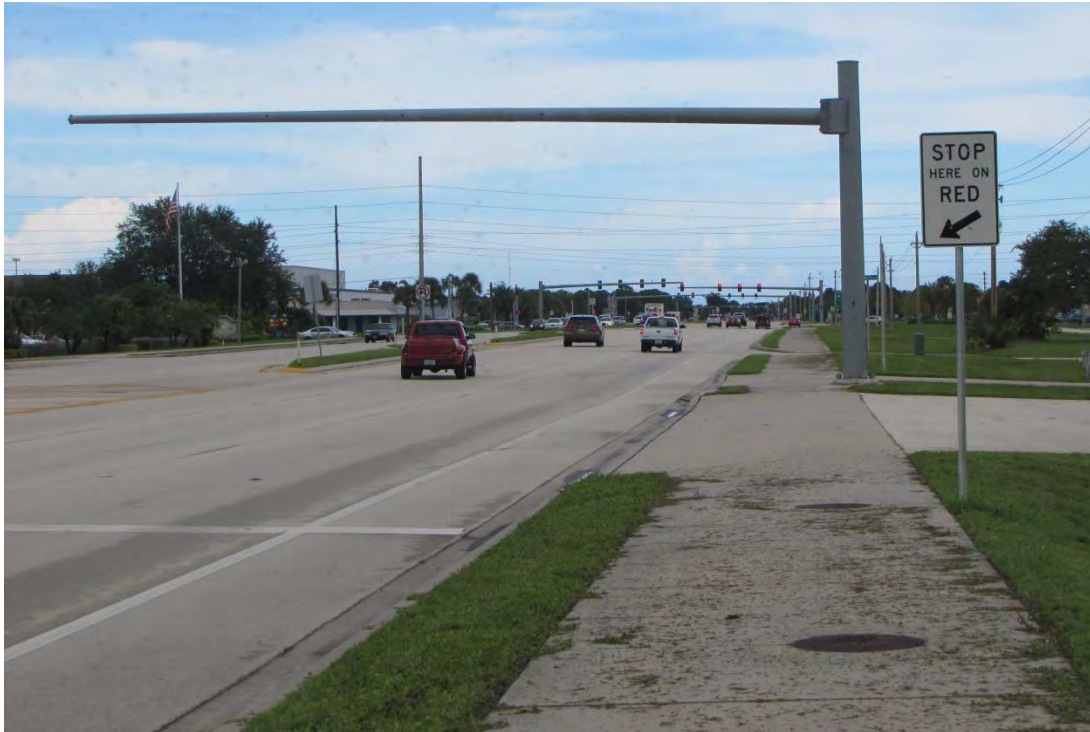
Figure 43

The mast arms at the intersection of Bottlebrush Drive and Palm Bay Road previously served as an emergency signal for a fire station on the northeast corner of the intersection (eastbound mast arm shown in **Figure 43**). The fire station was relocated and the signal heads were removed from the mast arms. However, the Stop Here on Red (R10-6) signage and stop bar pavement markings are still present on the eastbound and westbound approaches. The presence of the inactive emergency signal mast arms, signage, and pavement markings may deliver an inconsistent expectation to pedestrians/bicyclists and motorists in the area. Pedestrians/bicyclists may see the mast arms and assume that that location is a safe place to cross.
