# PEDESTRIAN / BICYCLE SAFETY REVIEW

US 1 / Broadway Boulevard to Fay Boulevard

## **Pedestrian/Bicycle Safety Review Report for US 1 (North) from Broadway Boulevard to Fay Boulevard**

**Field Review Dates:** July 13<sup>th</sup> and 14<sup>th</sup>, 2015 (daytime/nighttime reviews and follow up meeting)

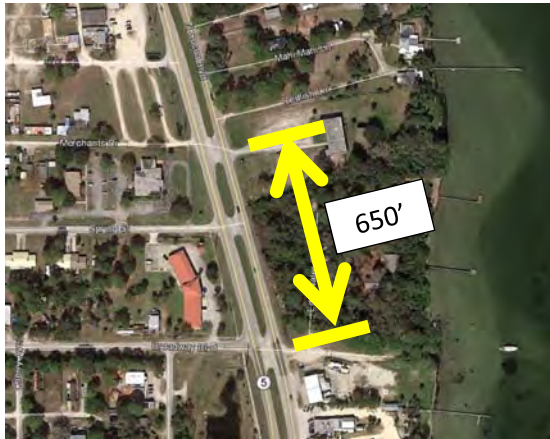
Figure 12

- Broadway Boulevard to Merchants Drive/Vintage Lane (**Figure 12**)
  - 3 full median openings within approximately 650 feet
- Cottrell Avenue to Florida Power and Light (FPL) Employee Entrance (**Figure 13**)
  - 3 full median openings within approximately 550 feet

US 1 is an access class 3 facility within the study corridor, with a full median spacing standard of 2,640 feet. An access management study is suggested to review the usage of the full median openings identified in **Figure 12** and **Figure 13** in order to possibly close/reconcile a few median openings. The study team recognizes it may not be feasible to close two of the three openings at each location in order to meet the spacing standards, thus converting one or more of the full openings to be directional may be more appropriate. If the study finds one or more median openings can be closed, provisions must be made for U-turns at downstream median openings.

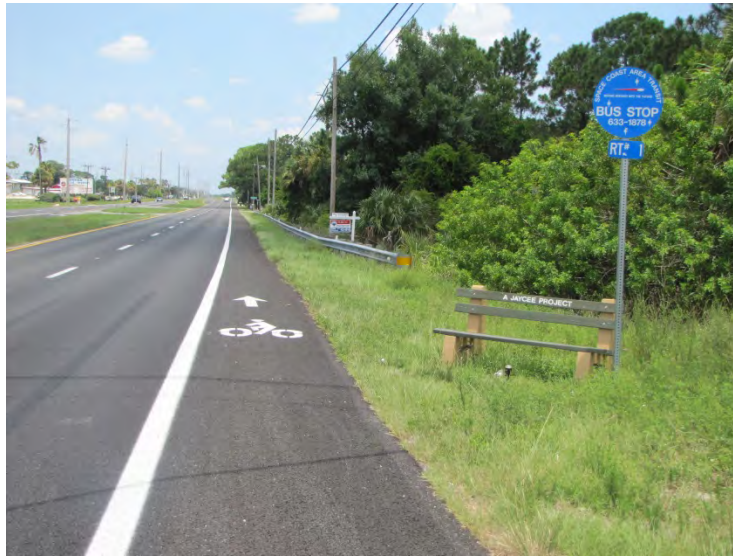
**Figure 18**

As part of the US 1 resurfacing project, the five foot paved shoulder was converted to a bicycle lane, as shown in **Figure 18**. The Plans Preparation Manual, Section 8.4.1 discusses that on divided roadways in or within one mile of an urban area and a design speed equal to or less than 45 mph, travel lanes shall be 11 feet with a 7 foot buffered bicycle lane.

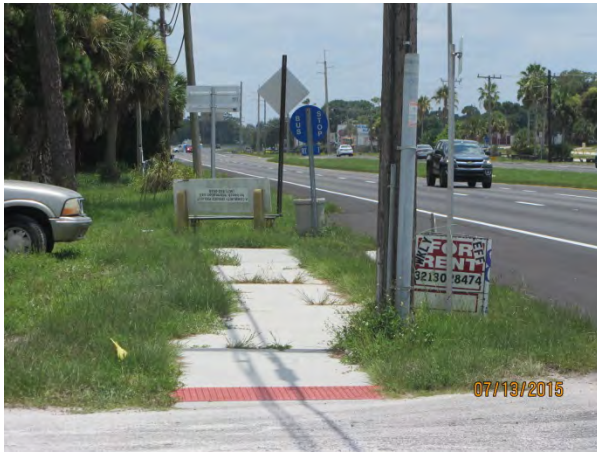
Figure 19

Some of the bus stop benches were not located next to a hard surface (sidewalk), as shown in **Figure 19** and **Figure 20**. In the case of both figures, the sidewalk was built with the US 1 resurfacing project but the bench was not moved accordingly.

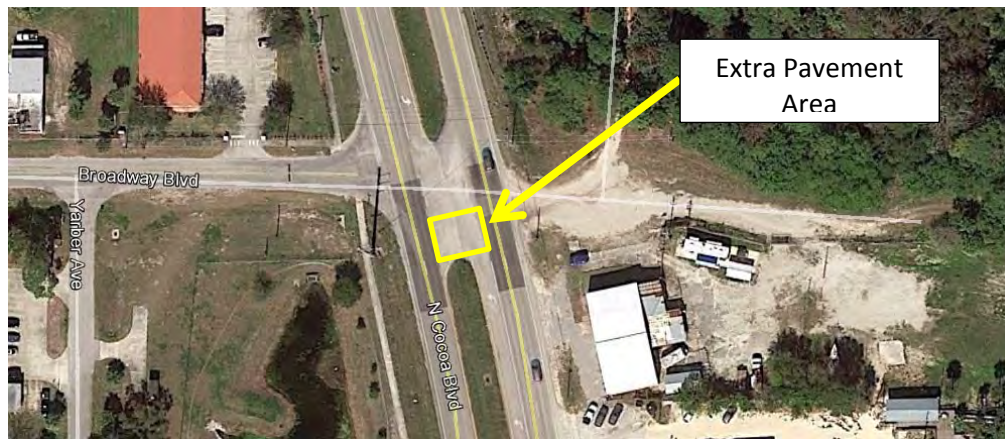
**Figure 22**

The full median opening at the intersection is larger than it needs to be, creating an unnecessary large pavement area (**Figure 22**). Pedestrians/bicyclists on the southeast corner of the intersection attempting to access the bus stop and businesses on the northwest corner have to walk across this large pavement area in the median opening, creating non-motorist/motorist conflict.

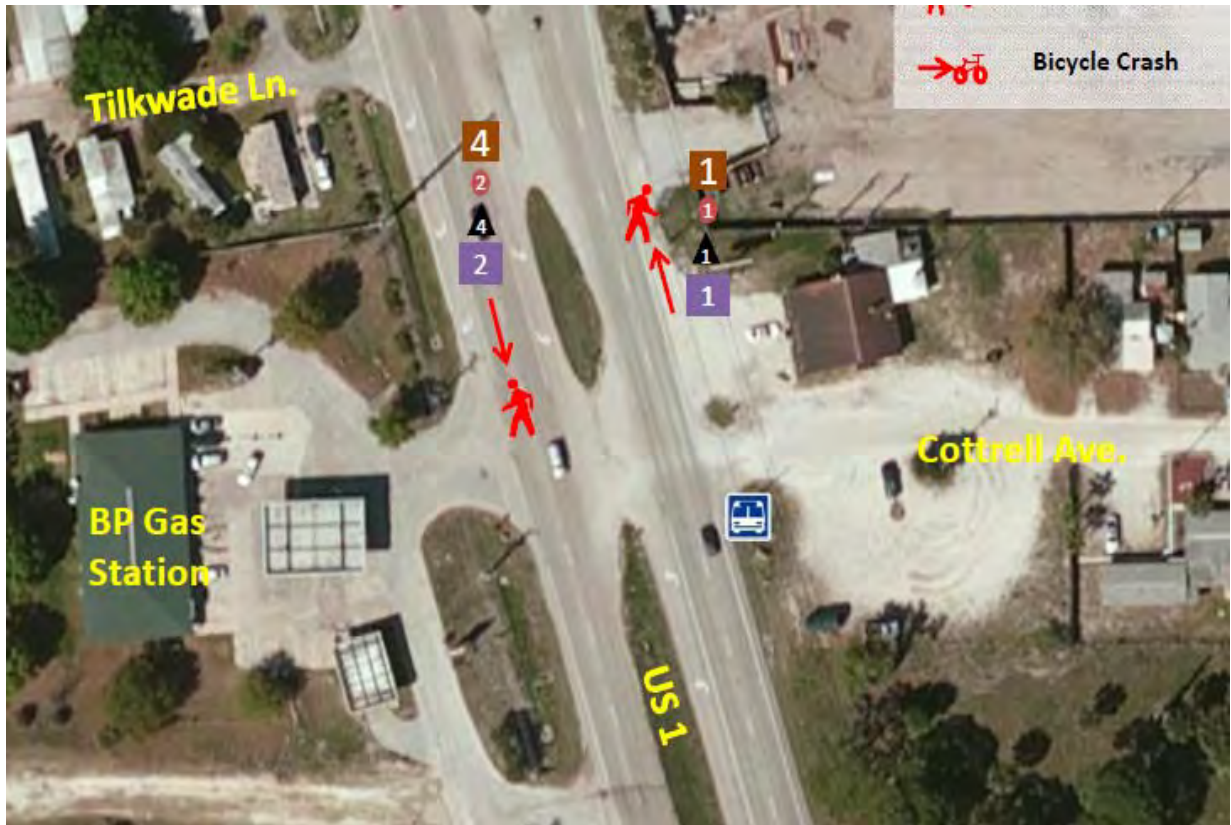
Figure 25

As mentioned in **Issue #3: Access Management**, access management at the Cottrell Avenue intersection is an issue (**Figure 25** displays two of the three median openings at this location). Along with these access management issues, northbound and southbound left turn lanes along with a southbound right turn lane make the pavement area wider than the standard four lane cross section at this intersection. The wider pavement area due to the turn lanes, plus the full median opening and no roadway lighting, makes this a difficult crossing location for pedestrians. This intersection experienced five (5) of the 12 (42 percent) crashes observed along the study corridor, with three (3) of those being fatal.

As discussed in **Issue #3**, a study should be performed to review closing/modifying these median openings. One possibility would be to convert the Cottrell Avenue intersection to a directional median opening, thus reducing the amount of pavement shown in **Figure 25**. As part of this study, the volumes for the exclusive southbound right turn lane should be reviewed and removal of this right turn lane should be considered. By possibly removing the right turn lane and converting to a directional median opening, pedestrian exposure during crossings would be reduced.

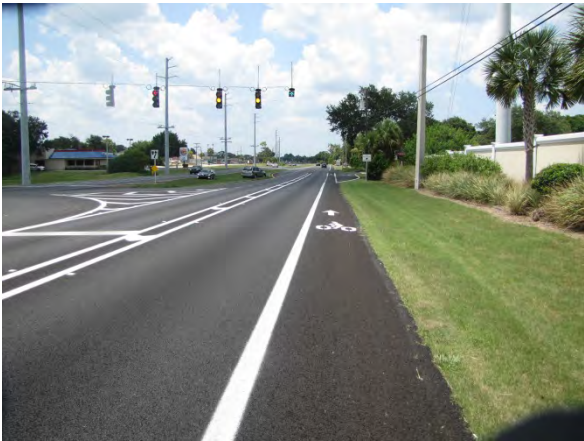
**Figure 29**

A continuous green northbound through lane is provided at the Port St. John Plaza intersection, as displayed in **Figure 29**. The following signage improvements were proposed for this intersection per the Qualitative Assessment report performed by FDOT Traffic Operations:

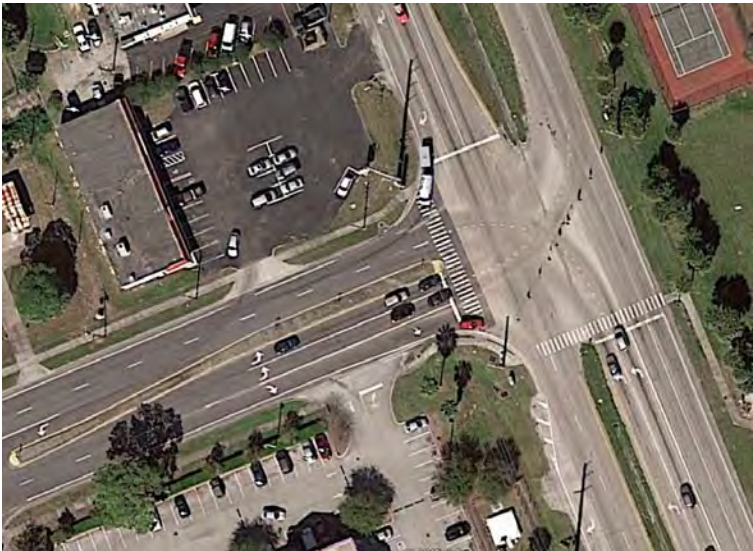
**Figure 36**

Currently, the eastbound approach at Fay Boulevard has the following lane and signal head configuration (**Figure 36** and **Figure 37**):

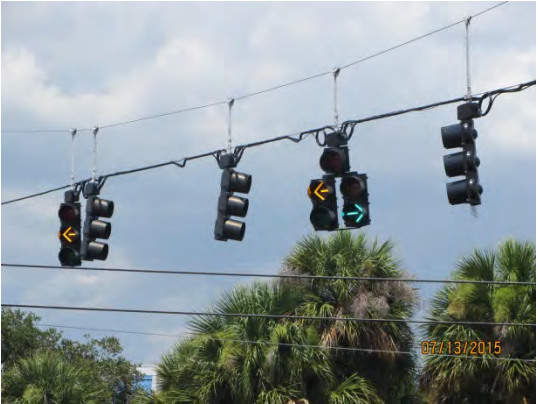
When the eastbound phase begins, the three section head will display a green left turn arrow and the five section head will display both the green left turn and right turn arrows. Once the eastbound phase is finished, the northbound left turn phase will begin. The eastbound right turns have an overlap with the northbound left turns, as displayed in **Figure 38** and **Figure 39**.

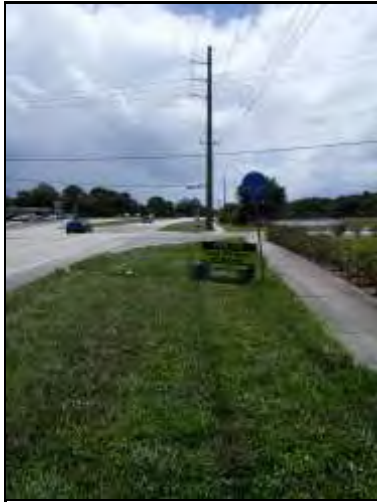
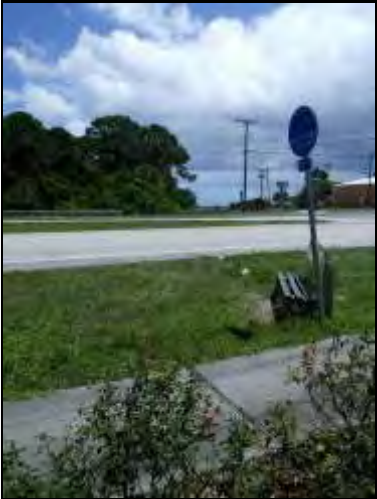
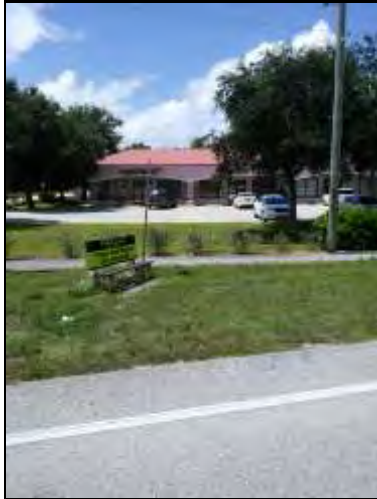
**Location:** N COCOA BLVD & BROADWAY BLVD **ID:** 924

**Is the B&A Safe:** Yes **B&A Condition:** Surface not firm, stable, or slip r

**Recommendations:** Pave a level 5'x8' slab with a raised 6" curb for the B&A area. Add a 9' path to connect the B&A to the existing sidewalk. Resurface the transition at the base of the curb ramp so that it is flush. Add detectable warnings to the nearby curb ramps. Stripe a crosswalk at the nearby intersection.

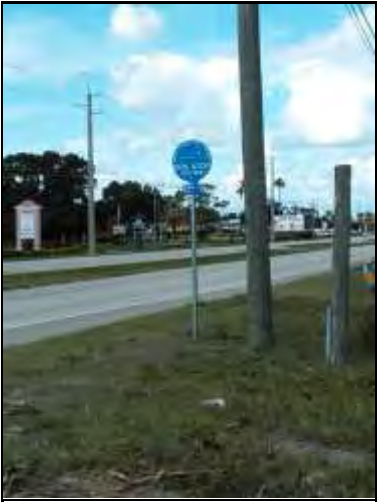
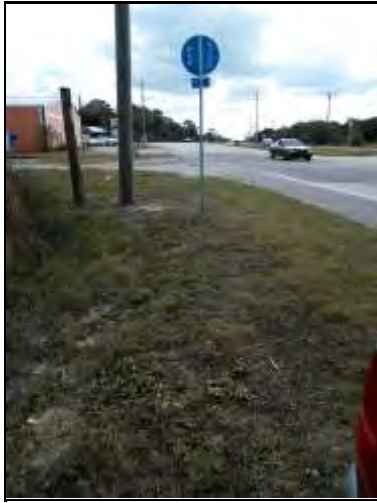
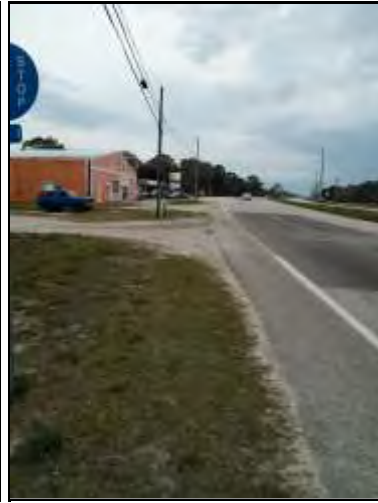
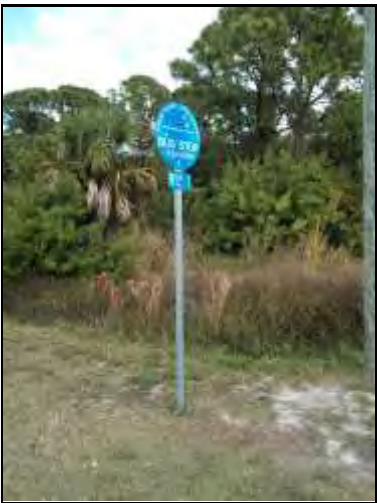
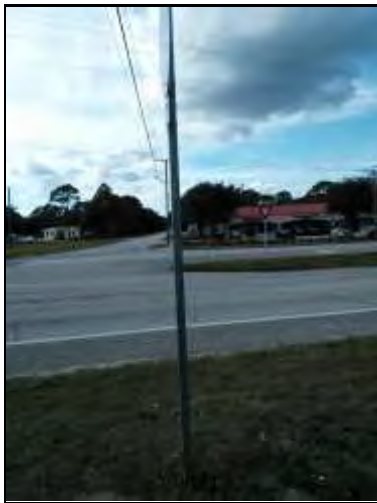
**Is the B&A Safe:** Yes **B&A Condition:** Surface not firm, stable, or slip r

**Recommendations:** Pave a level 5'x8' slab with a raised 6" curb for the B&A area and pave a ramp from the B&A area to the shoulder of the road, which will act as the accessible path. See note 1 and note 3. Add detectable warnings to the ramp.

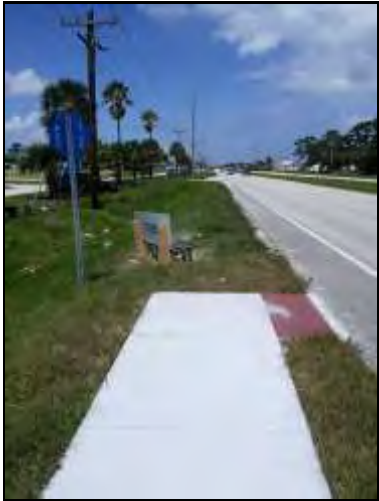
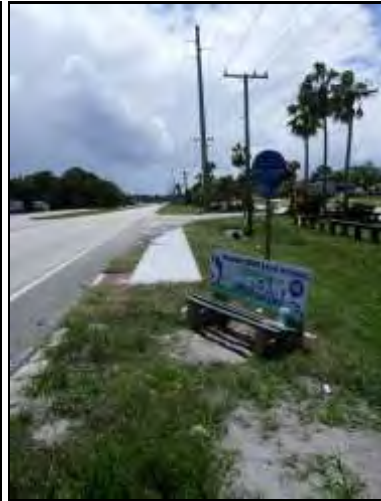
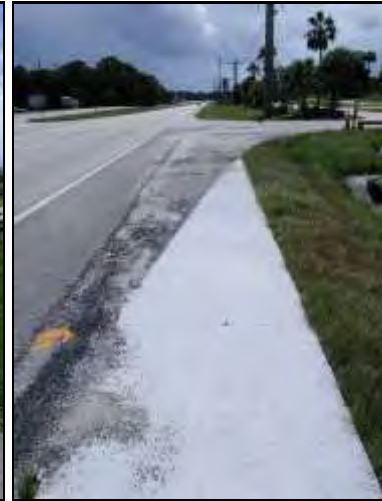
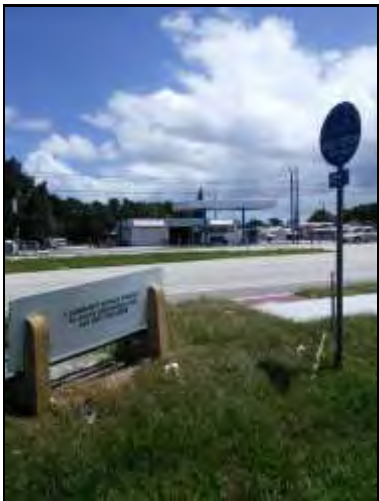
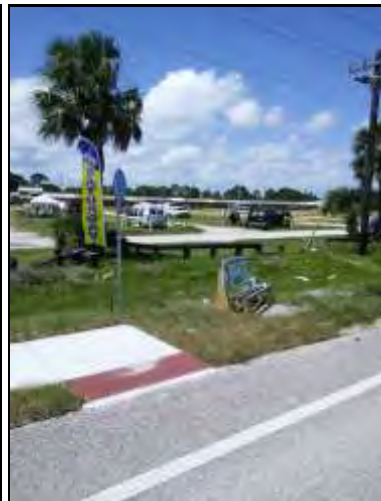
Stop Location: On an unpaved shoulder of roadway

B&A Condition: Surface not firm, stable, or slip r

Recommendations: Pave a level 5'x8' slab with a raised 6" curb for the B&A area and connect to the existing sidewalk. See note 1. Add detectable warnings to the nearby curb ramps.

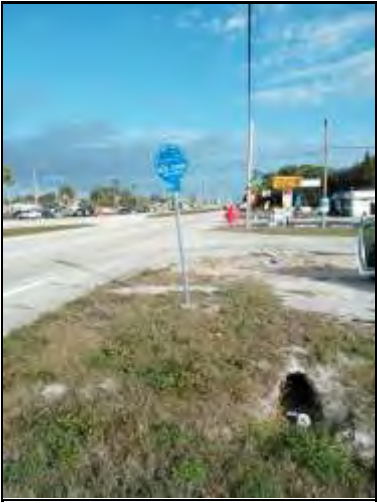
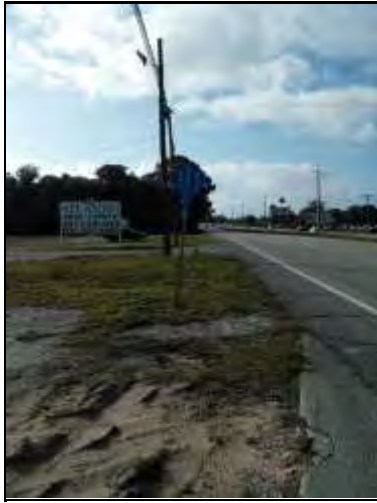
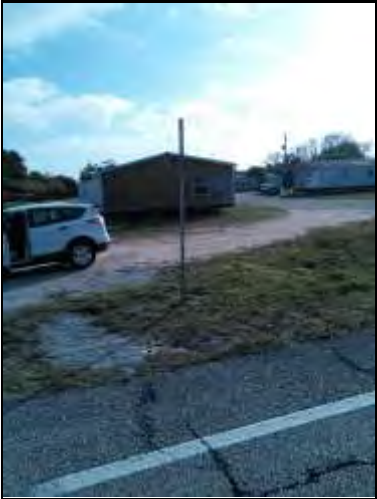
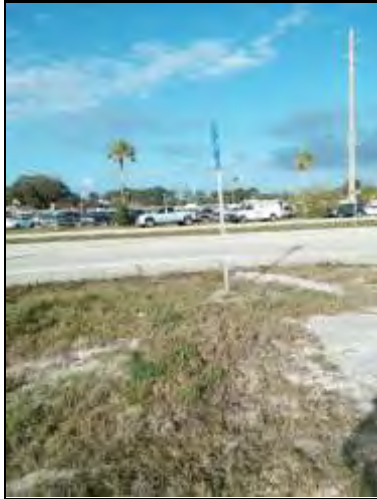
**Is the B&A Safe:** Yes **B&A Condition:** Surface not firm, stable, or slip r

**Recommendations:** Pave a level 5'x8' slab with a raised 6" curb for the B&A area and pave a ramp from the B&A area to the shoulder of the road, which will act as the accessible path. See note 1 and note 3. Add detectable warnings to the ramp.

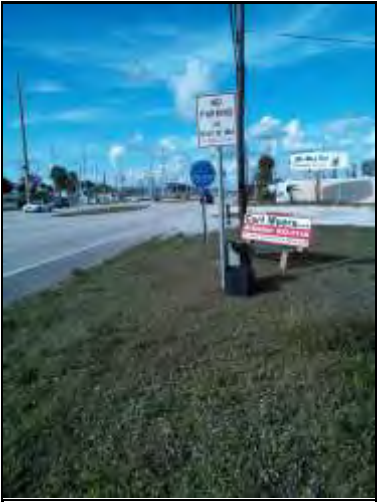
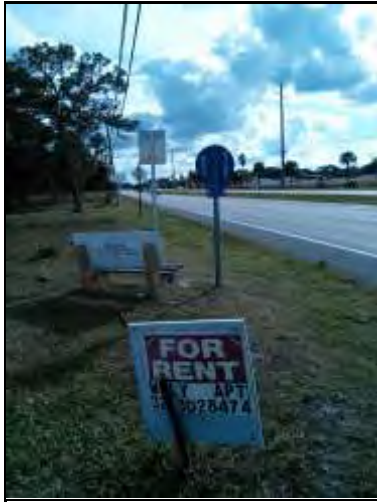
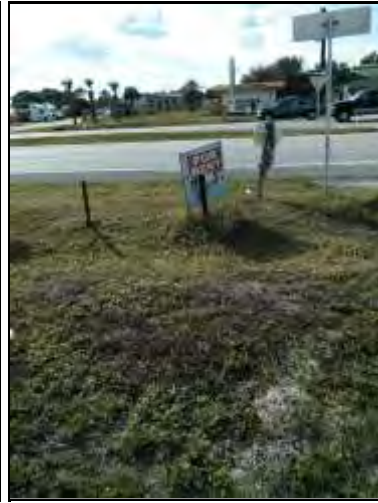
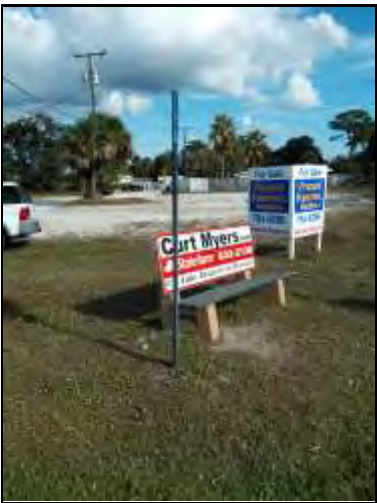
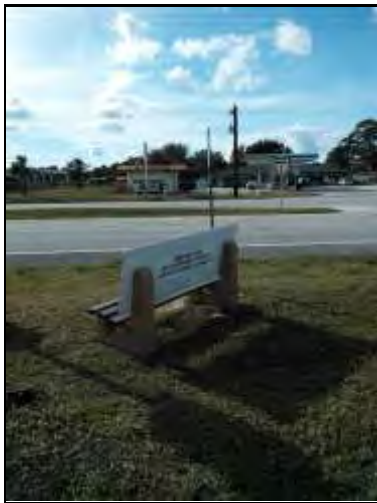
Location: N COCOA BLVD & PORT ST JOHN PLAZA

**Is the B&A Safe:** Yes **B&A Condition:** Surface not firm, stable, or slip r

**Recommendations:** Pave a level 5'x8' slab with a raised 6" curb for the B&A area and pave a ramp from the B&A area to the shoulder of the road, which will act as the accessible path. See note 1 and note 3. Add detectable warnings to the ramp. Move the bench and trash can so that they are flush with the edge of the sidewalk and outside of the B&A area.

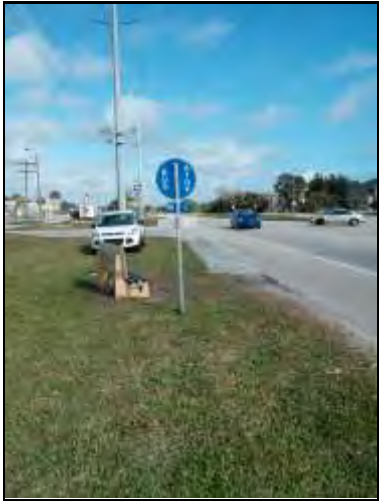
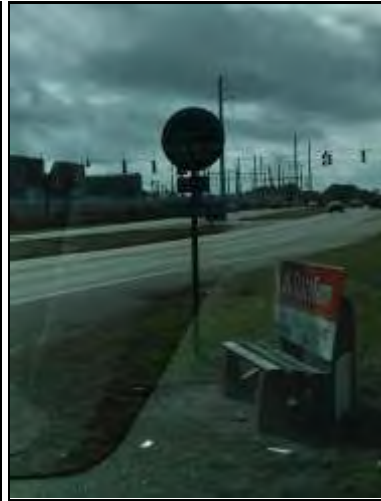
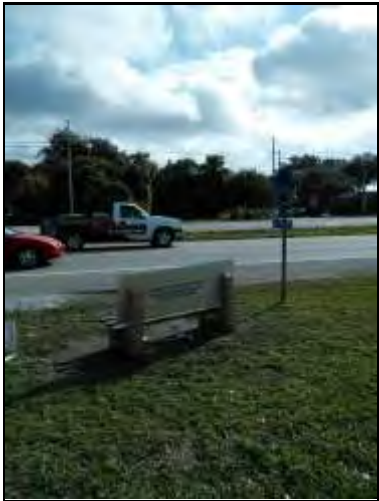
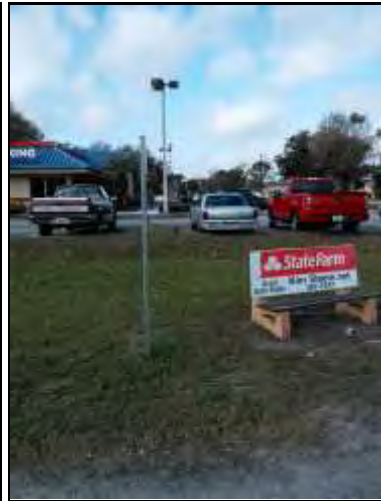
Stop Location: On an unpaved shoulder of roadway

B&A Condition: Surface not firm, stable, or slip r

Recommendations: Pave a level 5'x8' slab with a raised 6" curb for the B&A area and pave a ramp from the B&A area to the shoulder of the road, which will act as the accessible path. See note 1 and note 3. Add detectable warnings to the ramp. Move the bench so that it is flush with the edge of the sidewalk and outside of the B&A area.

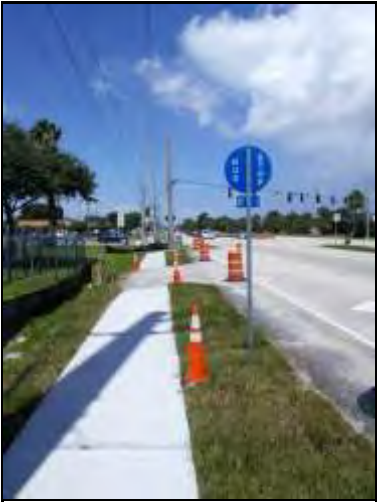
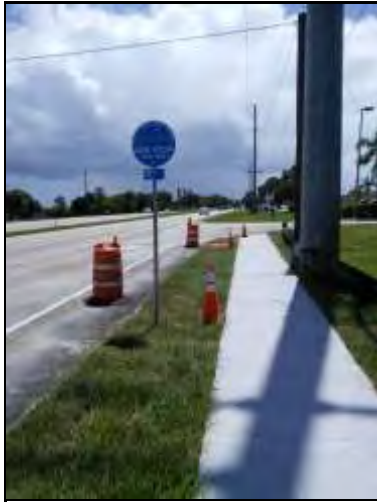
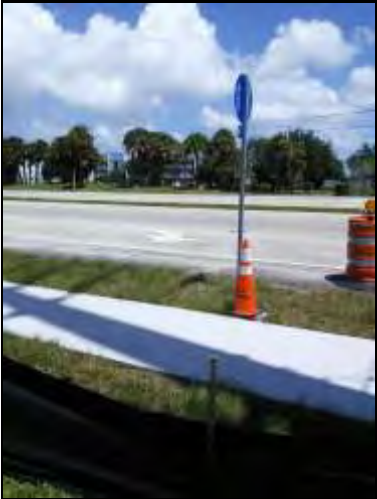
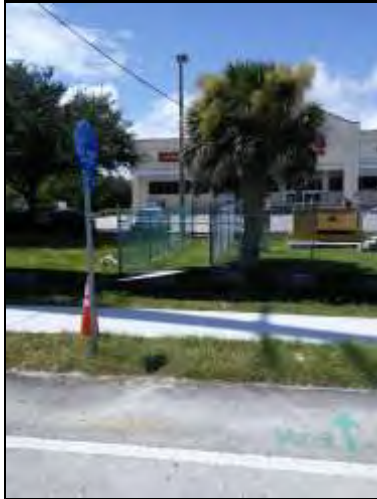
**Is the B&A 5'x8':** **B&A Condition:** Surface not firm, stable, or slip r

**Recommendations:** Move the stop 100' north. Resurface the B&A area to have a cross slope of <=2%. Remove the pavement at the existing B&A area and repave a level 5'x8' slab with a raised 6" curb to create a raised and level B&A area. See note 1. Add detectable warnings to the curb ramp. Move the bench so that it is flush with the edge of the sidewalk and outside of the B&A area.

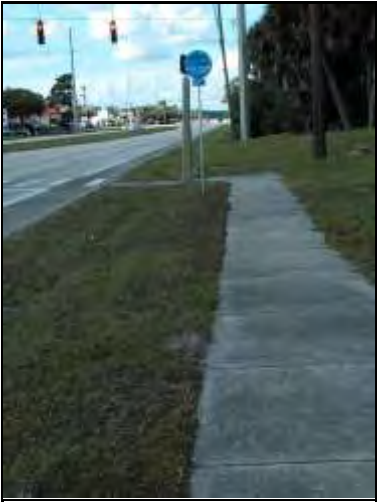
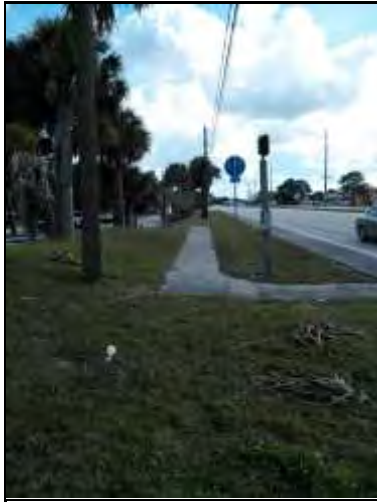
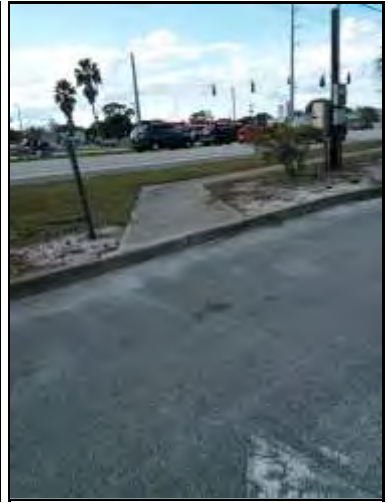
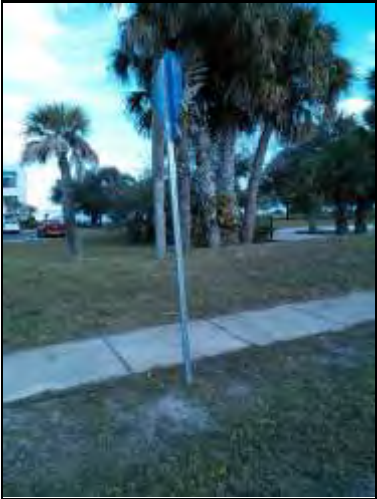
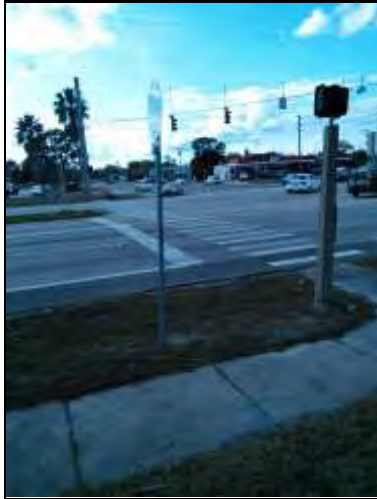
**Location:** N COCOA BLVD & FAY BLVD **ID:** 926

**Is the B&A Safe:** Yes **B&A Condition:** Surface not firm, stable, or slip r

**Recommendations:** Resurface the B&A area to have a cross slope of <=2%. Pave a level 5'x8' slab with a raised 6" curb for the B&A area. Construct a curb ramp with a slope <=8.3%. Add detectable warnings to the nearby curb ramps.
