PEDESTRIAN / BICYCLE SAFETY REVIEW

US 1 / University Boulevard to New Haven Avenue

Pedestrian/Bicycle Safety Review Report for US 1 (Melbourne) from University Boulevard to New Haven Avenue

Field Review Dates: August 25th and 26th, 2015 (daytime/nighttime reviews and follow up meeting)

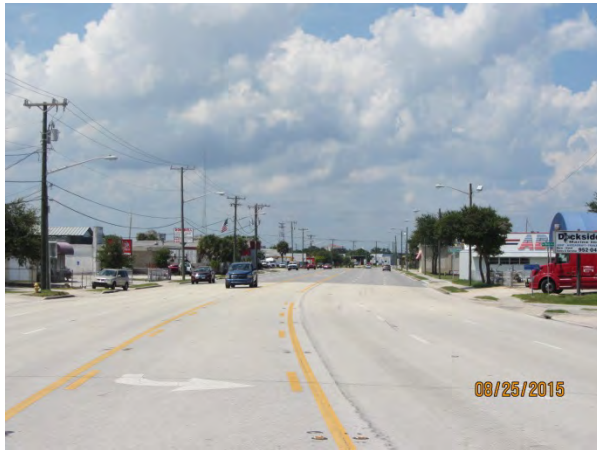
Figure 10

US 1 within the study limits consists of a seven lane cross section, with three 11' travel lanes northbound and three 11' travel lanes southbound separated by an 11' center two-way left-turn lane (TWLTL) as displayed in **Figure 10**. These types of facilities present numerous conflict points due to the TWLTL and the seven lane cross section requires mid-block crossing pedestrians/bicyclists to cross 77' of pavement at once or cross one set of travel lanes and wait in the TWLTL for a gap to cross the other set of travel lanes. If the pedestrian/bicyclist is waiting in the TWLTL, there are potential conflicts with vehicles, as observed in **Figure 11**. Four of the 12 crashes along the corridor involved a pedestrian/bicycle crossing mid-block between signalized intersections.

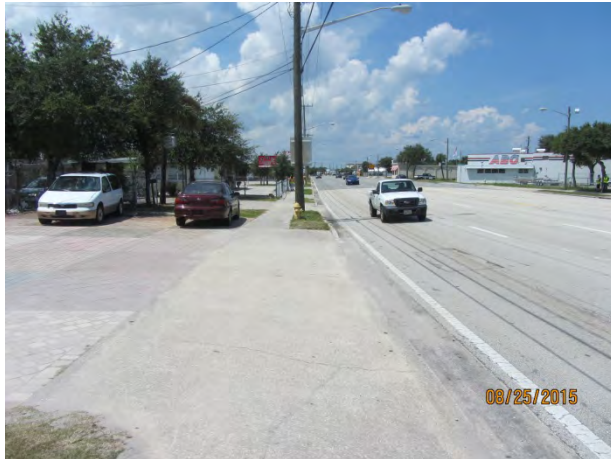
Figure 18

At some driveways throughout the corridor, the sidewalk merges into the existing driveway as displayed in **Figure 18** through **Figure 21**. With the sidewalk not being stand alone, it is subject to the cross slope of the driveway, which in most cases was between seven and 12 percent (based on field review measurements by the study team). The driveways measured exceeded the maximum two (2) percent cross slope per section R302.6 in the ADA PROWAG guidance.

Consider driveway reconstruction during the roadway's next 3R project to provide a level path for the sidewalk and meet ADA guidance. As part of this construction, consider reducing the driveway widths down to the 36' maximum per FDOT Standard Index 515. Also as part of this future 3R project, consider eliminating unused driveways, like those shown in **Figure 19** and **Figure 21**. US 1 was recently resurfaced from Roosevelt Avenue to north of New Haven Avenue, thus this may not happen for another 5 to 10 years. As properties redevelop along the corridor, consider rebuilding the driveways. It appears these improvements can be done without negatively impacting parking or site circulation on the subject parcels.

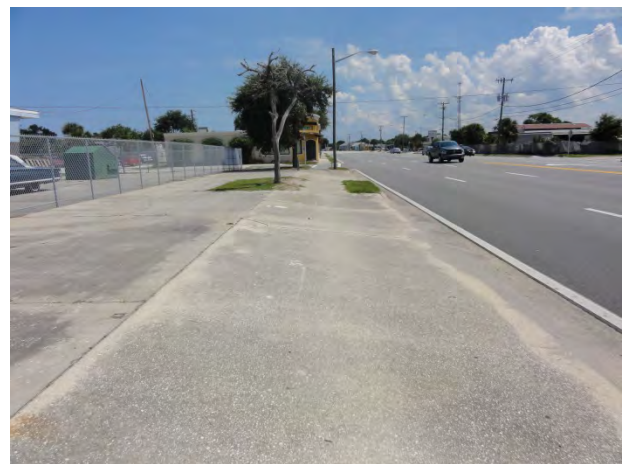
Figure 21

Along the study corridor, properties were observed as having multiple driveways onto US 1. Some of these properties were undeveloped parcels (**Figure 20**) while other properties currently do not have access to their driveways (**Figure 19** and **Figure 21**). A number of driveways were also noted to be longer than the 36' maximum driveway width as specified per FDOT Standard Index 515. While there was not a high amount of pedestrian/bicycle crashes at driveways (2 out of the 12 crashes), driveways are conflict points between pedestrians/bicyclists utilizing the sidewalk and vehicles exiting the property or turning from US 1. The higher the number of driveways along a corridor, the higher the potential for crashes between a pedestrian/bicycle utilizing the sidewalk and a vehicle exiting/entering a property.

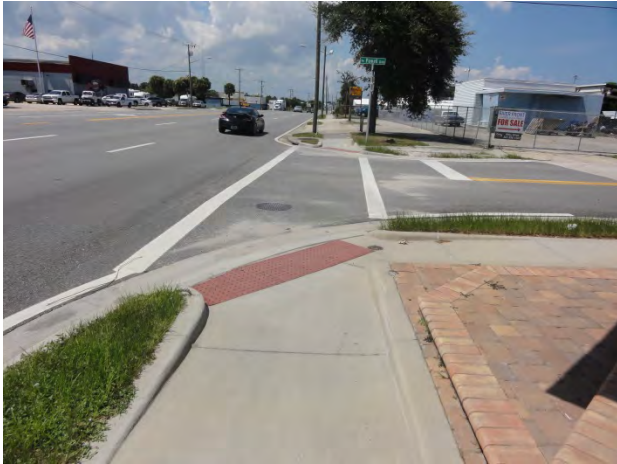
Figure 22

As part of the resurfacing project along US 1 from Roosevelt Avenue to north of New Haven Avenue, standard marked crosswalks and detectable warning surfaces were installed at all unsignalized minor street approaches (see **Figure 22** at Powell Avenue). Outside the limits of the resurfacing project (University Boulevard to Roosevelt Avenue), the unsignalized minor street approaches did not include marked crosswalks or detectable warning surfaces (see **Figure 23** at Hoag Avenue).

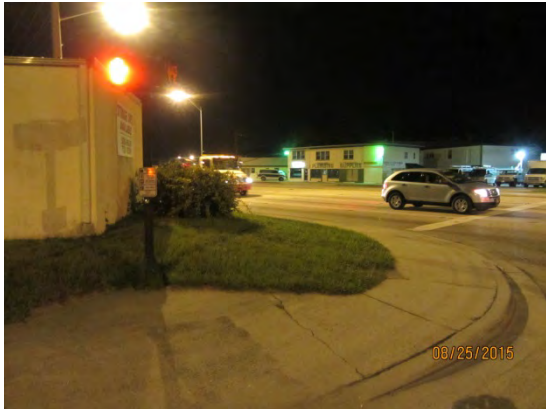
Figure 26

A bush is located upstream of the intersection on the northwest corner, restricting sight distance for southbound right turning vehicles to see pedestrians crossing the west leg of the intersection, as displayed in **Figure 26**.

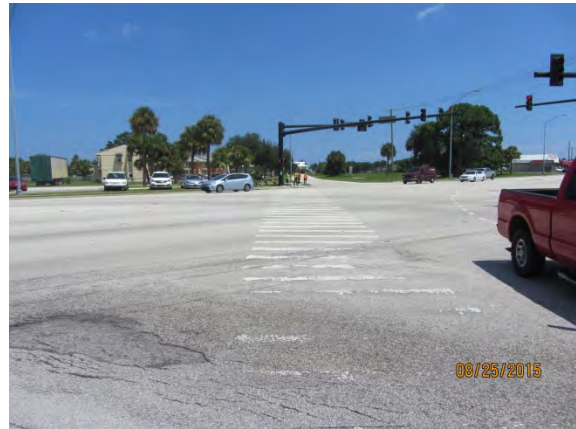
Figure 27

The crosswalks were faded on the east, north (**Figure 27**), and west (**Figure 28**) legs of the intersection along with the stop bars for all four approaches. The stop bar for the east leg (westbound approach) is approximately 25' away from the crosswalk. No detectable warning surfaces were present for the curb ramps at the intersection.

Consider re-striping the faded east, north, and west legs with Special Emphasis Crosswalk markings consistent with sheet 9 of the FDOT Design Standard Index 17346. Consider installing detectable warning surfaces on all curb ramps. Consider re-striping the stop bars at the intersection to emphasize where the vehicle needs to stop. Consider moving the east leg stop bar closer to the intersection. Per sheet 4 of the FDOT Design Standard Index 17346, the minimum distance between the stop bar and the marked crosswalk should be 4'.

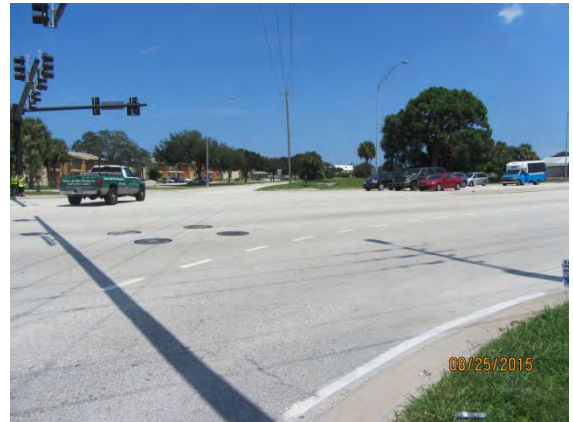
Figure 29

No crosswalk is striped on the south leg of the intersection, as displayed in **Figure 29**.

Consider striping the south leg crosswalk with Special Emphasis markings. When the south leg crosswalk is striped, corresponding pedestrian features (pedestrian countdown signal and push buttons) should also be installed. Due to the skew of the intersection, long crossing distance, setback of the stop bar on the west leg, and the dual eastbound right turn lanes, consider installing TURNING VEHICLES YIELD TO PEDESTRIANS (R10-15) on the mast arm and on a single post for the west leg approach. Because the east/west movements are split phased, another solution to the potential conflict between eastbound right turning vehicles and south leg pedestrians would be to have the pedestrian call on the south leg only activate with the westbound movement.

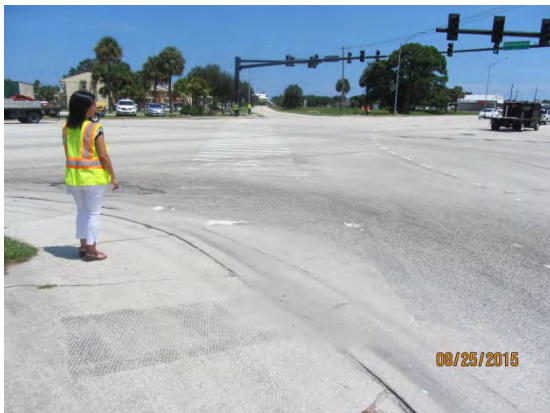
Figure 30

Due to the skew of the intersection, the north leg crosswalk does not lead to the curb ramp on the northwest corner (**Figure 30**). The curb ramp for the north leg crosswalk on the northeast corner of the intersection (**Figure 31**) points towards the middle of the intersection and doesn't lead to the crosswalk.

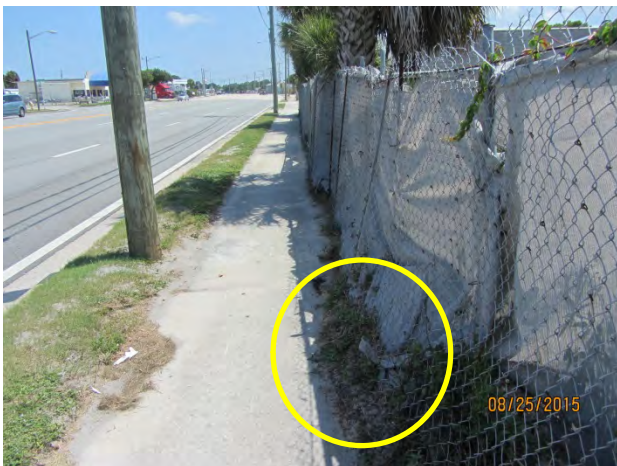
Figure 34

The Don Bell property fence line just south of Powell Avenue on the west side of the roadway has rusty wire ties poking through fence into the sidewalk as displayed in **Figure 32** and **Figure 33**. A metal pole was also observed sticking out of fence into the sidewalk as displayed in **Figure 34** and **Figure 35**. Protruding objects on the fence pose a hazard to pedestrians on the sidewalk.
