High Crash Corridors Analysis

Road Safety Audit Report for Wickham Road from Sarno Road to Parkway Drive

Project Title: Wickham Road Safety Audit - Sarno Road to Parkway Drive

Field Review Date: September 30th and October 1st, 2015 (AM/PM/afternoon/nighttime reviews and follow-up meeting)

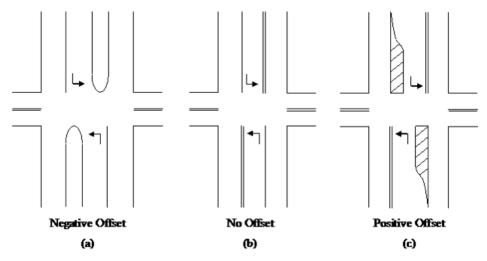
Figure 51 Illustration of Negative, No, and Positive Offset Left-turn Lanes (Source: FHWA Safety Evaluation of Offset Improvements for Left-Turn Lanes)

Wickham Road has exclusive left-turn lanes on the north and south approaches at all signalized intersections along the study corridor (Eau Gallie Boulevard shown in Figure 50) and in all cases, the left-turn phase is protected-permissive with a "doghouse" five-section signal head. The turn lanes also have a negative offset, as illustrated in Case "a" in Figure 51. The negative offset limits sight distance for northbound/southbound left-turn vehicles during the permissive left-turn phase by opposing left-turn vehicles. Left-turn crashes represent 13 percent of all crashes within the study area and are primary crash types at the following signalized intersections:

- In the near-term, replace "doghouse" five-section signal displays with 4-section flashing yellow arrow (FYA) protected/permissive left-turn display.
 - If the left-turn phasing is converted to a FYA display, consider providing protected only left-turn phasing during peak periods and allow the protected-permissive phasing during the off-peak periods.
- In the longer term, realign the northbound and southbound approaches to provide a positive offset to improve sight distance.
 - On the Wickham Road approaches to Eau Gallie Boulevard, shift the median to the right-hand side of the left-turn lane, as shown in **Figure 51(c)**.

Location	Issue Number	Issue	Suggestion		
	LONG-TERM PRIORITY				
		North/South Left-Turn	Consider realigning the northbound and southbound approaches to provide a positive offset to improve sight distance. On the		
Corridor Wide	1	Movements at	Wickham Road approaches to Eau Gallie Boulevard, shift the median to the right-hand side of the left-turn lane, as shown in		
		Signalized Intersection	Figure 51(c).
