# PEDESTRIAN ISSUES & SYSTEMIC ENGINEERING COUNTERMEASURES

**SPACE COAST**  
**TPO**  
TRANSPORTATION PLANNING ORGANIZATION

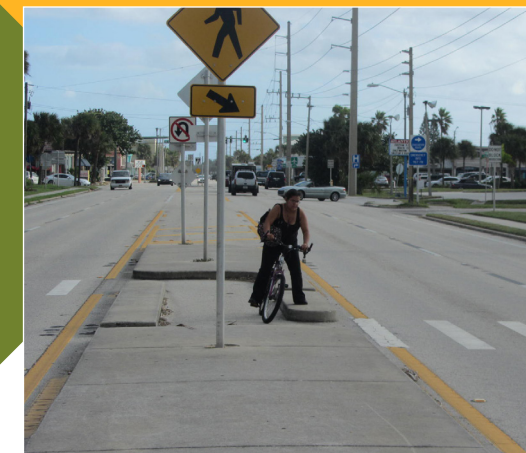
**Pedestrian Refuge Island**  
Photo: KAI

Roadways having a center two-way left-turn lane (TWLTL) or no refuge areas to cross between signalized intersections	Review locations for spot medians in places where they do not restrict turning movements at minor streets or major driveways (this is not a marked pedestrian crossing)		Near/Long Term	\$-\$-\$-\$
			Assess the feasibility of removing the center two-way left-turn lane and constructing a raised median		Near/Long Term	\$-\$-\$-\$
	Pedestrians Crossing Roadway	Potential pedestrian crossings within median area on divided roadways with grass median	Install a concrete pedestrian refuge island (this is not a marked pedestrian crossing)		Near/Long Term	\$-\$-\$-\$
		Not utilizing marked crosswalks or crossing at unmarked locations, locations with a history of pedestrian crossing crashes	Install pedestrian channelization barrier (FDOT Design Standard D804)	 	Near Term	\$-\$-\$
	Corridor Lighting	Burnt out light bulbs	Contact the owner/maintainer of the lighting system to replace burnt out bulbs		Maintenance	\$
